Central Fire Station

City of Everett ADA Transition Plan

June 2018

Year Built: 1908

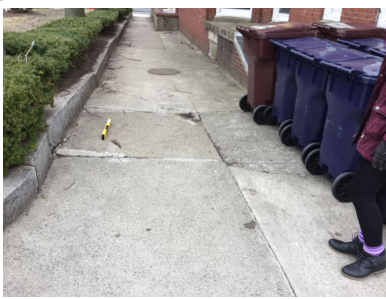
ID	Location	Element	Type	Photo	Issues	Current Measure	Recommendations	Quantity	Price	Cost Estimation	
Pedestrian Access Routes											
Walking Surface											
1	School St. to Broadway	Walking Surface	Sidewalk

Running slope > 1:20 (5.00%) Cross slope > 1:50 (2.00%) Beveled changes in level > 1/2"	6.7% 7.6% 2"	Reduce running slope to be no steeper than 1:20 (5.0%). Reduce cross slope to be no steeper than 1:50 (2.00%). Alter surface so that bevel height is 1/4" min.	1	448	\$448	
Street Crossing											
2	School St. and Corey St.	Street Crossing	N/A

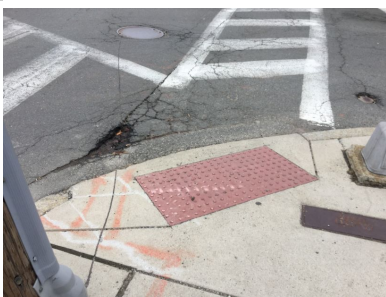
Surface not stable, firm, and slip-resistant	-	Repair surface.	1	103	\$103	
Curb Ramps and Blended Transitions											
Diagonal Curb Ramp											
3	School St. and Corey St.	Diagonal Curb Ramp	N/A

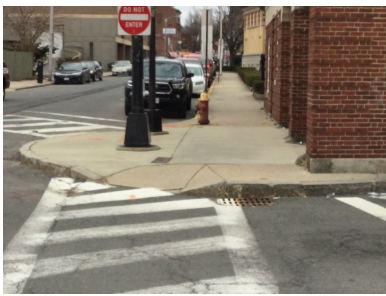
Running slope > 1:12 (8.33%) Detectable warning not provided	13.5% -	Provide a detectable warning on the curb ramp. Reduce running slope to be no steeper than 1:12 (8.33%).	1	1405	\$1405

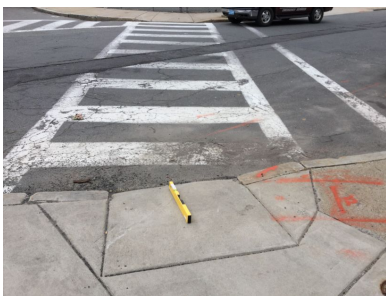
Perpendicular Curb Ramp											
4	School St. and Corey St.	Perpendicular Curb Ramp	N/A

Running slope is > 1:12 (8.33%) Transition from curb ramp to street is not flush Detectable warning not provided	11% 1" -	Reduce running slope to be no steeper than 1:12 (8.33%). Ensure transition from curb ramp to street is flush or free of changes in level. Provide a detectable warning on the curb ramp.	2	1490	\$2980

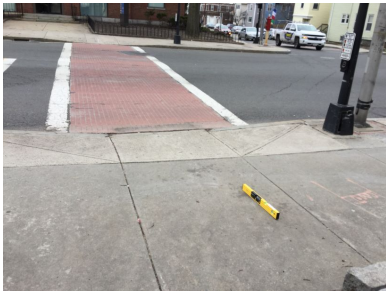
ID	Location	Element	Type	Photo	Issues	Current Measure	Recommendations	Quantity	Price	Cost Estimation	
5	Broadway	Perpendicular Curb Ramp	N/A

Landing > 1:50 (2.00%) Detectable warning not provided	5.2% -	Reduce slope to be no steeper than 1:50 (2.00%). Provide a detectable warning on the curb ramp.	2	303	\$606	
6	Broadway and Corey St.	Perpendicular Curb Ramp	N/A

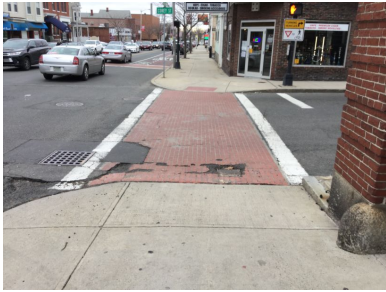
Surface not stable, firm and slip-resistant Detectable warning not provided	- -	Repair surface. Provide a detectable warning on the curb ramp.	1	283	\$283

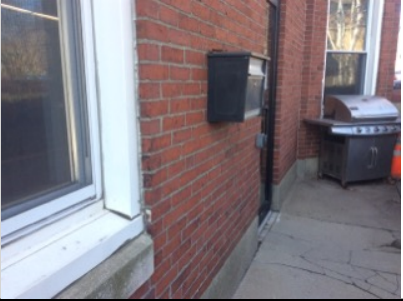
Obstructed by protruding objects	8"	Relocate mailbox.	1	Labor	\$0
8	Route to Entrance Door	1		Exterior Access Route	Walkway

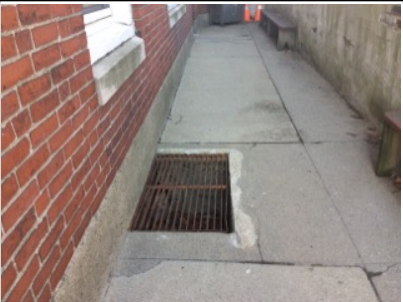
Surface openings > 1/2"		Replace or reposition so that openings are 1/2" max. and the long opening dimension is perpendicular to the dominant direction of travel.	1	1367	\$1367
9	Step Leading to Entrance and Exit Doors	1		Exterior Access Route	Walkway

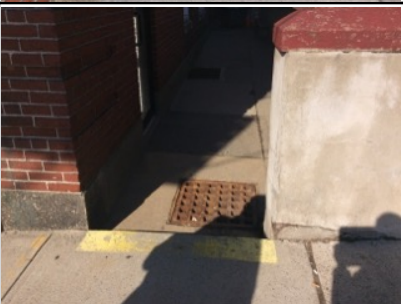
Surface openings > 1/2"		Replace or reposition so that openings are 1/2" max. and the long opening dimension is perpendicular to the dominant direction of travel.	1	1367	\$1367
10	Step Leading to Entrance and Exit Doors	1		Exterior Access Route	Walkway

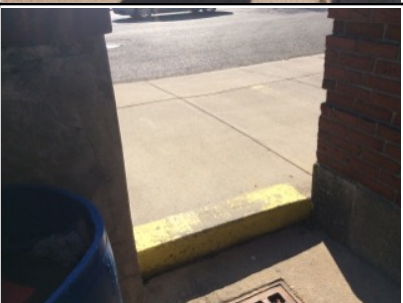
Level changes > 1/4"	6.5"	Alter change in level to be 1/4" high max. Consider installing a temporary metal ramp to provide an accessible entry route to the building. (Cost is for a 7' perforated metal ramp with a 5' x 5' platform courtesy of Amramp). N.B.: It is crucial that drainage be addressed with this design.	1	2800	\$2800

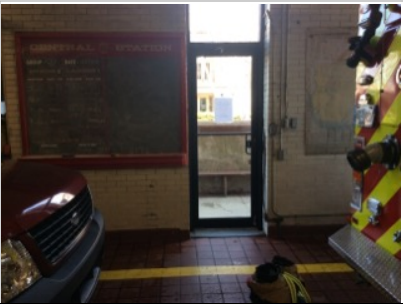
Entrance												
11	Main Entrance with Bell	1		Entrance	Main Entrance

Entrance not on an accessible route Clear width at door is < 32"	- 29"	Widen the door so that there is 32" min. clear width.	1	1683	\$1683

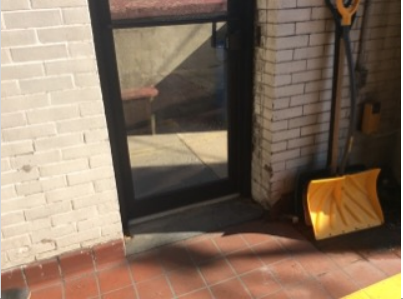
ID	Location	Floor	Room	Element	Type	Photo	Issues	Current Measure	Recommendations	Quantity	Price	Cost Estimation
Emergency Exit												
12	Exit by Truck Door	1		Emergency Exit	N/A

Emergency exit not on an accessible route Clear width at door < 32" Maneuvering clearance not provided at recess > 8"	3.4" 29" 12"	Widen the door so that there is 32" min. clear width. Install an automatic door opener. Try to address the 3.4" change in level at the door with the exterior ramp described previously.	1	3213	\$3213
13	Main Entrance with Bell	1		Emergency Exit	N/A

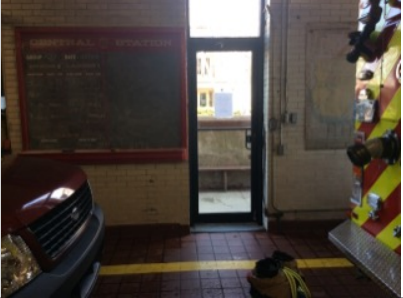
Emergency exit not on an accessible route Maneuvering clearance not provided at recess > 8"	- 12"	Install an automatic door opener.	1	1530	\$1530
Access to Goods and Services												
Interior Access Route												
14	Accessible Entrance Circulation Route	1		Interior Access Route	N/A

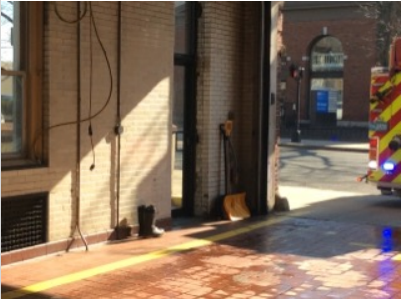
Route < 36" wide	26"	Ensure that a clear width of 36" min. is maintained at the accessible route. Currently the only accessible route in is by way of the fire door but when a truck is parked here the route narrows to 26" clear.	1	Labor	\$0

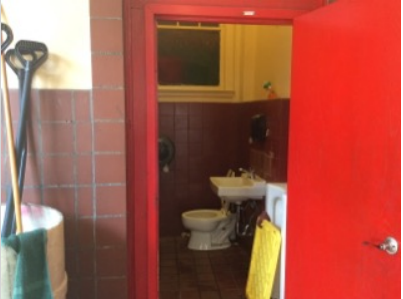
Doors, Doorways, & Gates												
15	Toilet Room	1		Doors, Doorways, & Gates	Toilet Room

Clear width at door < 32"	30"	Use offset hinges to widen the door so that there is 32" min. clear width.	1	1116	\$1116

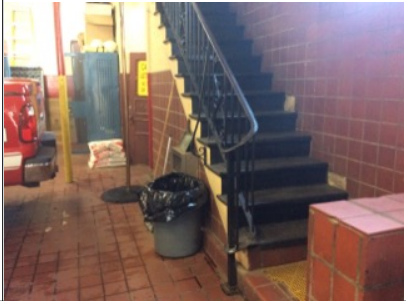
ID	Location	Floor	Room	Element	Type	Photo	Issues	Current Measure	Recommendations	Quantity	Price	Cost Estimation
Stairways												
16	Stair	1		Stairways	Interior

Handrails have non-compliant cross section Handrails not continuous where required		No accessible route to Level 2. Relocate public programs and services to an accessible location.	1	-	\$0
Signage												
17	Toilet Room	1		Signage	Designation

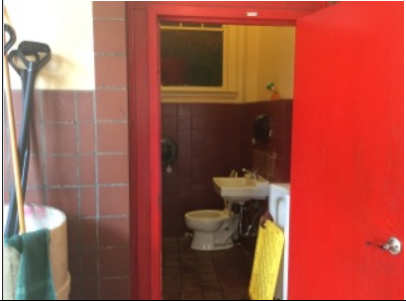
Not provided Raised characters not provided Braille not provided		Locate signage alongside the door on the latch side. Provide text with raised characters duplicated in braille.	1	116	\$116
18	Main Entrance with Bell	1		Signage	Egress

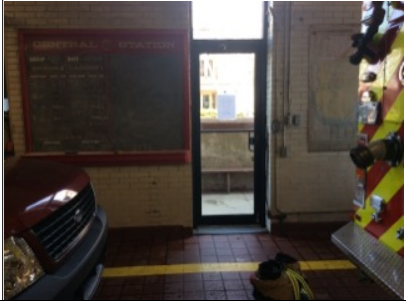
Raised characters not provided Braille not provided	-	Provide text with raised characters duplicated in braille.	2	116	\$232
Service Counter												
19	Service Counter	1		Service Counter	N/A

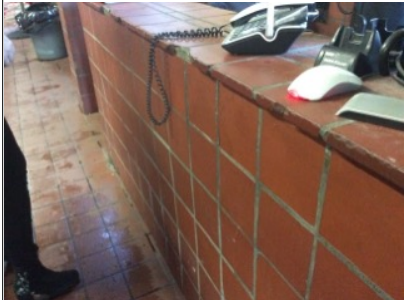
Counter > 36" high	40"	Provide a counter that is 36" max. above the ground or finish floor.	1	440	\$440

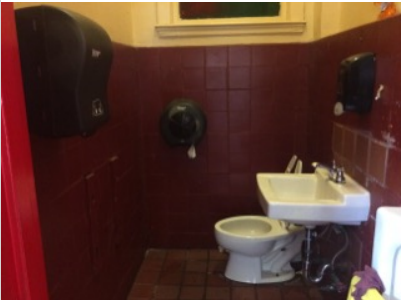
ID	Location	Floor	Room	Element	Type	Photo	Issues	Current Measure	Recommendations	Quantity	Price	Cost Estimation
Overall Access												
20	Toilet Room	1		Overall Access	Toilet Room

Turning space not provided Accessible plumbing fixtures or stalls not provided Dispensers not within reach range Audible and visible alarms not provided	51"	Redo toilet room to provide turning space. Provide one accessible wheelchair stall or add an accessible single-user toilet room. Lower dispensers to 42" max. above the floor. When fire system is updated, ensure that a visible and audible fire alarm is installed.	1	8192	\$8192
Overall Review												
21	Exit to Stair	2

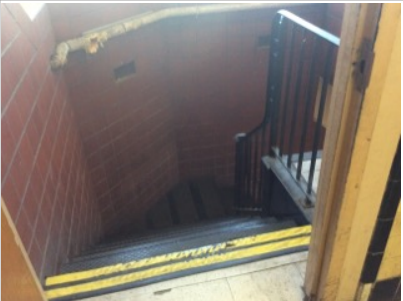
Route to second floor office is dangerous. Stairs from Level 2-1 lack handrails and a level platform at the door.	1		\$0
Best Practice												
22	Route From Entrance Door to Sidewalk	1

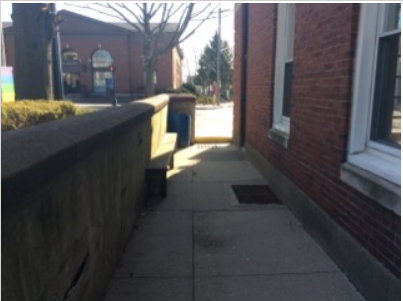
Best Practice		Provide exterior lighting to this part of the fire station during the night.	1		\$0
