## City of Everett ADA Transition Plan

March 2018

Institute for Human Centered Design

## City Hall

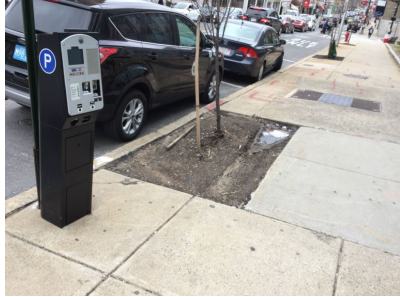
ID	Location	Element	Type	Photo	Issues	Current Measure	Recommendations	Quantity	Price	Cost Estimation
<b>Pedestrian Access Routes</b>										
<b>Walking Surface</b>										
E1	City Hall Entrance on Broadway	Walking Surface	Sidewalk

Level changes > 1/4"	3"	Alter change in level to be 1/4" high max. Provide tree grate.	1	350	\$350
<b>Curb Ramps and Blended Transitions</b>										
<b>Curb Ramp</b>										
E2	Broadway and Webster St.	Curb Ramp	N/A

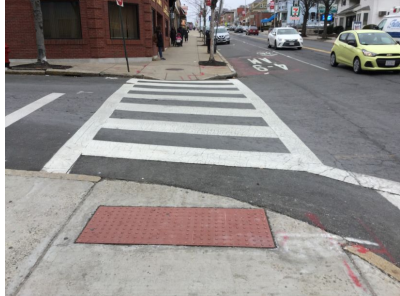
ID	Location	Element	Type	Photo	Issues	Current Measure	Recommendations	Quantity	Price	Cost Estimation
E5	Broadway and Webster St.	Detectable Warnings	Perpendicular

Detectable warnings not provided	-	Provide a detectable warning on curb ramp on opposite side.	1	180	\$180
<b>Street Furniture</b>										
<b>Benches &amp; Seating</b>										
E6	Broadway and Church St.	Benches & Seating	N/A

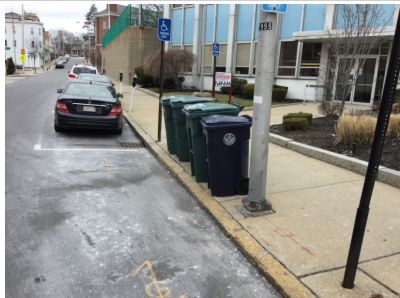
Clear floor space adjacent to the bench not provided	-	Provide a 30" x 48" clear space adjacent to the bench. Relocate trash can.	1	Labor	\$0
<b>Universal Design</b>										
E7	Church St. Accessible Entrance

Universal design recommendation - provide a curb cut at front of accessible space.	1	1225	\$1225

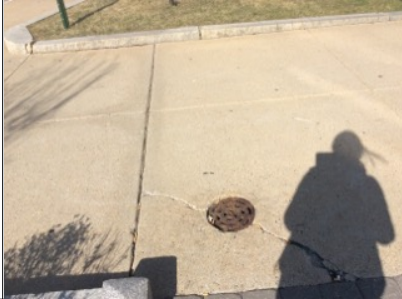
ID	Location	Floor	Room	Element	Type	Photo	Issues	Current Measure	Recommendations	Quantity	Price	Cost Estimation
<b>Approach and Entrance</b>												
<b>Exterior Access Route</b>												
1	Route to Accessible Street Entrance			Exterior Access Route	Exterior

Level changes > 1/4" Surface is not stable, firm, and slip-resistant		Alter change in level to be 1/4" high max. Repair surface.	1	103	\$103
<b>Off-Street Parking Lot or Garage</b>												
2	Parking Lot	Ext		Off-Street Parking Lot or Garage	Visitor

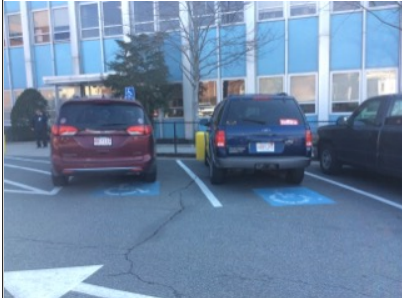
Total # of parking Total # of designated accessible parking spaces Total # of designated van accessible spaces	49 2 0	The parking lot has the required number of accessible car and van spaces. The only issues with the spaces are outlined below. An additional accessible space is provided but it was not counted because it lacks an access aisle.	1	-	\$0
3	Parking Lot (Large Space That Should be Designated Van Accessible)	Ext		Off-Street Parking Lot or Garage	Visitor

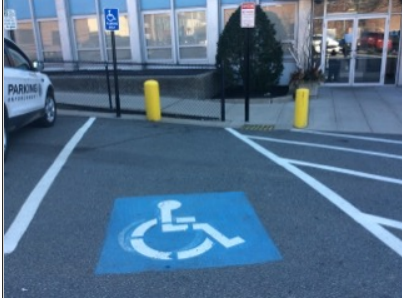
Running or cross slope at space > 1:50 (2.00%) Sign does not have the designation "Van Accessible"	4.2% -	Reduce running or cross slope to be no steeper than 1:50 (2.00%). Add the designation "Van Accessible" to the sign located at the van accessible space.	1	538	\$538

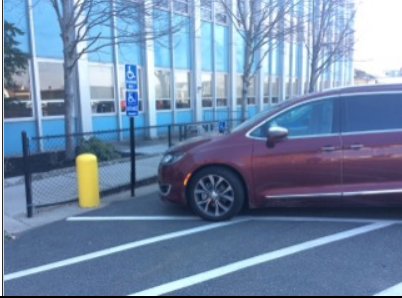
4	Parking Lot (Car Accessible Space)	Ext		Off-Street Parking Lot or Garage	Visitor

Running or cross slope at access aisle > 1:50 (2.00%)	2.7%	Reduce running or cross slope to be no steeper than 1:50 (2.00%).	1	288	\$288
5	Parking Lot (Accessible Space Lacking an Access Aisle)	Ext		Off-Street Parking Lot or Garage	Visitor

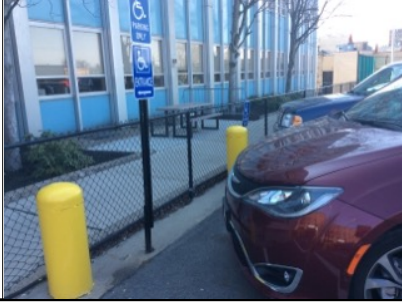
ID	Location	Floor	Room	Element	Type	Photo	Issues	Current Measure	Recommendations	Quantity	Price	Cost Estimation
6	Parking Lot (Car Accessible Space)	Ext		Off-Street Parking Lot or Garage	Visitor

Sign < 60" above finished grade	56:5"	Locate sign with the bottom of the sign 60" above the ground.	1	Labor	\$0
<b>Entrance</b>												
7	Front Entrance	1		Entrance	Main Entrance

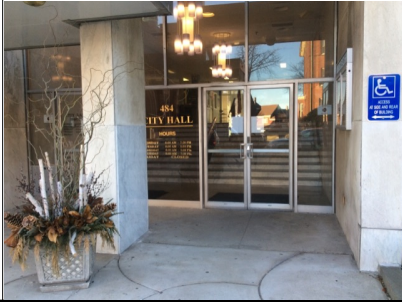
Neither door leaf is compliant Door requires >15 lbs. of force to open	26.5" 17 lbs	Provide automatic door openers for both doors in each set of double doors at this entrance/exit.	2	1530	\$3060
8	Accessible Entrance by Room 1	LL	1	Entrance	Main Entrance

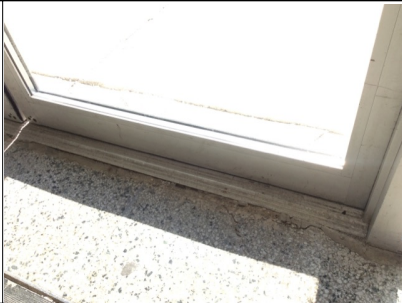
Surface not stable, firm, and slip-resistant at entrance		Repair surface.	1	103 / Labor	\$103
9	Parking Lot Entrance	Ext		Entrance	Secondary Entrance

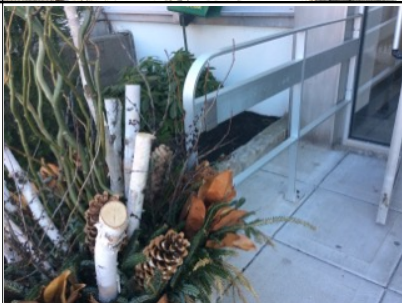
Clear floor space at opener not provided		Provide a 30" x 48" clear floor space at automatic door opener. Relocate planter. Consider providing additional contrast at button so that it's more visible.	1	Labor	\$0

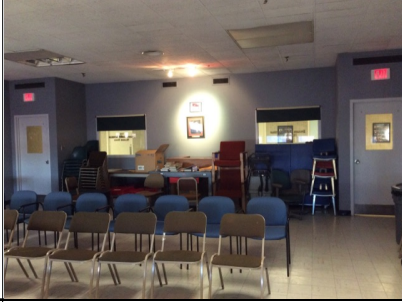
Tactile exit sign not provided		Ensure tactile exit signs with raised characters and braille are provided at exit doors. Mount signs between 48"- 60" above finish floor located on the latch side of the door.	2	116	\$232
12	Council Chambers	3	38	Means of Egress	N/A

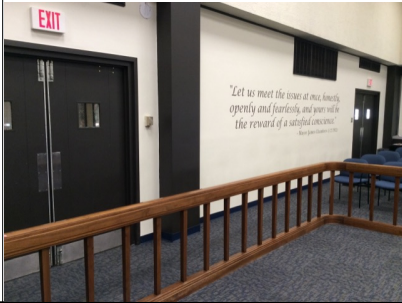
Tactile exit sign not provided		Ensure tactile exit signs with raised characters and braille are provided at exit doors. Mount signs between 48"- 60" above finish floor located on the latch side of the door.	2	116	\$232
13	Stair 1 by Room 9	LL	9	Means of Egress	N/A

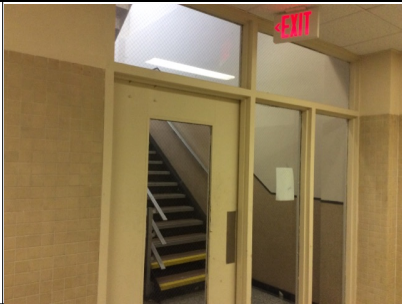
Tactile exit sign not provided		Ensure tactile exit signs with raised characters and braille are provided at exit doors leading to enclosed stairways. Mount signs between 48"- 60" above finish floor located on the latch side of the door.	1	116	\$116

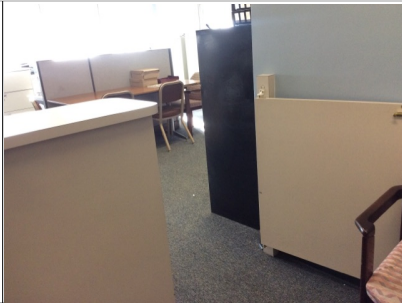
<b>Interior Access Route</b>												
14	Retirement Office	3	30	Interior Access Route	N/A

Route < 36" wide	28"	Ensure that a clear width of 36" min. is maintained at the accessible route.	1	Labor	\$0
15	Corridor by Elevator	1		Interior Access Route	N/A

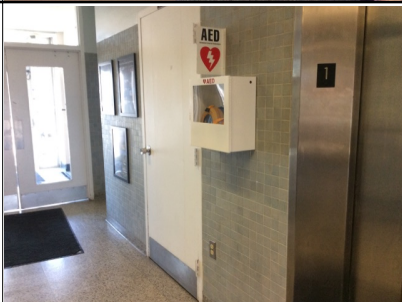
Obstructed by protruding objects	7.5"	Provide a cane detectable barrier at AED.	1	153	\$153

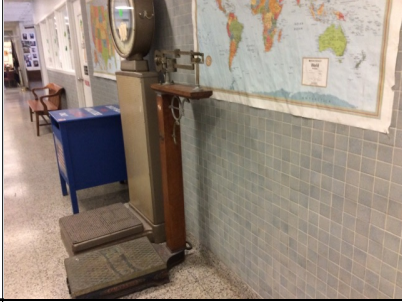
Obstructed by protruding objects	-	Reverse location of two scales so that wooden piece isn't protruding out.	1	Labor	\$0
17	Corridor by Elevator	3	38	Interior Access Route	N/A

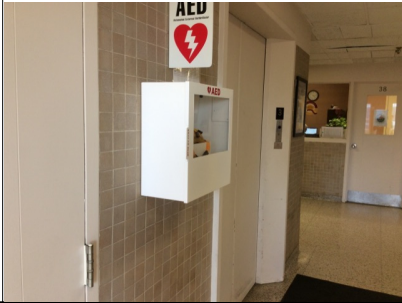
Obstructed by protruding objects		Provide a cane detectable barrier at AED.	1	153	\$153
18	Council Chambers	3	38	Interior Access Route	N/A

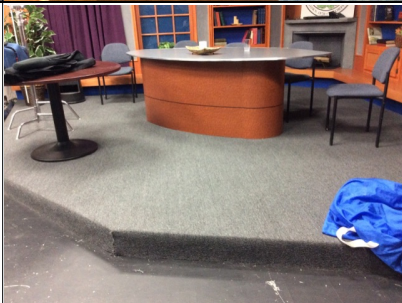
Level changes > 1/4"	7"	Remove step if possible. If not, provide a wood ramp to the stage. (Cost estimate for a wood ramp.)	1	1352	\$1352
<b>Doors, Doorways, &amp; Gates</b>												
20	Men's Toilet Room	2		Doors, Doorways, & Gates	Toilet Room

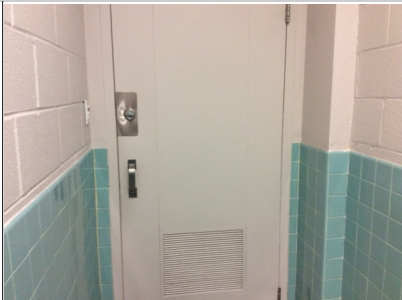
Maneuvering clearance(s) not provided	5"	Provide an automatic door opener.	1	1530	\$1530

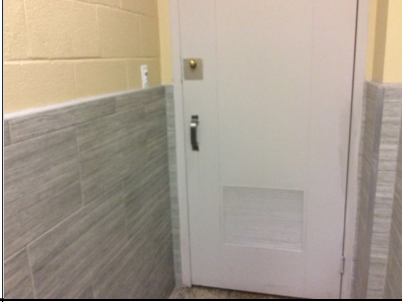
Maneuvering clearance(s) not provided	4"	Provide an automatic door opener.	1	1530	\$1530
22	Women's Toilet Room	3		Doors, Doorways, & Gates	Toilet Room

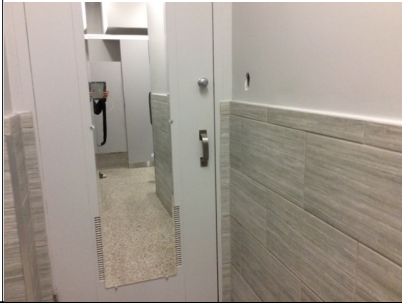
Maneuvering clearance(s) not provided	5"	Provide an automatic door opener.	1	1530	\$1530
23	City Council	3	38	Doors, Doorways, & Gates	Office

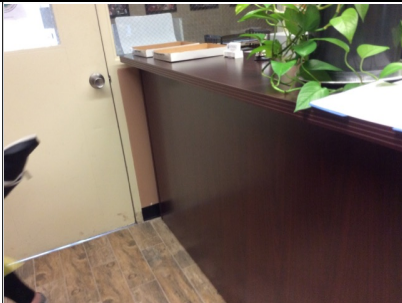
Maneuvering clearance(s) not provided		Relocate desk to provide 18" of maneuvering clearance on the latch pull side of the door.	1	Labor	\$0
24	Women's Toilet Room	LL		Doors, Doorways, & Gates	Toilet Room

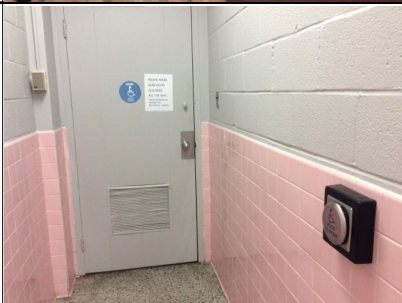
Maneuvering clearance(s) not provided	4.75"	Ensure that the automatic door opener is operational.	1	Labor	\$0
25	Men's Toilet Room	LL		Doors, Doorways, & Gates	Toilet Room

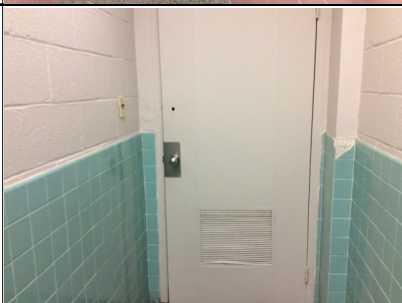
Maneuvering clearance(s) not provided Door requires > 5 lbs. of force to open	5" 12 lbs.	Provide an automatic door opener.	1	1530	\$1530

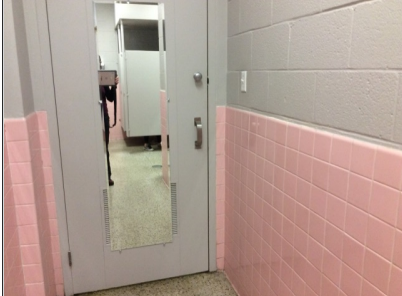
Maneuvering clearance(s) not provided Hardware not operable with a closed fist	4"	Provide an automatic door opener. Provide hardware that can be operable with one hand and not require tight grasping, pinching, or twisting of the wrist.	1	1772	\$1772
27	Hearing Room	3	37	Doors, Doorways, & Gates	Meeting Room

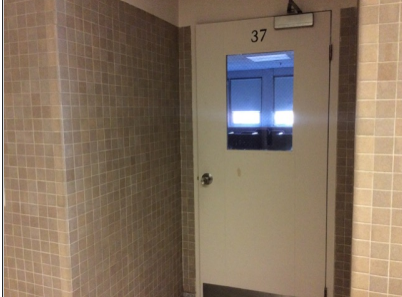
Maneuvering clearance(s) not provided Hardware not operable with a closed fist		Provide an automatic door opener. Provide hardware that can be operable with one hand and not require tight grasping, pinching, or twisting of the wrist.	2	1772	\$3544
28	City Clerk's Office, Collector's Office (3 Doors), Assessor's Office (2 Doors)	1	10 11 13	Doors, Doorways, & Gates	Office

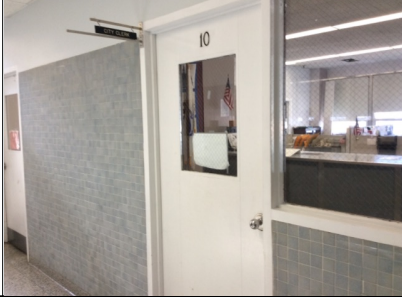
Hardware not operable with a closed fist		Provide hardware that can be operable with one hand and not require tight grasping, pinching, or twisting of the wrist.	6	242	\$1452

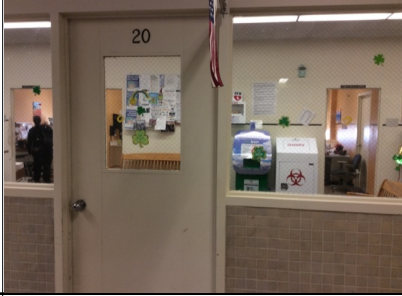
29	Health Department, City Solicitor, Meeting Rooms	2	20 21 27 28 29	Doors, Doorways, & Gates	Office

Hardware not operable with a closed fist		Provide hardware that can be operable with one hand and not require tight grasping, pinching, or twisting of the wrist.	5	242	\$1210
30	Facility Maintenance Office, Engineer's Office, Department of Planning & Development (2 Doors)	2	24 22 25	Doors, Doorways, & Gates	Office

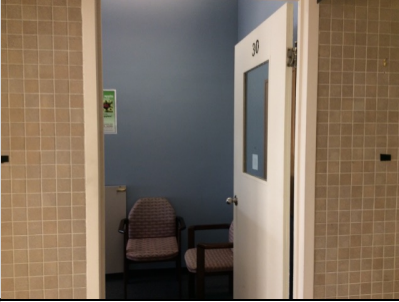
Hardware not operable with a closed fist		Provide hardware that can be operable with one hand and not require tight grasping, pinching, or twisting of the wrist.	3	242	\$726
32	City Council, Mayor's Office	3	38 31	Doors, Doorways, & Gates	Office

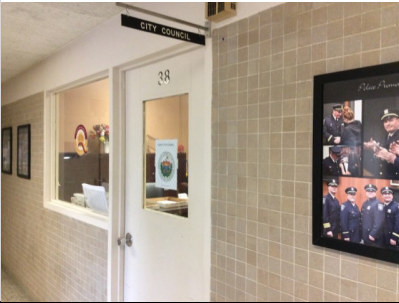
Hardware not operable with a closed fist		Provide hardware that can be operable with one hand and not require tight grasping, pinching, or twisting of the wrist.	2	242	\$484
33	Men's Toilet Room	LL		Doors, Doorways, & Gates	Toilet Room

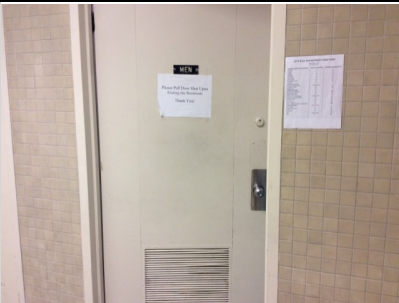
Hardware not operable with a closed fist		Provide hardware that can be operable with one hand and not require tight grasping, pinching, or twisting of the wrist.	1	242	\$242
34	Women's Toilet Room	LL		Doors, Doorways, & Gates	Toilet Room

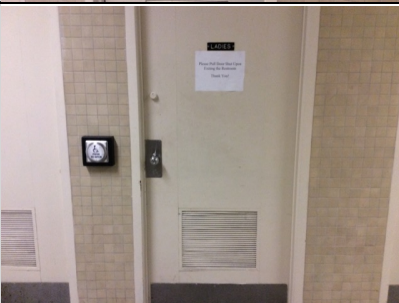
Hardware not operable with a closed fist		Provide hardware that can be operable with one hand and not require tight grasping, pinching, or twisting of the wrist.	1	242	\$242

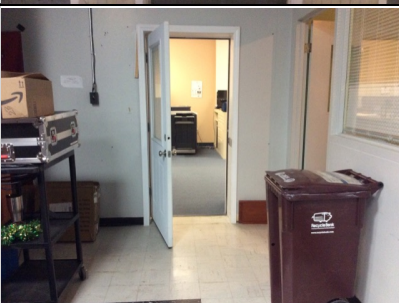
35	ECTV to TV Studio	LL	1	Doors, Doorways, & Gates	Meeting Room

Hardware not operable with a closed fist		Provide hardware that can be operable with one hand and not require tight grasping, pinching, or twisting of the wrist.	1	242	\$242

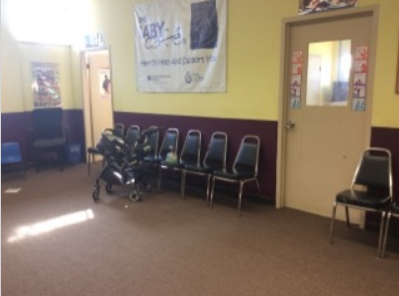
Hardware not operable with a closed fist		Provide hardware that can be operable with one hand and not require tight grasping, pinching, or twisting of the wrist.	3	242	\$726
37	Health Insurance, WIC Office, ECTV, IT	LL	2 1A 1 9	Doors, Doorways, & Gates	Office

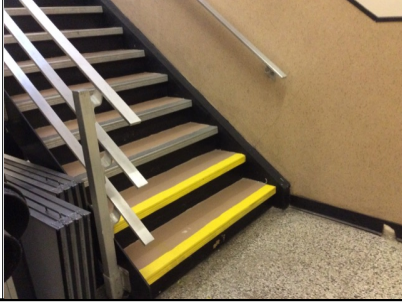
Handrails have non-compliant cross section Handrails not continuous where required		Provide handrails with 1 1/4" - 2" circular cross sections. Provide continuous handrails.	3	2220	\$6660
<b>Elevator</b>												
42	Elevator, All Levels	LL		Elevator	Interior

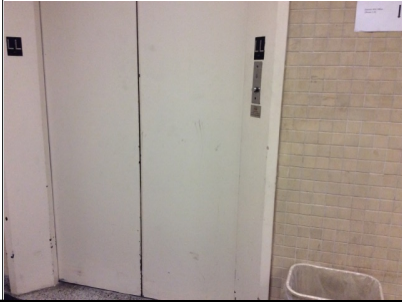
Elevator call buttons > 42" (MAAB) Elevator call buttons > 48"	52.5"	Lower call buttons to 42" max. above the finish floor at each level.	4	964	\$3856
43	Elevator	1		Elevator	Interior

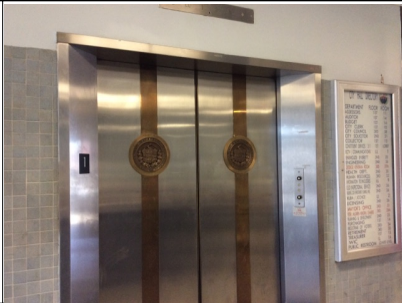
Hoistway signs not on both jambs Tactile stars not provided at main entry level		Provide hoistway signs on both sides of jambs. Provide a tactile star on both sides of jambs at main floor. At other floors, provide appropriate number. Provide a tactile star at the main floor on the control panel within the car.	2	48	\$96

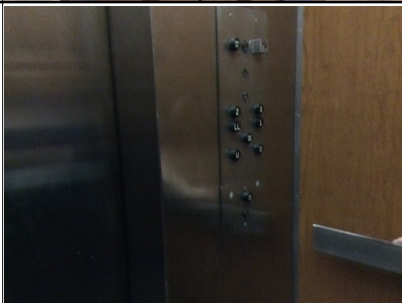
44	Elevator	LL		Elevator	Interior

Tactile stars not provided at main entry level Audible & visible car position indicators not provided	- -	Provide a tactile star at the main floor on the control panel within the car. Install audible and visible car position indicators.	1	1748	\$1748
<b>Signage</b>												
45	Auditor Purchasing Treasurer Budget and Other Offices on Level 1	1		Signage	Designation

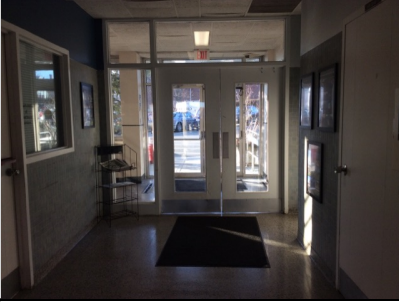
Raised characters not provided Braille not provided		Provide text with raised characters duplicated in braille.	5	116	\$580
47	Women's Toilet Room and Men's Toilet Room	2		Signage	Designation

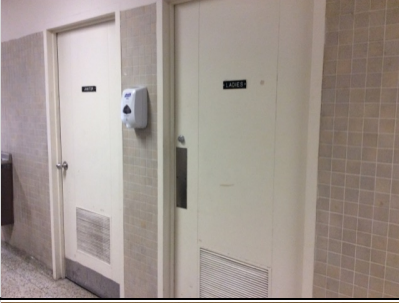
Raised characters not provided Braille not provided		Provide text with raised characters duplicated in braille.	2	116	\$232
48	Inspectional Services and Other Offices on Level 2	2	26	Signage	Designation

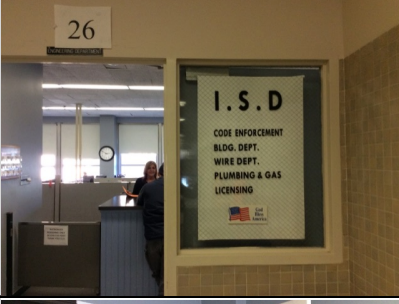
Raised characters not provided Braille not provided		Provide text with raised characters duplicated in braille.	14	116	\$1624
49	Human Resources and Other Offices on Level 3	3	32	Signage	Designation

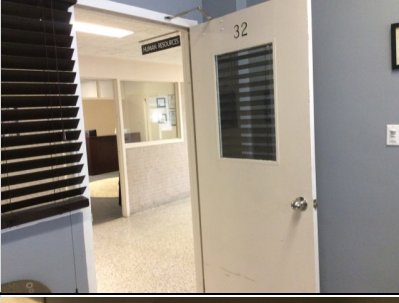
Raised characters not provided Braille not provided		Provide text with raised characters duplicated in braille.	13	116	\$1508

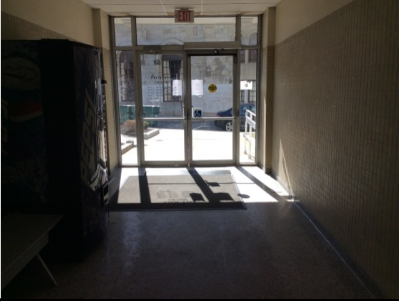
Raised characters not provided Braille not provided		Provide text with raised characters duplicated in braille.	1	116	\$116
52	WIC Office and Other Offices throughout Lower Level	LL	1A	Signage	Designation

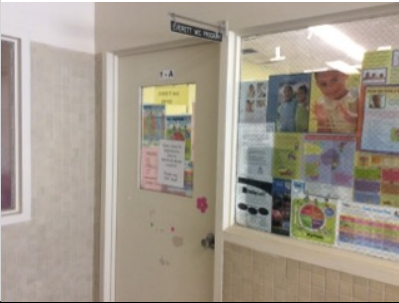
Raised characters not provided Braille not provided		Provide text with raised characters duplicated in braille.	9	116	\$1044
53	Women's Toilet Room and Men's Toilet Room	3		Signage	Designation

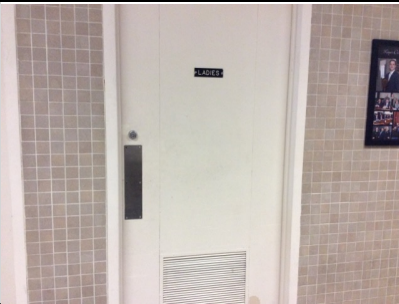
Raised characters not provided Braille not provided International Symbol of Acc. not compliant		Provide text with raised characters duplicated in braille. Replace sign with a sign containing the International Symbol of Accessibility.	2	116	\$232
54	Parking Lot Entrance	1		Signage	Informational

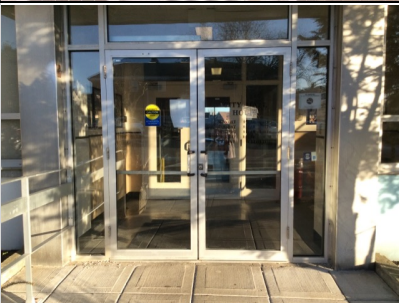
International Symbol of Acc. not compliant		Replace sign with a sign containing the International Symbol of Accessibility.	1	116	\$116

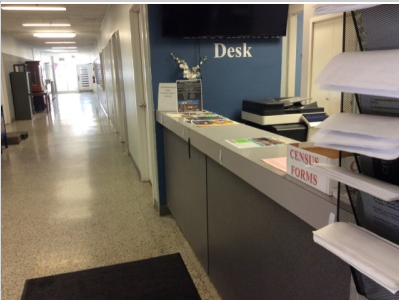
Counter > 36" high	42"	Provide a counter that is 36" max. above the ground or finish floor.	1	440	\$440

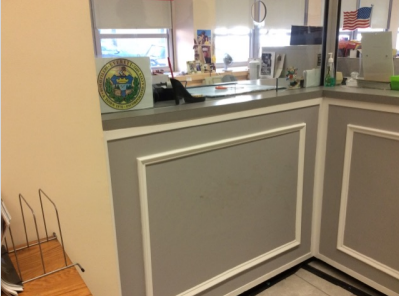
Counter > 36" high	42"- 43.3"	Provide a counter that is 36" max. above the ground or finish floor.	2	440	\$880
57	City Clerk's Office, Assessor's Office	1	10 11	Service Counter	N/A

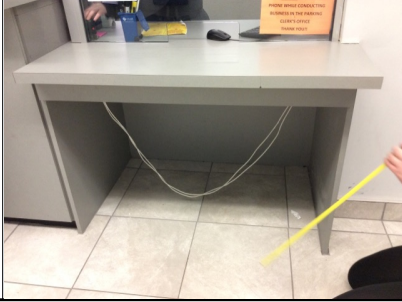
Forward approach w/ part of counter surface < 30" long		Relocate wire out of clear space at counter. Provide a portion of the counter surface that is 30" long min. and 36" high max. with 27" min. knee and toe clearance under the counter.	1	Labor	\$0
<b>Operable Parts</b>												
62	Elevator			Operable Parts	Equipment

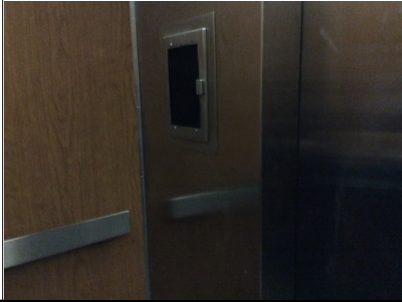
Reach < 15" or > 48"(forward/side approach)	56"	Relocate phone so that controls are between 15"- 48" above finish floor.	1	Labor / 128	\$128
63	ECTV	LL	1	Operable Parts	Clothes Rod/Hooks

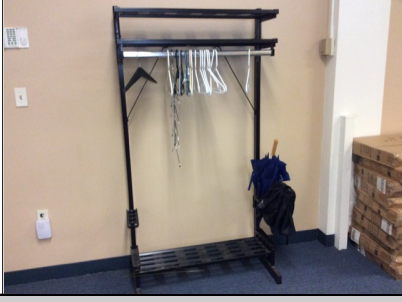
Reach < 15" or > 48"(forward/side approach)	59"	Provide a clothes rod or coat hook 15"- 48" above finish floor.	1	128	\$128
<b>Dining or Work Surfaces</b>												
64	Human Resources Retirement Office Meeting Room, and Auditor's Office on 1	3 1	32 30	Dining or Work Surfaces	Work Surface

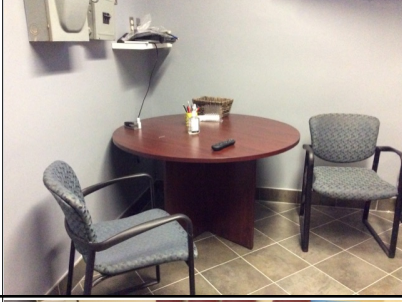
Knee or toe clearance not provided	9"	Provide at least 1 dining or work surface with 27" min. knee and toe clearance.	3	350	\$1050

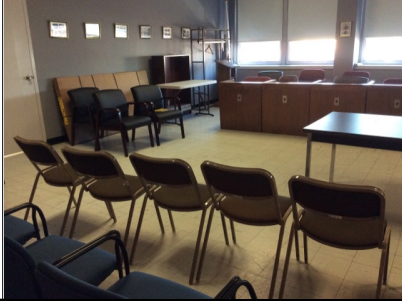
Assistive listening devices not provided		If audible communication is integral to the use of the space, provide an assistive listening system.	1	1214	\$1214
67	Council Chambers	3	38	Assembly Area	N/A

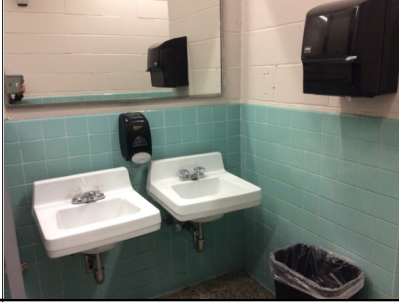
Faucet is not operable with a closed fist Plumbing underneath is exposed Mirror above lavatory w/reflective surface > 40" Dispensers not within reach range	- - 49" 56"	Provide a faucet that can be operable with one hand and not require tight grasping, pinching, or twisting of the wrist for at least one lavatory. Insulate or otherwise configure pipes to prevent contact, for at least one lavatory. Lower mirror so that the bottom surface is at 40" max. above finish floor. Relocate dispenser to 42" max. above the floor.	1	1030	\$1030
85	Men's Toilet Room	LL		Lavatory	N/A

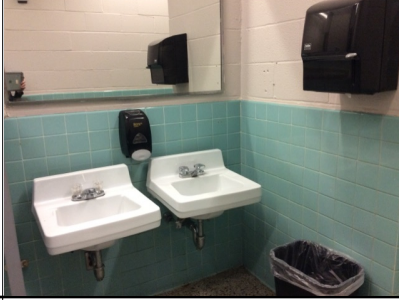
Faucet is not operable with a closed fist Plumbing underneath is exposed Mirror above lavatory w/reflective surface > 40" Dispensers not within reach range	- - 49" 56"	Provide a faucet that can be operable with one hand and not require tight grasping, pinching, or twisting of the wrist for at least one lavatory. Insulate or otherwise configure pipes to prevent contact, for at least one lavatory. Lower mirror so that the bottom surface is at 40" max. above finish floor. Relocate dispenser to 42" max. above the floor.	1	493 46 128 353	\$4934612835 3

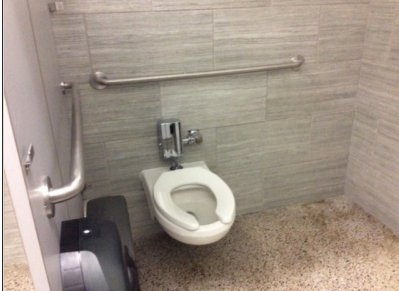
Door has incorrect swing		Reverse swing at door and replace keeper.	1	128	\$128

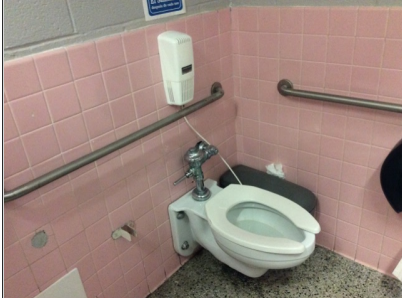
Door has incorrect swing		Reverse swing at door and replace keeper. Per MAAB, ensure no devices are mounted above either grab bar, obstructing its use.	1	128 Labor	\$128
76	Men's Toilet Room	3		Toilet Compartment	Accessible Compartment

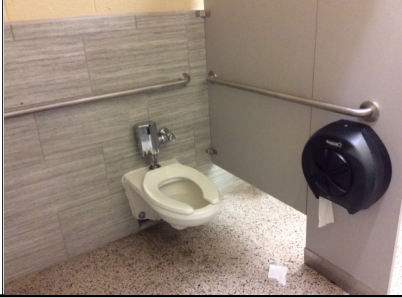
Door has incorrect swing Door has malfunctioning self-closing hinge		Reverse swing at door and replace keeper. Repair hinge.	1	128 Labor	\$128
<b>Urinal</b>												
77	Men's Toilet Rooms	LL 2		Urinal	N/A

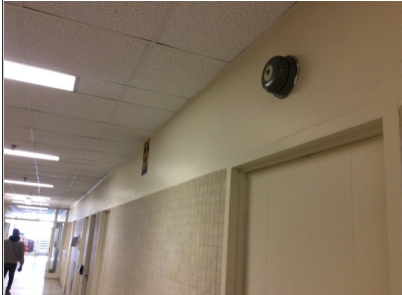
No visible fire alarm provided within room		When fire system is updated, ensure that a visible fire alarm is installed in each room and in corridors. Currently only audible alarms are installed in corridors throughout the building. In existing facilities, visual alarms shall not be required except where an existing fire alarm system is upgraded or replaced, or a new fire alarm system installed.	1	-	\$0
