Connolly Center (Armory)

City of Everett ADA Transition Plan

July 2018

Year Built: c. 1910

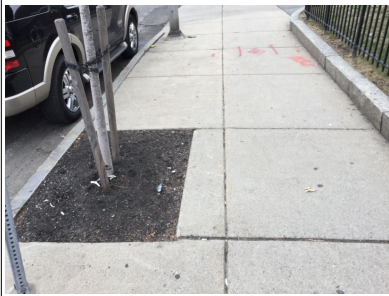
Level changes > 1/4"	2"	Provide a tree grate.	1	1454	\$1454
Curb Ramps and Blended Transitions										
Perpendicular Curb Ramp										
2	Chelsea Place	Perpendicular Curb Ramp	N/A

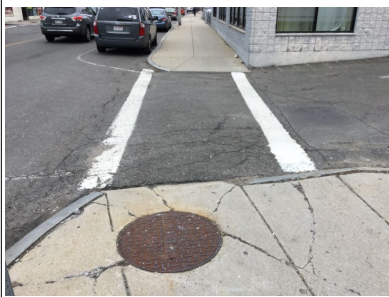
Transition from curb ramp to street is not flush Surface not stable, firm and slip-resistant Detectable warning not provided	1" - -	Ensure transition from curb ramp to street is flush or free of changes in level. Repair surface. Provide a detectable warning on the curb ramp.	1	548	\$548
3	Armory Entrance	Perpendicular Curb Ramp	N/A

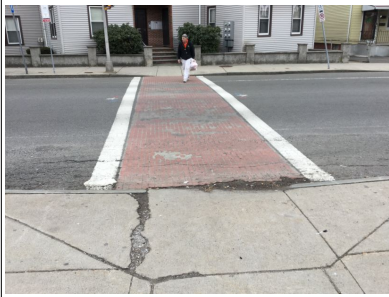
Surface not stable, firm and slip-resistant Detectable warning not provided	- -	Repair surface. Provide a detectable warning on the curb ramp.	2	283	\$566
Off-Street Parking Lot or Garage

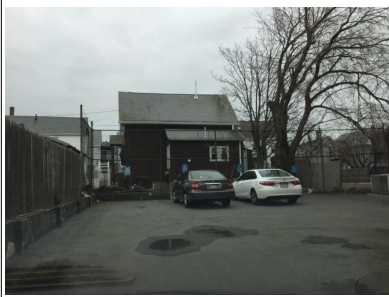
Parking Lots										
4	Back Lot	Parking Lots	Vistor

Total # of parking Total # of designated accessible parking spaces Total # of designated van accessible spaces Access aisle not provided Sign does not have the designation "Van Accessible" Sign < 60" above finished grade	6 4 0 - - 48"	Provide at least 1 van accessible space. Provide a marked access aisle that is at least 96" wide. Provide a van accessible sign and locate sign with the bottom of the sign 60" above the ground.	1	400 Labor	\$400

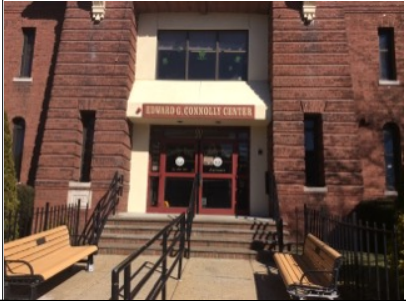
Entrance not on an accessible route		Provide a directional sign indicating the location of the nearest accessible entrance.	1	173	\$173
6	Accessible Entrance	Ext.		Entrance	Secondary Entrance

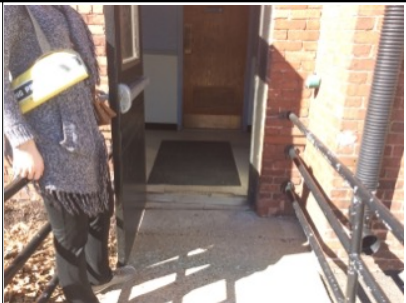
Maneuvering clearance is not provided Threshold not beveled Threshold > 1/2" high	- - 2"	Provide an automatic door opener. Bevel threshold. Alter threshold to be 1/2" high max.	1	1605	\$1605

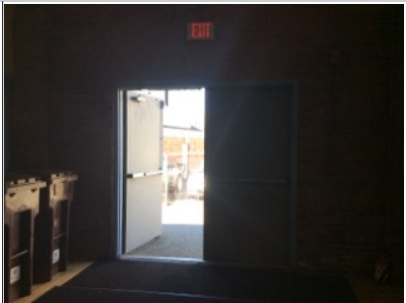
F. Emergency Exit												
7	Emergency Exit in Main Hall	1		Emergency Exit	N/A

Emergency exit not on an accessible route	-	Provide a directional sign indicating the location of the nearest emergency exit.	1	116	\$116
8	Accessible Exit	1		Emergency Exit	N/A

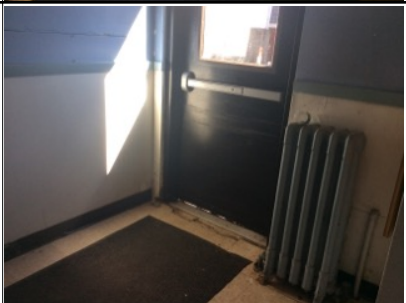
Maneuvering clearance(s) not provided Threshold > 1/2" high Threshold not beveled	- 1" -	Provide an automatic door opener. Ensure it's on stand-by power Alter threshold to be 1/2" high max. Bevel threshold.	1	1605	\$1605
9	Back Exit From Main Hall	1		Emergency Exit	N/A

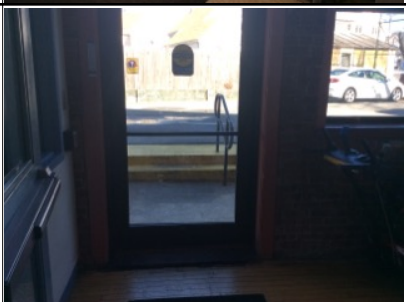
Automatic door opener not operable	-	Repair or replace the door opener.	1	1350	\$1350

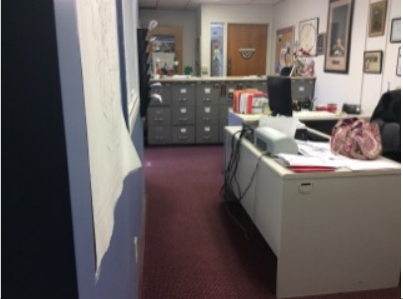
B. Interior Access Route												
10	Veterans Services Office	1		Interior Access Route	N/A

Route < 36" wide Obstructed by protruding objects	30" 6"	Ensure that a clear width of 36" min. is maintained at the accessible route. Replace the file folder with one that does not protrude into the circulation path.	1	Labor 128	\$128
11	Kitchen in Main Hall	1		Interior Access Route	N/A

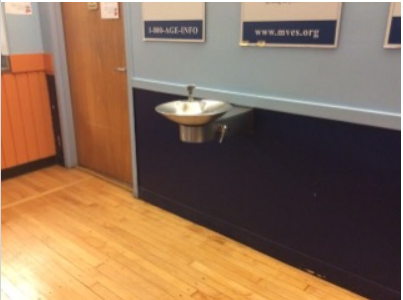
Obstructed by protruding objects	22" -	Provide a cane detectable barrier at the drinking fountain.	1	439	\$439

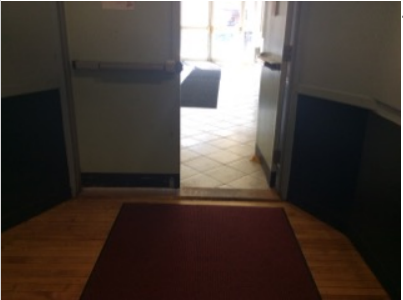
Threshold not beveled Threshold > 1/2" high	- 1"	Bevel threshold. Alter threshold to be 1/2" high max.	1	75	\$75
13	Women's Multi-User Toilet Room in Main Hall	1		Doors, Doorways, & Gates	Toilet Room

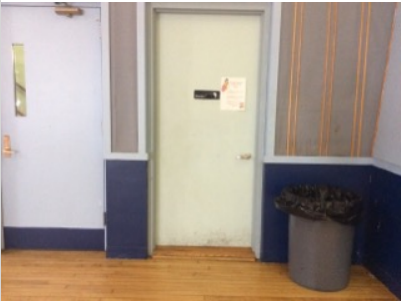
Threshold > 1/2" high Door requires > 5 lbs. of force to open	2" 15 lbs	Alter threshold to be 1/2" high max. Adjust closers so doors do not require more than 5 pounds of force to open.	1	75 Labor	\$75
14	Veterans Services Office	1		Doors, Doorways, & Gates	Circulation

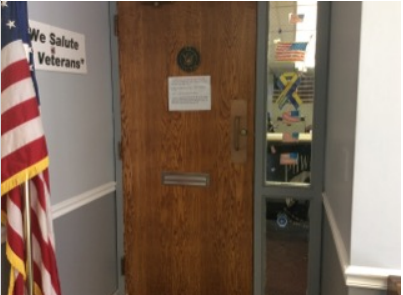
Door requires > 5 lbs. of force to open	10 lbs	Adjust closers so doors do not require more than 5 pounds of force to open.	1	Labor	\$0

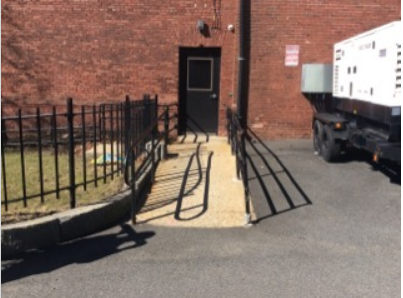
Ramp < 48" wide Running slope >1:12 (8.33%) Handrails < 34" or > 38" above ramp surface. Edge protection < 4" high	44" 11% 32" -	Widen ramp so that the clear width is 48" min. Reduce running slope to be no steeper than 1:12 (8.33%). Alter so the handrails are 34"- 38" high above the floor. Provide edge protection that prevents the passage of a 4" diameter sphere, where any portion of the sphere is within 4" of the finish floor or ground surface.	1	9833	\$9833
16	Accessible Entrance	Ext.		Ramps	Other

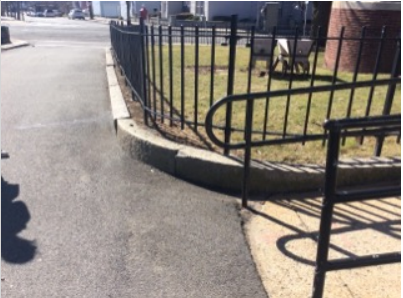
Handrails do not extend 12" past top & bottom	-	Alter handrails to extend horizontally above the landing for 12" min. beyond the top and bottom of ramp runs.	1	100	\$100

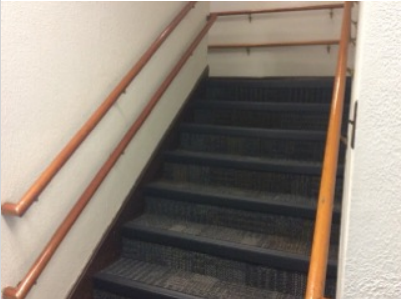
E. Stairways												
17	Stairs to Adult Learning Center Office	1		Stairways	Interior

Handrail height < 34" or > 38" Handrail height < 18" or > 20" (MAAB) Handrails do not extend 12" from stairs	32" 22" -	Alter so the handrails are 34"- 38" high above the floor. Alter so the handrails are 18"- 20" high above the floor. Top: Ensure handrails extend horizontally above the landing for 12" min. beginning above the first riser nosing.	2	Labor 1510	\$3020
18	Stairs to Adult Learning Center Office	2		Stairways	Interior

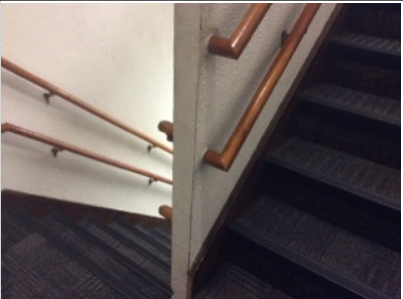
Handrails do not extend 12" from stairs	-	At the bottom of the stair flight, handrails shall extend at the slope of the stair flight for a horizontal distance at least equal to one tread depth beyond the last riser nosing. Extensions shall return to a wall, guard, or the landing surface or shall be continuous to the handrail of an adjacent stair flight.	2	400	\$800
19	Staircase 2	2		Stairways	Interior

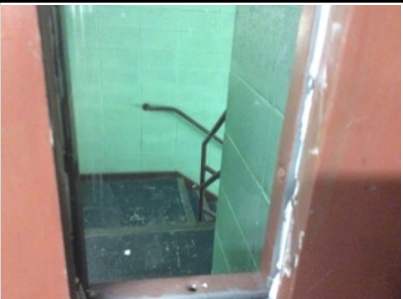
Handrails have non-compliant cross section Handrails not continuous where required		Provide compliant handrail on this stair with a 1 1/4" - 2" circular cross section.	2	1110	\$2220

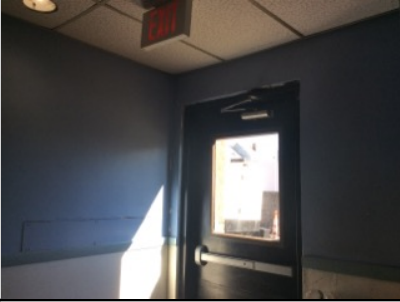
Raised characters not provided Braille not provided	- -	Provide text with raised characters duplicated in braille.	1	116	\$116
21	Emergency Exit in Main Hall	1		Signage	Egress

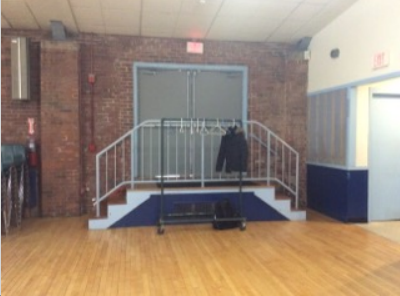
Raised characters not provided Braille not provided	- -	Provide text with raised characters duplicated in braille.	1	116	\$116
22	Veterans Services Office	1		Signage	Egress

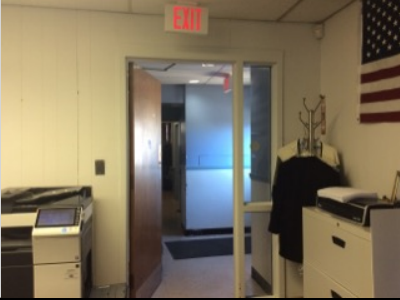
Raised characters not provided Braille not provided	- -	Provide text with raised characters duplicated in braille.	1	116	\$116
23	Gender Neutral Toilet Room	2		Signage	Designation

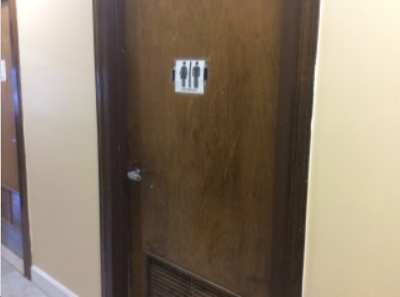
Raised characters not provided Braille not provided Sign not located on the latch side of the door	- - -	Provide text with raised characters duplicated in braille. Locate sign at permanent rooms alongside the door on the latch side.	1	116 Labor	\$116

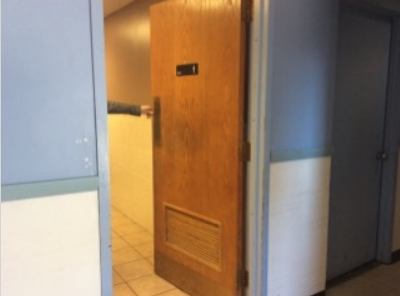
24	Men's Multi-User Toilet Room	1		Signage	Designation

Raised characters not provided Braille not provided Sign not located on the latch side of the door	- - -	Provide text with raised characters duplicated in braille. Locate sign at permanent rooms alongside the door on the latch side.	1	116 Labor	\$116

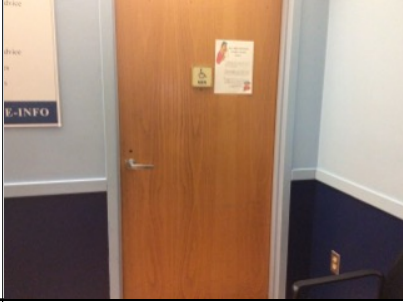
Raised characters not provided Braille not provided Sign not located on the latch side of the door	- - -	Provide text with raised characters duplicated in braille. Locate sign at permanent rooms alongside the door on the latch side.	1	116 Labor	\$116
26	Women's Single-User Toilet Room by Kitchen	1		Signage	Designation

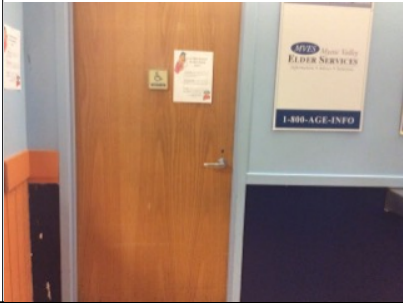
Raised characters not provided Braille not provided Sign not located on the latch side of the door	- - -	Provide text with raised characters duplicated in braille. Locate sign at permanent rooms alongside the door on the latch side.	1	116 Labor	\$116

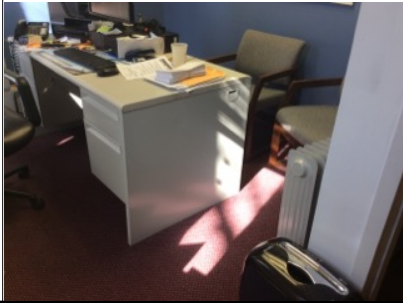
J. Service Counter												
27	Veterans Services Office	1		Service Counter	N/A

Maneuvering clearances not provided		Reconfigure the space so that there is adequate maneuvering clearance near the office desk.	1	Labor	\$0
28	Veterans Services Office	1		Service Counter	N/A

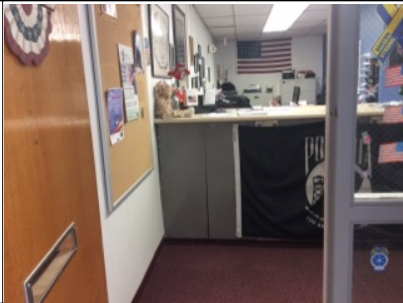
Counter > 36" high	41"	Provide a counter that is 36" max. above the ground or finish floor.	1	440	\$440

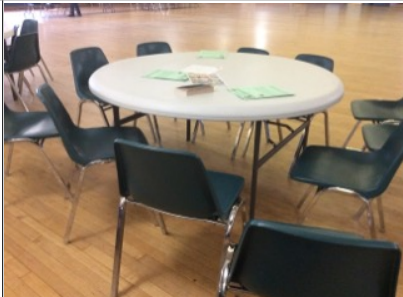
M. Dining or Work Surfaces												
29	Main Hall	1		Dining or Work Surfaces	Dining Surface

At least one or 5% accessible tables not provided Knee or toe clearance not provided	10 26"	Provide at least 1 dining or work surface with 27" min. knee and toe clearance.	1	350	\$350

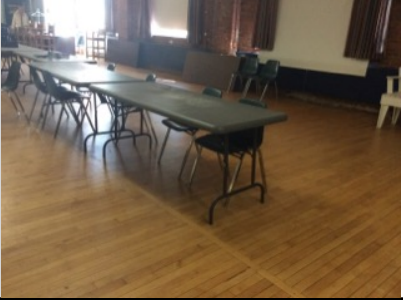
At least one or 5% accessible tables not provided Knee or toe clearance not provided	5 26"	Provide at least 1 dining or work surface with 27" min. knee and toe clearance.	1	350	\$350

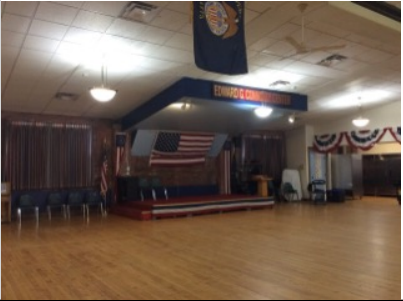
N. Assembly Area												
31	Stage in Main Hall	1		Assembly Area	N/A

Accessible route to stage not provided	-	Provide an accessible route to the stage. Consider installing a ramp. (Cost estimate for a temporary metal ramp with handrails.)	1	2800	\$2800
32	Stage in Main Hall	1		Assembly Area	N/A

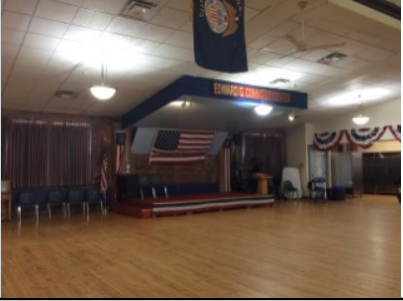
Assistive listening devices not provided	-	If audible communication is integral to the use of the space, provide an assistive listening system. (Cost estimate is for a maximum capacity of 1200.)	1	9865	\$9865

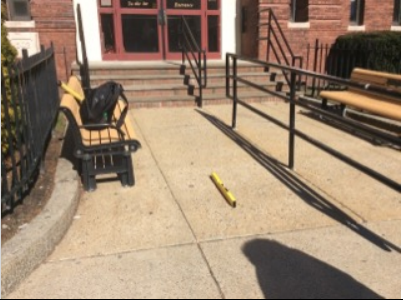
T. Benches												
33	Main Entrance	Ext.		Benches	N/A

Running slope > 1:50 (2.00%)	8.7%	Ensure that 20% of benches have a running slope no greater than 1:50 (2.00%) around the bench and in the clear floor space.	1	300	\$300

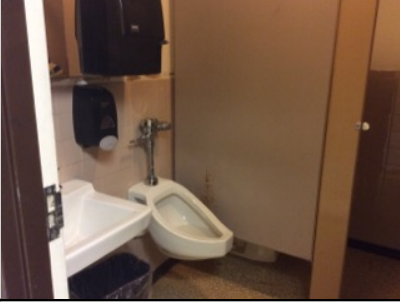
Accessible plumbing fixtures or stalls not provided Sign to accessible toilet not provided Audible and visible alarms not provided	- - -	Provide a directional sign indicating the location of the nearest accessible toilet or bathing room. When fire system is updated, ensure that a visible and audible fire alarm is installed.	1	426	\$426
35	Men's Multi-User Toilet Room	1		Overall Access	Toilet Room

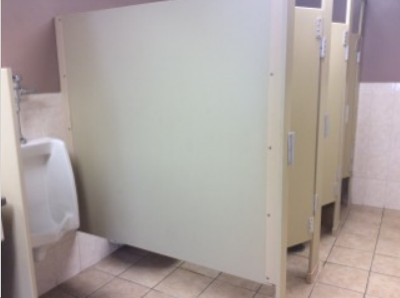
Accessible plumbing fixtures or stalls not provided Audible and visible alarms not provided	- - -	Provide one accessible wheelchair stall. When fire system is updated, ensure that a visible and audible fire alarm is installed.	1	3437	\$3437
36	Women's Multi-User Toilet Room in Main Hall	1		Overall Access	Toilet Room

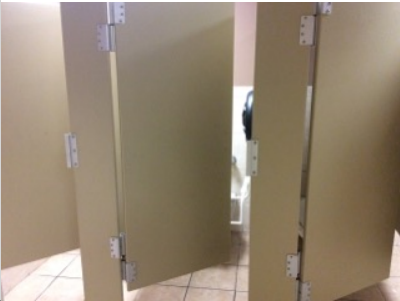
Accessible plumbing fixtures or stalls not provided Audible and visible alarms not provided	- -	Provide one accessible wheelchair stall. When fire system is updated, ensure that a visible and audible fire alarm is installed.	1	3437	\$3437

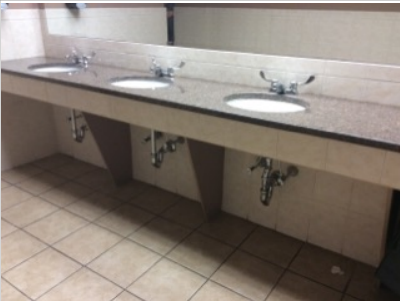
B. Lavatory												
37	Women's Multi-User Toilet Room in Main Hall	1		Lavatory	N/A

Lavatory rim or counter > 34" high Plumbing underneath is exposed Mirror above lavatory w/reflective surface > 40"	35" - 42"	Insulate or otherwise configure pipes to prevent contact, for at least one lavatory. Lower mirror so that the bottom surface is at 40" max. above finish floor.	1	174	\$174
38	Men's Multi-User Toilet Room	1		Lavatory	N/A

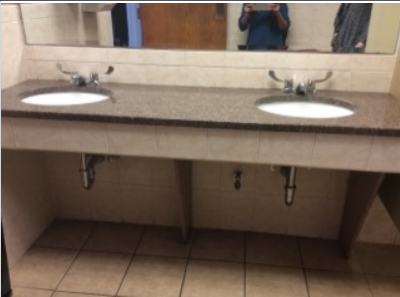
Plumbing underneath is exposed Mirror above lavatory w/reflective surface > 40"	- 41"	Insulate or otherwise configure pipes to prevent contact, for at least one lavatory. Lower mirror so that the bottom surface is at 40" max. above finish floor.	1	174	\$174

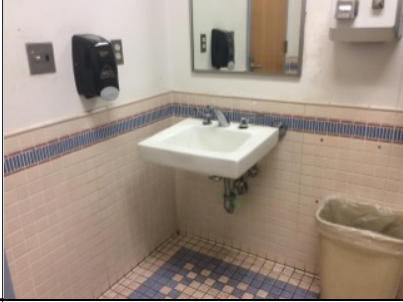
Plumbing underneath is exposed Mirror above lavatory w/reflective surface > 40"	- 42"	Insulate or otherwise configure pipes to prevent contact, for at least one lavatory. Lower mirror so that the bottom surface is at 40" max. above finish floor.	1	174	\$174
40	Women's Single-User Toilet Room by Kitchen	1		Lavatory	N/A

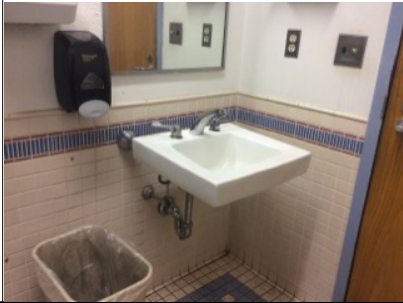
Plumbing underneath is exposed Mirror above lavatory w/reflective surface > 40"	- 42"	Insulate or otherwise configure pipes to prevent contact, for at least one lavatory. Lower mirror so that the bottom surface is at 40" max. above finish floor.	1	174	\$174

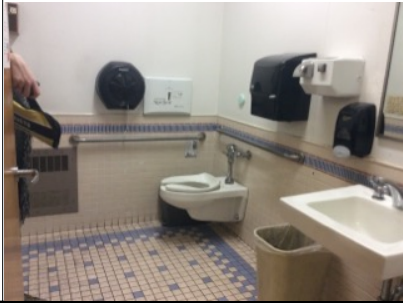
C. Single-User Toilet												
41	Women's Single-User Toilet Room by Kitchen	1		Single-User Toilet	N/A

Flush control not on open side Side grab bar < 54" from back wall Side or rear grab bar < 33" or > 36" high Toilet paper dispenser is not compliant Toilet cover dispenser is not compliant Hook located > 48" high	- 47" 30" - 61"	Relocate the flush control to the open side. Mount grab bars to 33"- 36" above the floor. Relocate toilet paper so that it is 15" min high, located under the grab bar, and between 7" and 9" from the front of the toilet. Relocate toilet cover dispenser so the operable parts are no higher than 42" on the side of the toilet. Locate hook no higher than 48". Ensure no dispensers are mounted above the grab bars.	1	1096	\$1096
42	Men's Single-User Toilet Room by Kitchen	1		Single-User Toilet	N/A

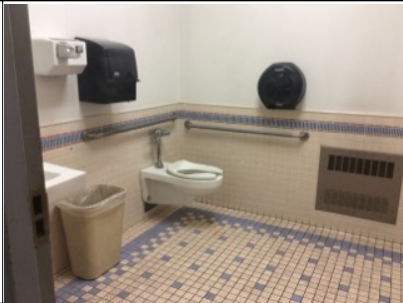
Side grab bar < 54" from back wall Side or rear grab bar < 33" or > 36" high Toilet paper dispenser is not compliant	45" 30" -	Mount grab bars to 33"- 36" above the floor. Relocate toilet paper so that it is 15" min high, located under the grab bar, and between 7" and 9" from the front of the toilet. Ensure no dispensers are mounted above the grab bars.	1	481	\$481

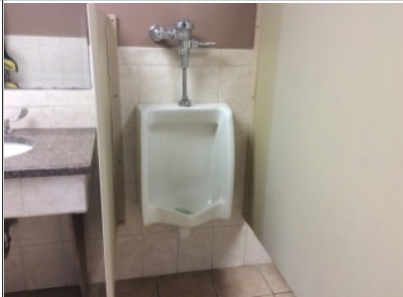
E. Urinal												
43	Men's Multi-User Toilet Room	1		Urinal	N/A

Rim > 17" high Flush control too high or not properly located	21" 51"	Provide at least one urinal with the rim no higher than 17" above the finish floor. Mount flush control at 44" max. above the finish floor.	1	1624	\$1624

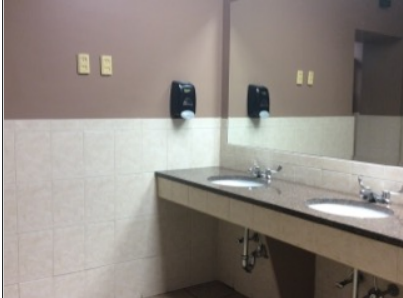
Controls > 42" high	49"	Relocate so the control of the soap dispenser is 42" max. above the finish floor.	1	353	\$353
45	Men's Multi-User Toilet Room	1		Dispensers	Hand Dryer

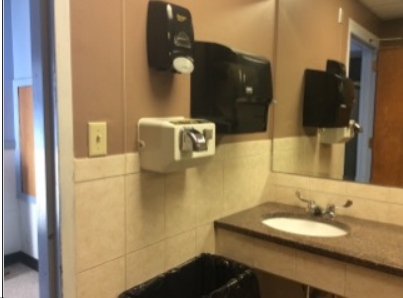
Controls > 42" high Dispenser acts as a protruding object	51" 10"	Relocate so the control of the hand dryer is 42" max. above the finish floor and the dryer is out of the circulation path.	1	353	\$353
46	Men's Multi-User Toilet Room	1		Dispensers	Soap Dispenser

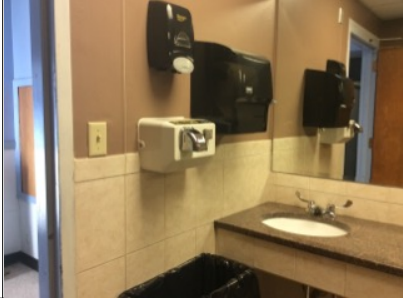
Controls > 42" high Dispenser acts as a protruding object	62" 4.5"	Relocate so the control of the soap dispenser is 42" max. above the finish floor and the dispenser is out of the circulation path.	1	353	\$353
47	Men's Multi-User Toilet Room	1		Dispensers	Paper Towel Dispenser

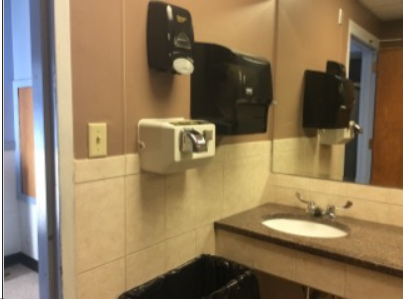
Controls > 42" high Dispenser acts as a protruding object	58" 10"	Relocate so the control of the paper towel dispenser is 42" max. above the finish floor and the dispenser is out of the circulation path.	1	353	\$353

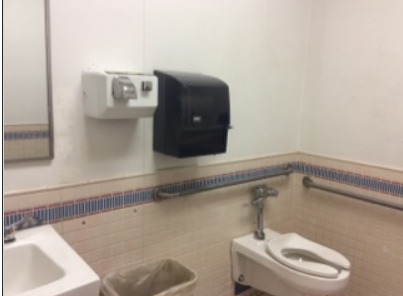
48	Men's Single-User Toilet Room by Kitchen	1		Dispensers	Hand Dryer

Controls > 42" high Dispenser acts as a protruding object	54" 10"	Relocate so the control of the hand dryer is 42" max. above the finish floor and the dryer is out of the circulation path.	1	353	\$353

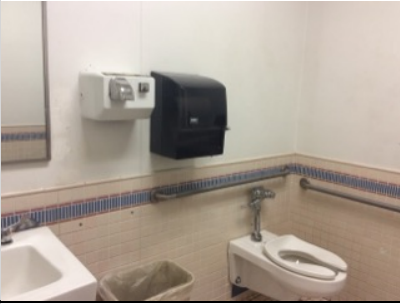
Controls > 42" high Dispenser acts as a protruding object	47" 10"	Relocate so the control of the paper towel dispenser is 42" max. above the finish floor and the dispenser is out of the circulation path. Ensure no dispensers are mounted above grab bars.	1	353	\$353
50	Women's Multi-User Toilet Room in Main Hall	1		Dispensers	Hand Dryer

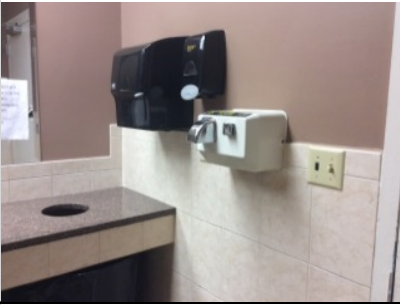
Controls > 42" high Dispenser acts as a protruding object	52" 10"	Relocate so the control of the hand dryer is 42" max. above the finish floor and the dryer is out of the circulation path.	1	353	\$353
51	Women's Multi-User Toilet Room in Main Hall	1		Dispensers	Paper Towel Dispenser

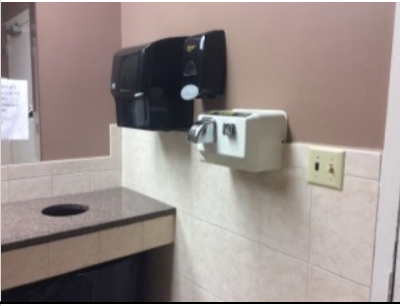
Controls > 42" high Dispenser acts as a protruding object	55"	Relocate so the paper towel dispenser is 42" max. above the finish floor. Relocate dispenser out of the circulation path.	1	353	\$353

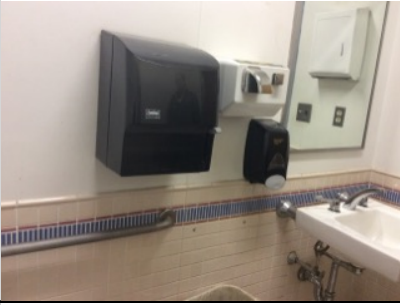
52	Women's Single-User Toilet Room by Kitchen	1		Dispensers	Hand Dryer

Controls > 42" high Dispenser acts as a protruding object	54" 10"	Relocate so the operable part of the hand dryer is 42" max. above the finish floor. Relocate dispenser out of the circulation path.	1	353	\$353
53	Women's Single-User Toilet Room by Kitchen	1		Dispensers	Paper Towel Dispenser

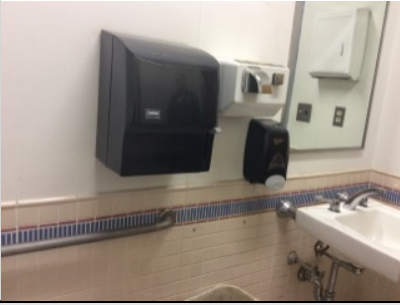
Controls > 42" high Dispenser acts as a protruding object	47" 10"	Relocate so the control of the paper towel dispenser is 42" max. above the finish floor and the dispenser is out of the path of travel. Ensure no dispensers are mounted above grab bars.	1	353	\$353

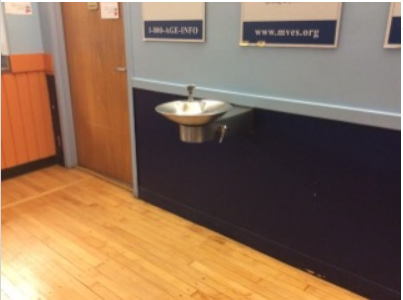
Standing height fountain does not have cane protection	-	Provide a cane detectable barrier skirt under the high unit.	1	445	\$445
55	Main Hall	1		Drinking Fountains	High

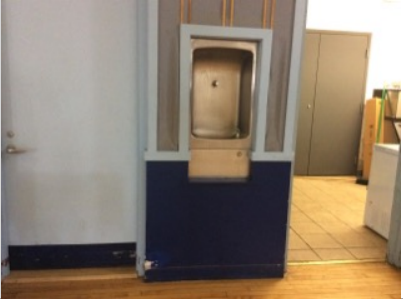
Knee or toe clearance not provided Drinking fountain for seated users not provided.	-	Provide a drinking fountain for seated users.	1	2014	\$2014
