# Department of Public Works

## City of Everett ADA Transition Plan

July 2018

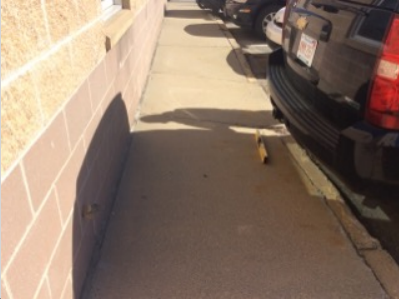
Cross slope > 1:50 (2.00%)	10.5%	Reduce cross slope to be no steeper than 1:50 (2.00%).	1	90	\$90
Curb Ramp												
2	Main Entrance	Ext.		Curb Ramp	Blended Transition

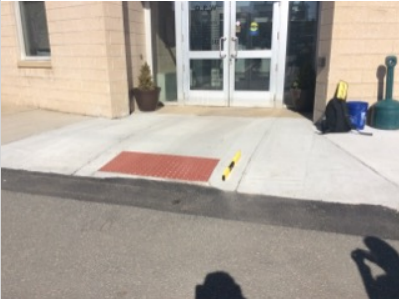
Running slope > 1:12 (8.33%)	15.8%	Reduce running slope to be no steeper than 1:12 (8.33%).	1	120	\$120
3	Parking Lot	Ext.		Curb Ramp	Parallel

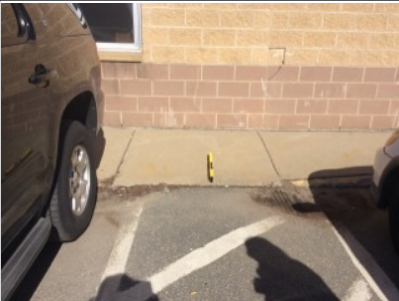
Landing not provided at top of curb ramp	-	Provide landing at top of curb ramp or reconfigure ramp.	1	1225	\$1225
Off-Street Parking Lot or Garage												
4	Parking Lot	Ext.		Off-Street Parking Lot or Garage	Visitor

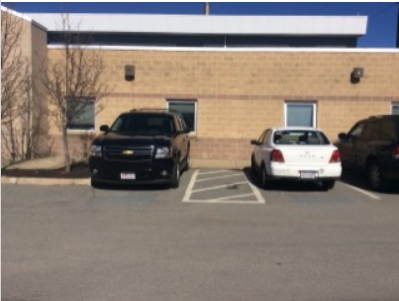
Total # of parking Total # of designated accessible parking spaces Total # of designated van accessible spaces Vehicle space < 96" wide at car space Sign not provided	58 3 0 89" -	Provide one van accessible and two car accessible spaces. Provide signage at both spaces. Ensure accessible space is at least 96" wide. Provide a sign with the bottom of the sign 60" min. above the ground and the top 96" max. above the ground.	1	1325	\$1325

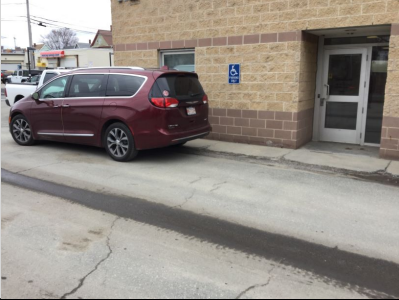
Access aisle not provided Sign < 60" above finished grade	- 55"	Provide a marked access aisle that is at least 60" wide./Provide a marked access aisle that is at least 96" wide. Locate sign with the bottom of the sign 60" above the ground.	1	150 Labor	\$150
Access to Goods and Services												
Doors, Doorways, & Gates												
6	Main Entrance	1		Doors, Doorways, & Gates	Circulation

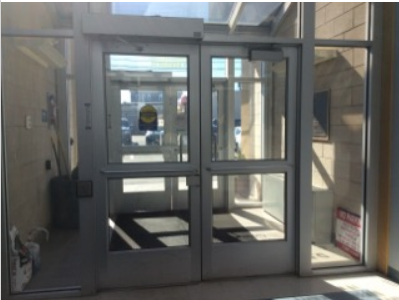
Automatic door opener not operable	-	Repair or replace the door opener.	2	1530	\$3060
Signage												
7	Staff Break Room (Used for Voting)	1		Signage	Designation

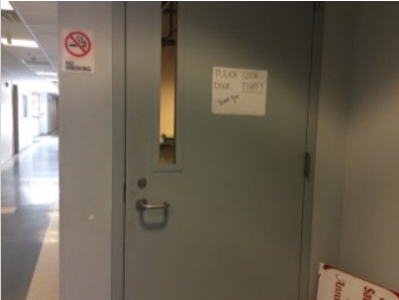
Not provided Raised characters not provided Braille not provided	- - -	Locate signage alongside the door on the latch side. Provide text with raised characters duplicated in braille.	1	116	\$116

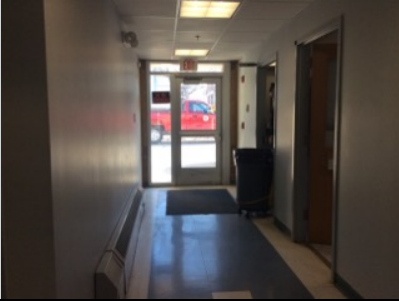
8	Emergency Exit by Staff Break Room	1		Signage	Egress

Raised characters not provided Braille not provided	- -	Provide text with raised characters duplicated in braille.	1	116	\$116
9	Exit to Parking Lot from End of Main Hallway	1		Signage	Egress

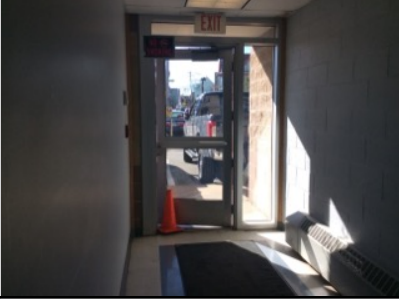
Raised characters not provided Braille not provided	- -	Provide text with raised characters duplicated in braille.	1	116	\$116

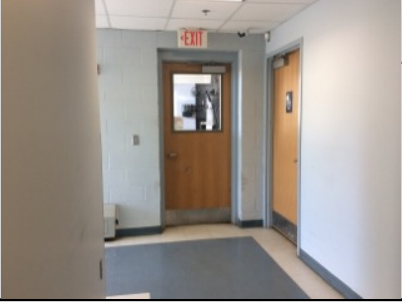
Raised characters not provided Braille not provided	- -	Provide text with raised characters duplicated in braille.	1	116	\$116
Service Counter												
11	Welcome Desk	1		Service Counter	N/A

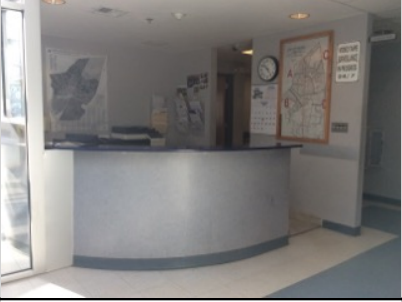
Counter > 36" high	41"	Provide a counter that is 36" max. above the ground or finish floor.	1	440	\$440
12	Main Entrance	1		Service Counter	N/A

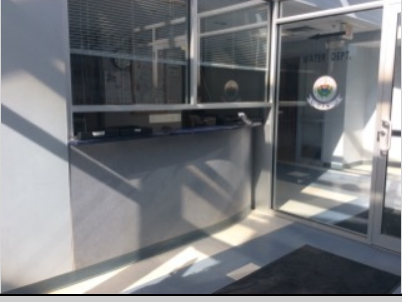
Counter > 36" high	41"	Provide a counter that is 36" max. above the ground or finish floor.	1	440	\$440
Operable Parts												
13	Main Entrance	1		Operable Parts	Equipment

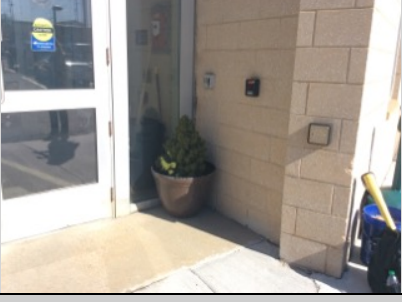
Clear floor space not provided	-	Relocate plants to provide a 30" by 48" clear floor space positioned for a forward approach at call button. Relocate plant.	1	Labor	\$0
Picnic Tables												
14	Main Entrance	Ext.		Picnic Tables	N/A

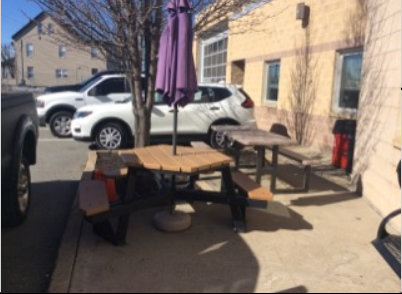
Number of seating spaces at picnic tables Number of accessible seating spaces Toe or knee clearance at tables not provided	7 0 25"	Provide at least 1 dining surface with toe and knee clearance.	1	700	\$700

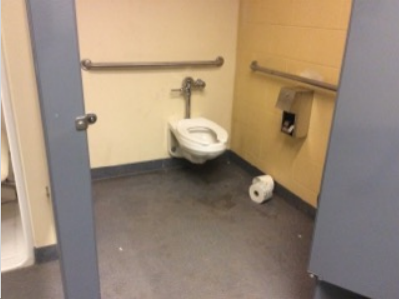
Door has malfunctioning self-closing hinge	-	Repair hinge.	1	Labor	\$0
16	Men's Toilet Room	1		Toilet Compartment	Accessible Compartment

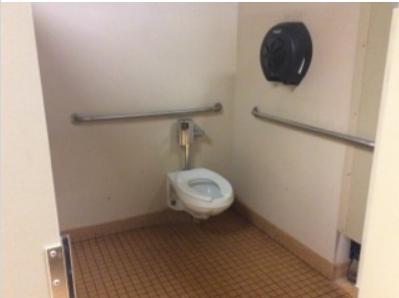
Non-compliant toilet paper dispenser	-	Relocate toilet paper so that it is 15" min high, located under the grab bar, and between 7" and 9" from the front of the toilet. Replace dispenser if it does not allow continuous paper flow.	1	353	\$353
Dispensers												
17	Men's Toilet Room	1		Dispensers	Soap Dispenser

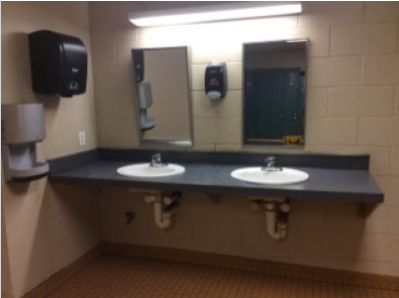
Controls > 42" high	53"	Relocate so the operable part of the soap dispenser is 42" max. above the finish floor.	1	353	\$353
18	Men's Toilet Room	1		Dispensers	Paper Towel Dispenser

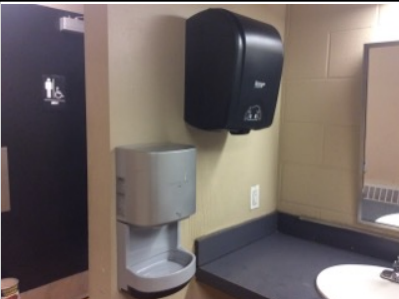
Controls > 42" high	55"	Relocate so the control of the paper towel dispenser is 42" max. above the finish floor.	1	353	\$353

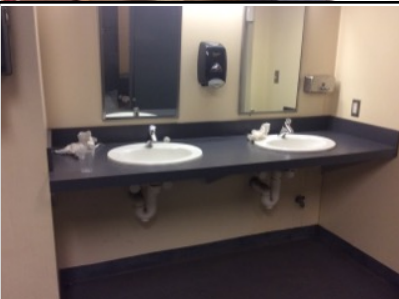
19	Women's Toilet Room	1		Dispensers	Soap Dispenser

Controls > 42" high	47"	Relocate so the operable part of the soap dispenser is 42" max. above the finish floor.	1	353	\$353

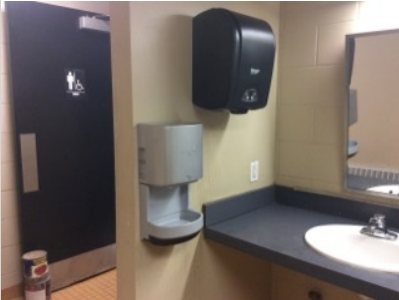
Controls > 42" high Dispenser acts as a protruding object	43" 6"	Relocate so the control of the hand dryer is 42" max. above the finish floor and out of the circulation path.	1	353	\$353
21	Women's Toilet Room	1		Dispensers	Paper Towel Dispenser

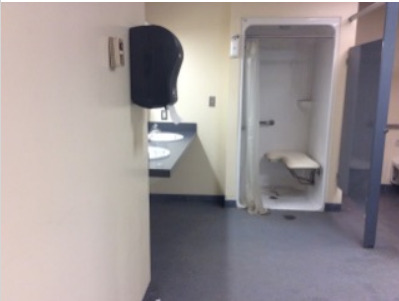
Controls > 42" high Dispenser acts as a protruding object	50" 10"	Relocate so the control of the paper towel dispenser is 42" max. above the finish floor and out of the circulation path.	1	353	\$353
Shower Compartment												
22	Women's Toilet Room	1		Shower Compartment	Transfer Type

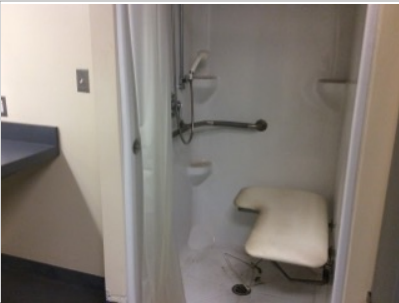
Clear floor space not provided at shower Size of shower compartment non compliant Seat is not between 17"- 19" high	34" deep 20"	If this shower is used by the public it should be brought into compliance. (Provide a 48" x 36" clear floor space for a transfer shower, measuring 48" back from the control wall. Provide a transfer shower that is 36" by 36". Mount seat between 17"- 19" above the finish floor.)	1	-	\$0
