Glenwood Cemetery

City of Everett ADA Transition Plan

June 2018

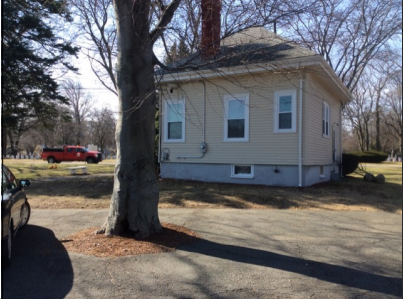
Not provided from all site arrival points	-	Ensure an accessible route is provided from all points of arrival. (Cost based on 30' of asphalt walkway.)	1	390	\$390
2	Office Entrance - Front Gate	Ext.		Exterior Access Route	Sidewalk

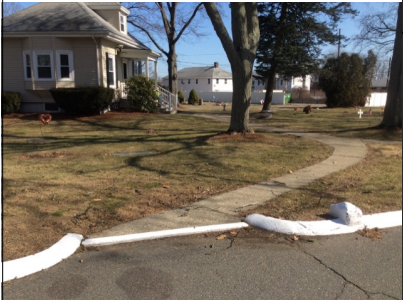
Exterior route < 36" wide Level changes > 1/4"	24" 2"	Ensure that a clear width of 36" min. is maintained at the accessible route. Alter change in level to be 1/4" high max. (Cost based on 30' of asphalt walkway.)	2	258	\$516
3	Cemetery - Section D Gazebo	Ext.		Exterior Access Route	Exterior

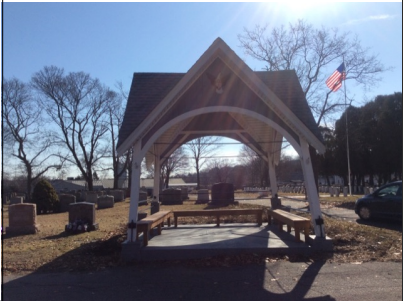
Level changes > 1/4"	9"	Alter change in level to be 1/4" high max. (Cost estimate for a 9' pressure treated wood ramp.)	1	2568	\$2568
4	Wehner WWI Memorial	Ext.		Exterior Access Route	Exterior

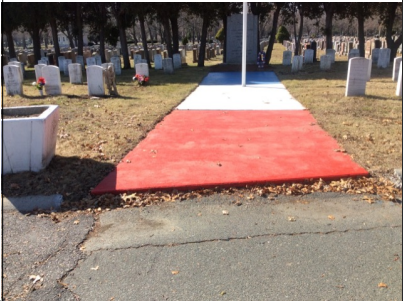
Level changes > 1/4"	3"	Alter change in level to be 1/4" high max.	1	103	\$103

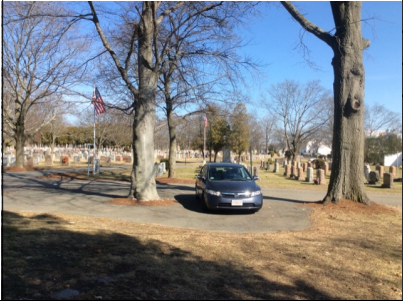
Total # of parking Total # of designated accessible parking spaces Total # of designated van accessible spaces Access aisle not provided Sign not provided	2 0 0 - -	Provide 1 van accessible space. Provide a marked access aisle that is at least 60" wide./Provide a marked access aisle that is at least 96" wide. Provide a sign with the bottom of the sign 60" min. above the ground and the top 96" max. above the ground.	1	925	\$925

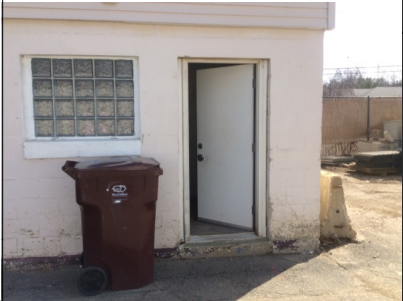
Threshold > 1/2" high	5"	Alter threshold to be 1/2" high max. (Cost estimate for a 5' by 5' concrete platform at door and a ramp to it with no handrails.)	1	345	\$345
Signage												
7	Mechanical Building - Toilet Room	Ext.		Signage	Designation

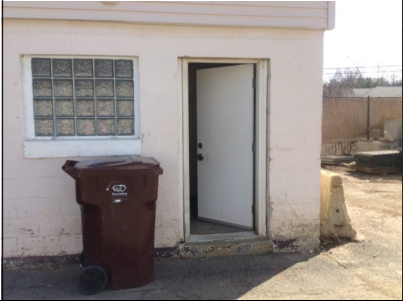
Not provided		Locate signage alongside the door on the latch side.	1	116	\$116
Benches												
8	Cemetery - Section F	Ext.		Benches	N/A

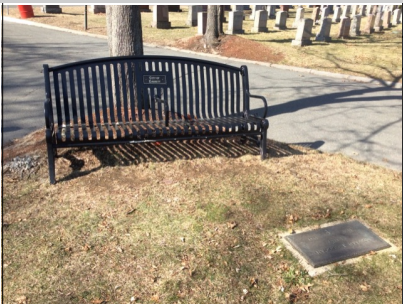
No accessible route to 20% of benches 20% of benches have clear space < 36" x 48"	<ul style="list-style-type: none">--	Ensure that 1 bench in this area is located on an accessible route and has a clear floor space of 36" wide min. by 48" deep min. (Cost for relocating bench.)	1	128	\$128

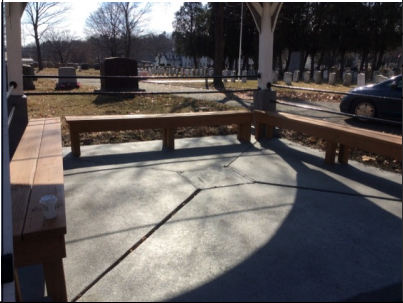
9	Cemetery - Section D	Ext.		Benches	N/A

No accessible route to 20% of benches 20% of benches have clear space < 36" x 48" Shoulder alignment not provided at bench	<ul style="list-style-type: none">---	Ensure that 1 bench in this area is located on an accessible route and has a clear floor space of 36" wide min. by 48" deep min. Provide shoulder alignment with the adjacent wheelchair space. The shoulder alignment of the wheelchair space shall be measured 36" from the front of the wheelchair space. (Cost based on a new park bench.)	1	650	\$650

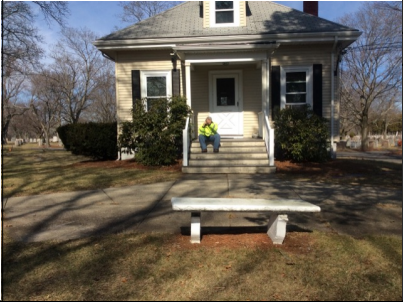
20% of benches have clear space < 36" x 48" Shoulder alignment not provided at bench	- -	Ensure that 1 bench in this area is located on an accessible route and has a clear floor space of 36" wide min. by 48" deep min. Provide shoulder alignment with the adjacent wheelchair space. The shoulder alignment of the wheelchair space shall be measured 36" from the front of the wheelchair space. (Cost based on a new park bench.)	1	650	\$650
Toilet & Bathing Rooms												
Lavatory												
11	Mechanical Building - Toilet Room	Ext.		Lavatory	N/A

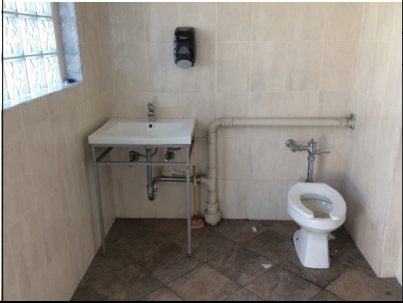
The main toilet room located in the mechanical building contains a lavatory that lacks toe and knee clearance and possesses exposed plumbing. The toilet’s flush control is not located on the open side of the toilet, and there are no grab bars provided.

Toe or knee clearances not provided Plumbing underneath is exposed	- -	Provide at least one lavatory with knee and toe clearance positioned for a forward approach. Insulate or otherwise configure pipes to prevent contact, for at least one lavatory.	1	889	\$889

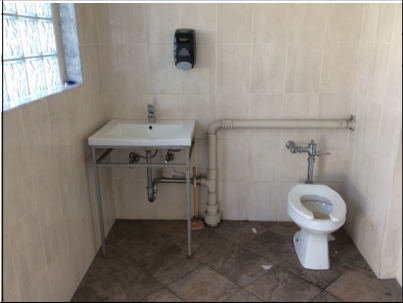
Single-User Toilet												
12	Mechanical Building - Toilet Room	Ext.		Single-User Toilet	N/A

Flush control not on open side Grab bar not provided	- -	Relocate the flush control to the open side. Provide one grab bar on the side wall of the toilet and one on the rear wall.	1	636	\$636
Dispensers												
13	Mechanical Building - Toilet Room	Ext.		Dispensers	Paper Towel Dispenser

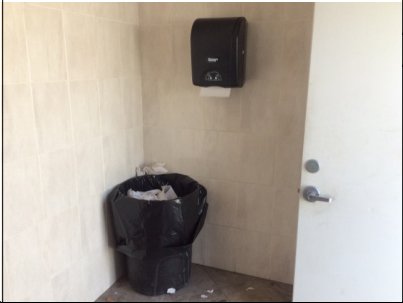
Controls > 42" high Clear floor space not provided at accessory	54" -	Relocate paper towel dispenser so the operable part is 42" max. above the finish floor and has a 30" min. by 48" min. clear floor space.	1	353	\$353
Universal Design

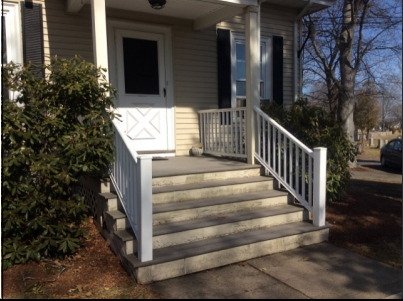
Not provided	-	Consider providing signage readable from the bottom of the set of stairs going to the office that explains that cemetery business is now conducted in City Hall.	1	173	\$173
15	Mechanical Building	Ext.

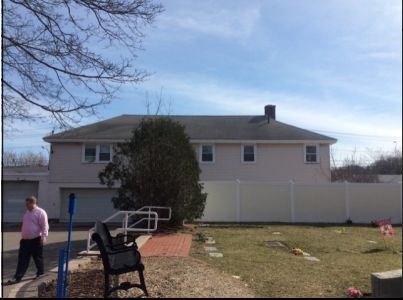
Not provided		Consider providing wayfinding signs near the Cemetery Entrance, toilet rooms and plot sections.	1		\$0
16	Thomas P. Murray Memorial Island	Ext.

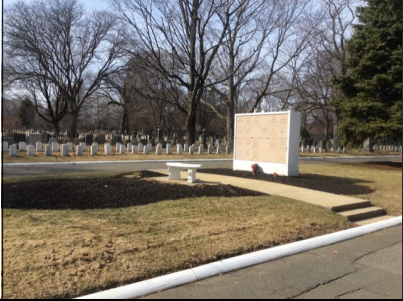
Not provided		Consider providing handrails at the Memorial.	2		\$0
