## Health and Wellness Center

## City of Everett ADA Transition Plan

July 2018

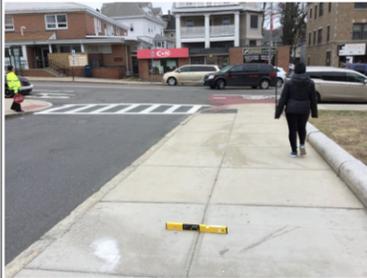
ID	Location	Element	Type	Photo	Issues	Current Measure	Recommendations	Quantity	Price	Cost Estimation
<b>Pedestrian Access Routes</b>										
<b>Walking Surface</b>										
1	Maple Avenue Near Broadway	Walking Surface	Sidewalk

Cross slope > 1:50 (2.00%)	2.9%	Reduce cross slope to be no steeper than 1:50 (2.00%). (Cost estimate for 6' of concrete.)	1	120	\$120
2	Pleasant St.	Walking Surface	Sidewalk

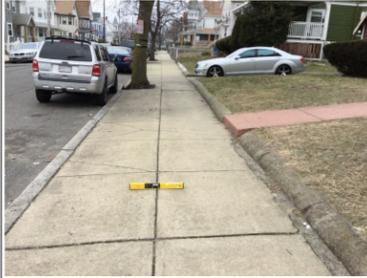
Cross slope > 1:50 (2.00%)	5.5%	Reduce cross slope to be no steeper than 1:50 (2.00%). (Cost estimate for 10' of concrete.)	1	200	\$200
3	39 Pleasant St.	Walking Surface	Sidewalk

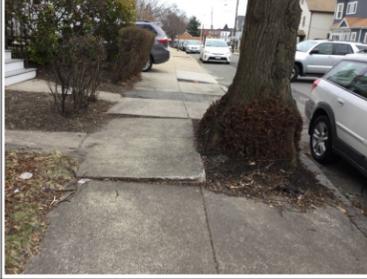
Level changes > 1/4"	3"	Alter change in level to be 1/4" high max.	1	206	\$206
4	Broadway Near Pleasant St.	Walking Surface	Sidewalk

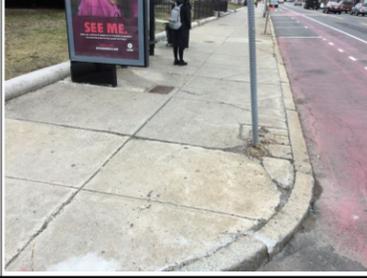
Level changes > 1/4"	1"	Alter change in level to be 1/4" high max.	1	103	\$103
5	Maple Avenue Main Entrance	Walking Surface	Sidewalk

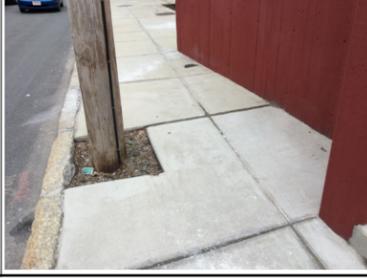
Level changes > 1/4"	2"	Alter change in level to be 1/4" high max. Infill area around post.	1	69	\$69

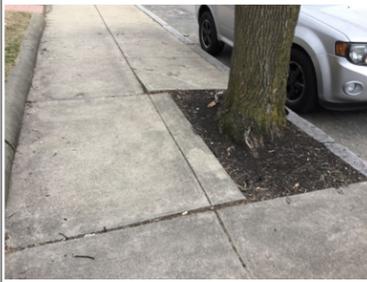
ID	Location	Element	Type	Photo	Issues	Current Measure	Recommendations	Quantity	Price	Cost Estimation
6	Pleasant St.	Walking Surface	Sidewalk

Beveled changes in level > 1/2"	1"	Alter surface so that bevel height is 1/4" min. Provide a tree grate and repair concrete.	1	1557	\$1557
<b>Curb Ramps and Blended Transitions</b>										
<b>Perpendicular Curb Ramp</b>										
7	Broadway and Hampshire St.	Perpendicular Curb Ramp	N/A

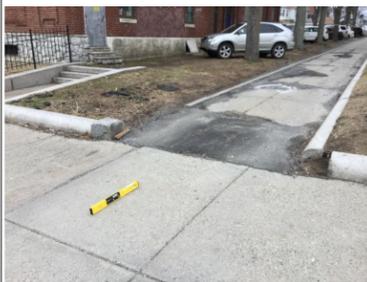
Landing > 1:50 (2.00%)	6.7%	Reduce slope to be no steeper than 1:50 (2.00%).	1	123	\$123
8	Maple Avenue	Perpendicular Curb Ramp	N/A

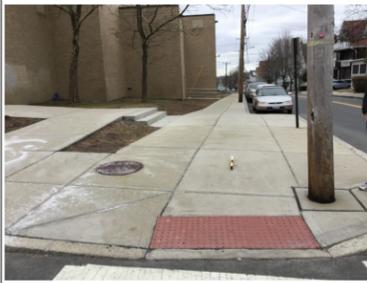
Landing > 1:50 (2.00%)	3%	Reduce slope to be no steeper than 1:50 (2.00%).	1	123	\$123
9	Maple Avenue	Perpendicular Curb Ramp	N/A

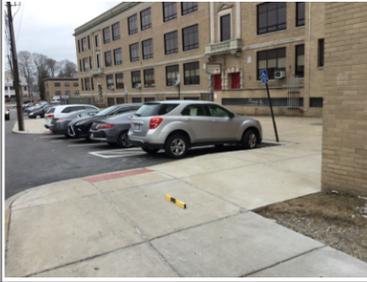
Landing > 1:50 (2.00%)	4.1%	Reduce slope to be no steeper than 1:50 (2.00%).	1	123	\$123
10	Broadway and Hampshire St.	Perpendicular Curb Ramp	N/A

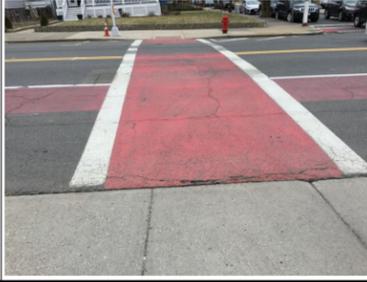
Detectable warning not provided	-	Provide a detectable warning on the curb ramp.	1	180	\$180

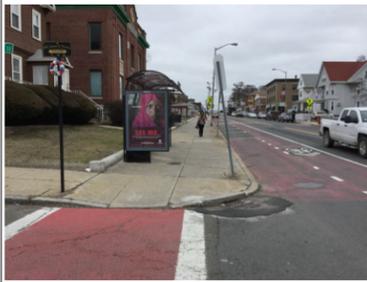
ID	Location	Element	Type	Photo	Issues	Current Measure	Recommendations	Quantity	Price	Cost Estimation
<b>Detectable Warnings</b>										
11	Broadway and Pleasant St.	Detectable Warnings	Perpendicular

Detectable warnings not provided	-	Provide a detectable warning on curb ramp/platform edge.	1	180	\$180
12	Pleasant St. and Linden St.	Detectable Warnings	Perpendicular

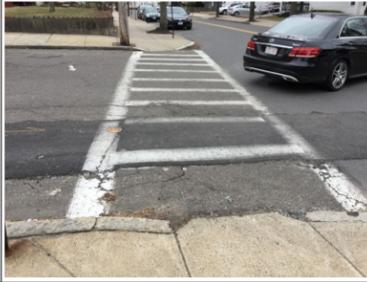
Detectable warnings not provided	-	Provide a detectable warning on curb ramp.	2	180	\$360
<b>Off-Street Parking Lot or Garage</b>										
<b>Parking Lots</b>										
13	Maple Avenue Parking	Parking Lots	Vistor

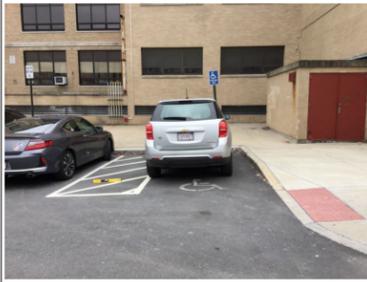
Total # of parking Total # of designated accessible parking spaces Total # of designated van accessible spaces Running or cross slope at access aisle > 1:50 (2.00%) Sign does not have the designation "Van Accessible"	20 1 0 5.2% -	Reduce running or cross slope to be no steeper than 1:50 (2.00%). Add the designation "Van Accessible" to the sign located at the van accessible space.	1	640	\$640

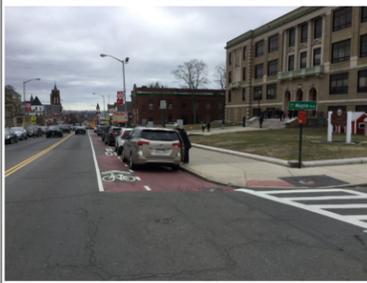
<b>On-Street Parking</b>										
<b>Parking Space</b>										
14	Broadway	Parking Space	Marked

Total # of parking spaces per block Total # of designated accessible parking spaces per block Vehicle space < 13' wide Running or cross slope at space > 1:50 (2.00%)	9 0 125" 5%	Provide at least 1 accessible space per block. Provide an accessible space that is at least 13' wide. Reduce running or cross slope to be no steeper than 1:50 (2.00%).	1	925	\$925

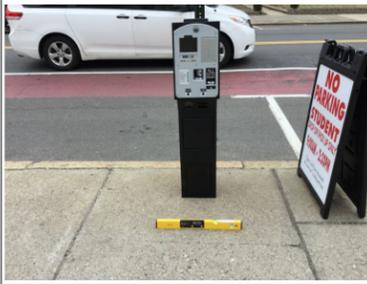
ID	Location	Element	Type	Photo	Issues	Current Measure	Recommendations	Quantity	Price	Cost Estimation
<b>Parking Meters and Pay Stations</b>										
15	Broadway	Parking Meters and Pay Stations	N/A

Not operable with a closed fist Pay station not on accessible route	- 4.3% cross	Ensure operable parts can be operable with one hand and not require tight grasping, pinching or twisting of the wrist. Provide an accessible route to the pay station.	1	128	\$128

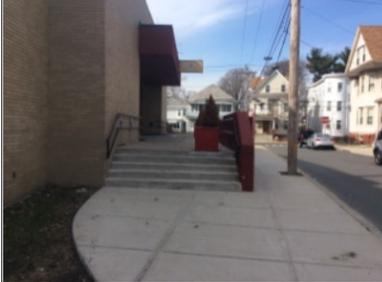
ID	Location	Floor	Room	Element	Type	Photo	Issues	Current Measure	Recommendations	Quantity	Price	Cost Estimation
<b>Approach and Entrance</b>												
<b>Entrance</b>												
16	Entry	Ext.		Entrance	Main Entrance

Directional sign to accessible entrance not provided		Provide a directional sign indicating the location of the nearest accessible entrance at the point where the route becomes inaccessible.	1	173	\$173
<b>Access to Goods and Services</b>												
<b>Means of Egress</b>												
17	Exit by Golf Room	1		Means of Egress	N/A

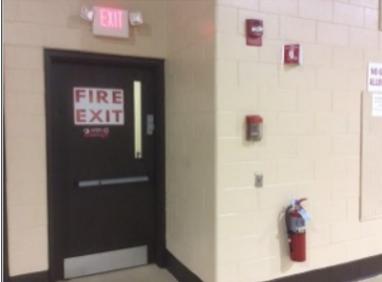
Tactile exit sign not provided		Ensure tactile exit signs with raised characters and braille are provided at exit doors leading to enclosed stairways. Mount signs between 48"-60" above finish floor located on the latch side of the door.	1	116	\$116
18	Fire Exit by Gym Toilet Rooms	1		Means of Egress	N/A

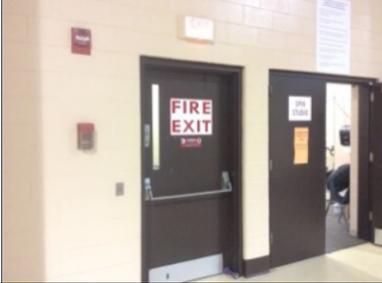
Tactile exit sign not provided		Ensure tactile exit signs with raised characters and braille are provided at exit doors leading to enclosed stairways. Mount signs between 48"-60" above finish floor located on the latch side of the door.	1	116	\$116

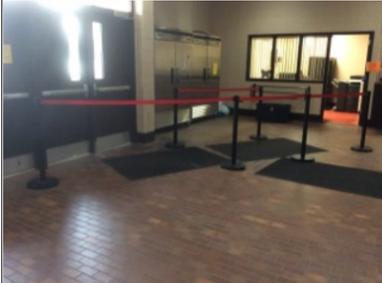
<b>Interior Access Route</b>												
19	Lobby Stanchions	1		Interior Access Route	N/A

Obstructed by protruding objects		Stanchions act as protruding objects. Provide ADA compliant cane detectable stanchions.	4	100	\$400

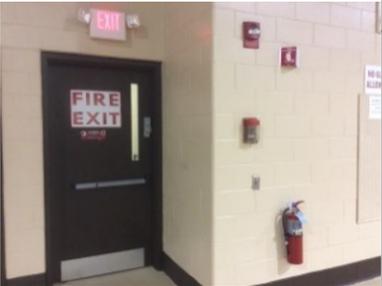
ID	Location	Floor	Room	Element	Type	Photo	Issues	Current Measure	Recommendations	Quantity	Price	Cost Estimation
<b>Doors, Doorways, &amp; Gates</b>												
20	Exit by Golf Room	1		Doors, Doorways, & Gates	Emergency Egress

Maneuvering clearance(s) not provided	2"	Provide an automatic door opener.	1	1530	\$1530
21	Men's Toilet Room in Lobby	1		Doors, Doorways, & Gates	Toilet Room

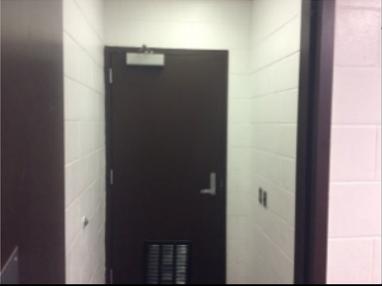
Maneuvering clearance(s) not provided	10"	Provide an automatic door opener.	1	1530	\$1530
22	Women's Toilet Room in Gym	1		Doors, Doorways, & Gates	Toilet Room

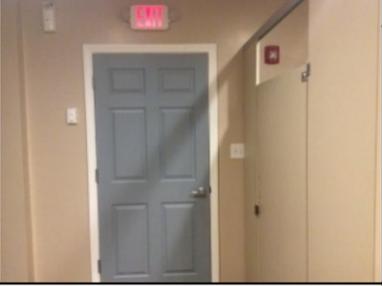
Maneuvering clearance(s) not provided	8.75"	Provide an automatic door opener.	1	1530	\$1530
23	Women's Toilet Room in Lobby	1		Doors, Doorways, & Gates	Toilet Room

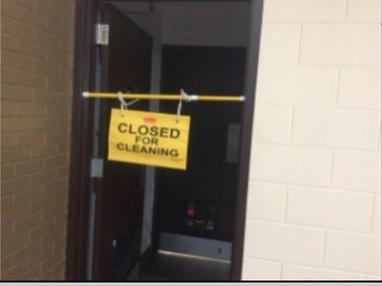
Door requires > 5 lbs. of force to open	12 lbs.	Adjust closers so doors do not require more than 5 pounds of force to open.	1	Labor	\$0
<b>Ramps</b>												
24	Front Entrance Ramp	Ext.		Ramps	Exterior

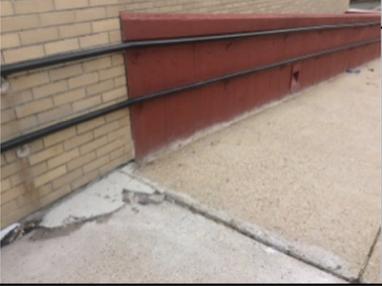
The exterior ramp to the main entrance has damage to the surface and had accumulated water on the day of the survey.

Surface not stable, firm, and slip-resistant		Repair surface.	1	103	\$103

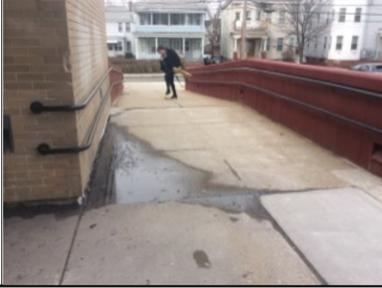
ID	Location	Floor	Room	Element	Type	Photo	Issues	Current Measure	Recommendations	Quantity	Price	Cost Estimation
25	Front Entrance Ramp	Ext.		Ramps	Exterior

Does not prevent accumulation of water		Repair ramp surface to prevent accumulation of water.	1	103 Labor	\$103
<b>Stairways</b>												
26	Fire Exit by Gym Toilet Rooms	1		Stairways	Interior

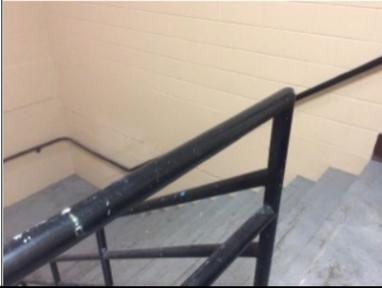
Handrails not continuous where required		Provide continuous handrails. Central handrail is not continuous.	1	660	\$660
27	Fire Exit by Lobby Counter	1		Stairways	Interior

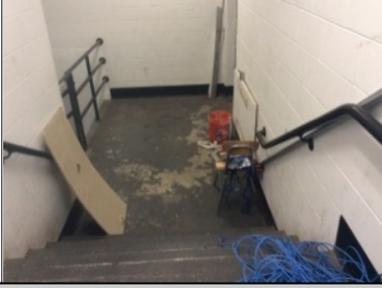
Not maintained in operable working condition		Ensure stairs are maintained in operable working condition. Remove clutter and ensure that exit door to exterior is operable.	1	Labor	\$0
<b>Signage</b>												
28	Exits to YMCA Back of Gym	1		Signage	Egress

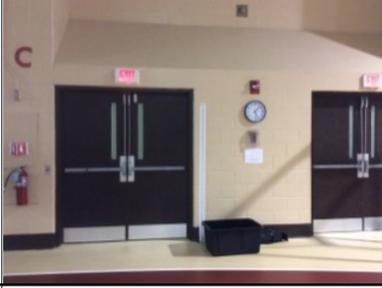
Raised characters not provided Braille not provided		Provide text with raised characters duplicated in braille.	2	116	\$232

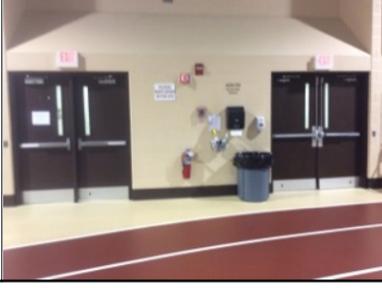
29	Exits to YMCA Before Basketball Courts by Weight Area	1		Signage	Egress

Raised characters not provided Braille not provided		Provide text with raised characters duplicated in braille.	2	116	\$232

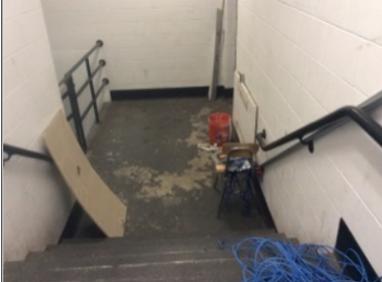
ID	Location	Floor	Room	Element	Type	Photo	Issues	Current Measure	Recommendations	Quantity	Price	Cost Estimation
30	Fire Exit by Lobby Counter	1		Signage	Egress

Raised characters not provided Braille not provided		Provide text with raised characters duplicated in braille.	2	116	\$232
31	Fire Exits by Lobby	1		Signage	Egress

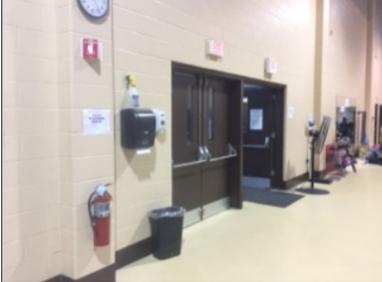
Raised characters not provided Braille not provided		Provide text with raised characters duplicated in braille.	4	116	\$464
32	Group Fitness, Golf Room and Cardio Room	1		Signage	Designation

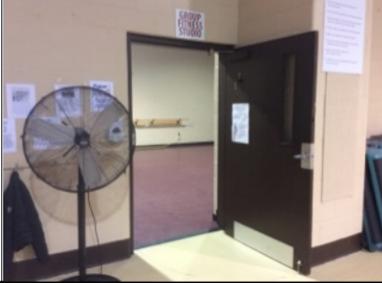
Raised characters not provided Braille not provided		Provide text with raised characters duplicated in braille.	3	116	\$348
33	Lobby Exits	1		Signage	Egress

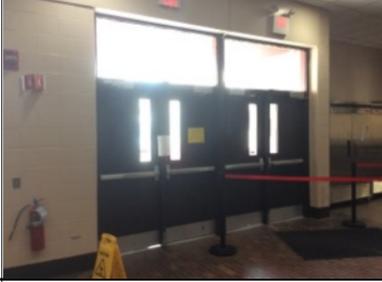
Raised characters not provided Braille not provided		Provide text with raised characters duplicated in braille at 4 exit doors.	4	116	\$464
34	Spin Studio	1		Signage	Designation

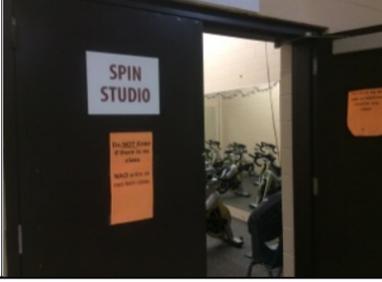
Raised characters not provided Braille not provided		Provide text with raised characters duplicated in braille.	1	116	\$116

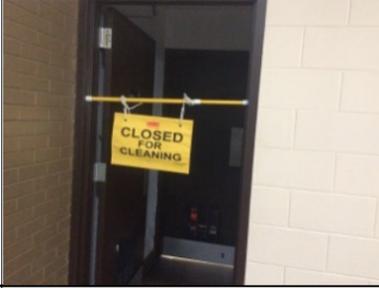
ID	Location	Floor	Room	Element	Type	Photo	Issues	Current Measure	Recommendations	Quantity	Price	Cost Estimation
35	Women's Toilet Room in Lobby	1		Signage	Designation

Raised characters not provided Braille not provided Sign not located on the latch side of the door		Provide text with raised characters duplicated in braille. Locate sign at permanent rooms alongside the door on the latch side.	1	116 Labor	\$116
36	Men's Toilet Room in Lobby	1		Signage	Designation

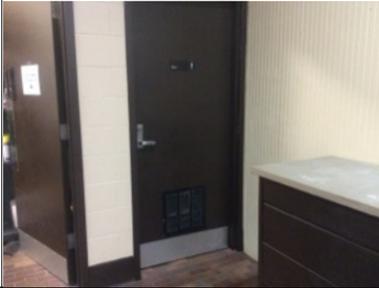
Raised characters not provided Braille not provided International Symbol of Acc. not compliant		Provide text with raised characters duplicated in braille. Replace sign with a sign containing the International Symbol of Accessibility.	1	116	\$116
<b>Service Counter</b>												
37	Front Counter	1		Service Counter	N/A

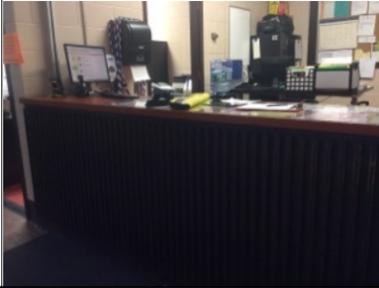
The main service counter is located higher than 36 inches above the finish floor.

Counter > 36" high	42.5"	Provide a counter that is 36" max. above the ground or finish floor.	1	440	\$440

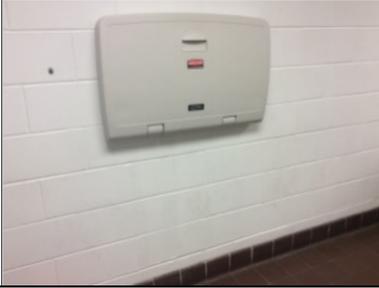
<b>Operable Parts</b>												
38	Women's Toilet Room in Lobby	1		Operable Parts	Equipment

Reach < 15" or > 48"(forward/side approach)	57"	Relocate baby changing station so that controls are between 15"- 48" above finish floor. In order to pull down baby changing station with a closed fist, one must reach over the top of the baby changing station. This should be located 15"- 48" above finish floor. Best practice: Provide a baby changing station in the lobby men's toilet room as well.	1	128	\$128
<b>Locker Room</b>												
39	Men's Toilet Room in Gym	1		Locker Room	N/A

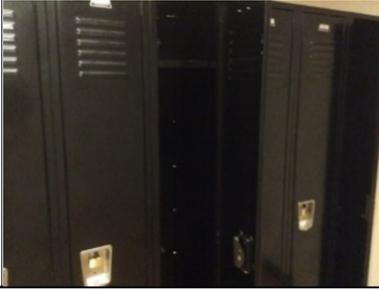
Total # of locker Total # of accessible locker 5% of lockers are not accessible Storage > 48" high	10 0 - 58"	Provide at least 1 accessible locker (or ensure 5% of all lockers are accessible) . Ensure that at least 5% of lockers are accessible, and no higher than 48 inches above the floor.	1	330	\$330

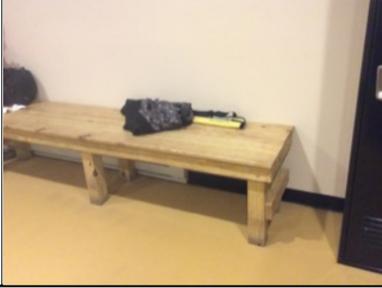
ID	Location	Floor	Room	Element	Type	Photo	Issues	Current Measure	Recommendations	Quantity	Price	Cost Estimation
40	Women's and Men's Toilet Room in Gym	1		Locker Room	N/A

Bench is not 17"-19" high	21"	Install a bench with the top of the seat between 17"- 19" above finish floor.	2	100	\$200
<b>Toilet &amp; Bathing Rooms</b>												
<b>Overall Access</b>												
41	Women's and Men's Toilet Rooms in Lobby	1		Overall Access	Toilet Room

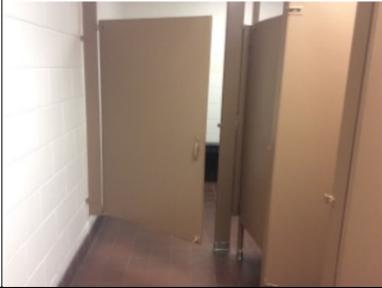
Audible and visible alarms not provided	-	When fire system is updated, ensure that a visible and audible fire alarm is installed.	2	346	\$692
<b>Lavatory</b>												
42	Men's Toilet Room in Gym	1		Lavatory	N/A

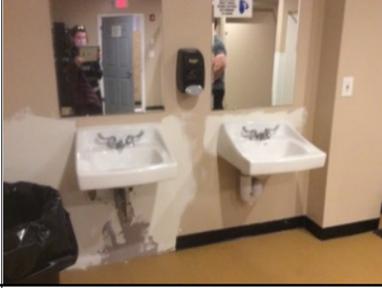
Plumbing underneath is exposed		Insulate or otherwise configure pipes to prevent contact, for at least one lavatory. Currently the lavatory with the PVC pipes lacks 27" high knee clearance. The easiest solution would be to wrap the pipes at the sink to the left, which has the proper knee clearance.	1	46	\$46

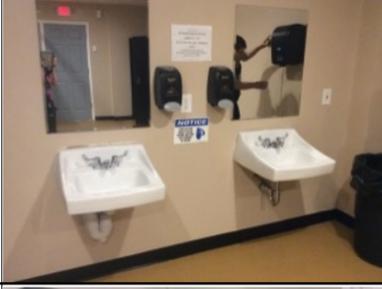
43	Women's Toilet Room in Gym	1		Lavatory	N/A

Plumbing underneath is exposed		Insulate or otherwise configure pipes to prevent contact, for at least one lavatory. Currently the lavatory with the PVC pipes lacks 27" high knee clearance. The easiest solution would be to wrap the pipes at the sink to the left, which has the proper knee clearance.	1	46	\$46
44	Women's Toilet Room in Lobby	1		Lavatory	N/A

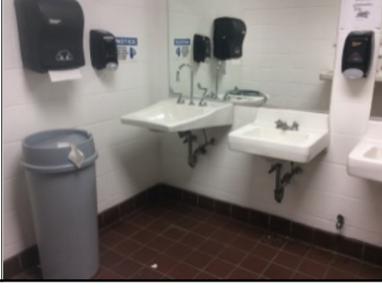
Plumbing underneath is exposed		Insulate or otherwise configure pipes to prevent contact, for at least one lavatory. Elongated lavatory is mounted too high to be used as the accessible lavatory. Wrap pipes of one of the other lavatories.	1	46	\$46

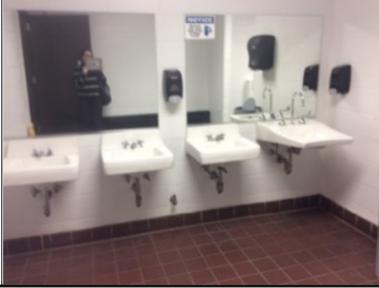
ID	Location	Floor	Room	Element	Type	Photo	Issues	Current Measure	Recommendations	Quantity	Price	Cost Estimation
45	Men's Toilet Room in Lobby	1		Lavatory	N/A

Plumbing underneath is exposed Dispensers not within reach range	- 45.8"	Insulate or otherwise configure pipes to prevent contact, for at least one lavatory. Elongated lavatory is mounted too high to be used as the accessible lavatory. Wrap pipes of one of the other lavatories. Relocate soap dispenser to 42" max. above the floor.	1	399	\$399
<b>Toilet Compartment</b>												
46	Women's Toilet Room in Lobby	1		Toilet Compartment	Accessible Compartment

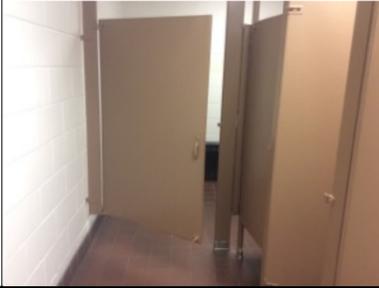
Door has incorrect swing Door has inadequate maneuvering clearance	- 7"	Reverse swing at door and replace keeper. (Note: 7" clear on the push side is still not compliant with the MAAB, but it is a better solution than swinging the door out.)	1	128	\$128
47	Women's Toilet Room in Lobby	1		Toilet Compartment	Accessible Compartment

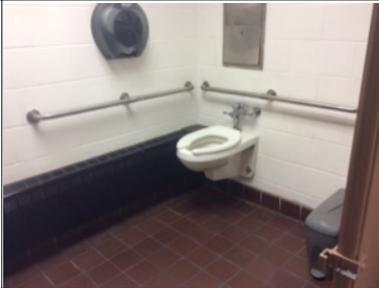
Door has malfunctioning self-closing hinge Toilet seat <17" or > 19" high Flush control not on open side Coat hook > 48"	- 23.5" - 62.8"	Repair hinge. Install a toilet with a seat height 17"- 19" above the floor. Provide the flush control on the open side of the toilet (transfer side). Lower coat hook so that it is no higher than 48".	1	Labor 1345	\$1345

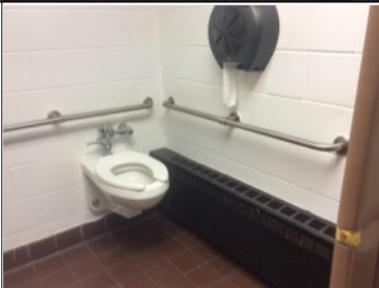
48	Men's Toilet Room in Lobby	1		Toilet Compartment	Accessible Compartment

Door has malfunctioning self-closing hinge Toilet seat <17" or > 19" high Coat hook > 48"	- 23.5" 62.8"	Repair hinge. Install a toilet with a seat height 17"- 19" above the floor. Lower coat hook so that it is no higher than 48".	1	Labor 1158	\$1158
49	Women's Toilet Room in Gym	1		Toilet Compartment	Accessible Compartment

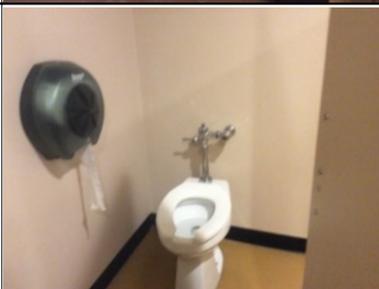
Grab bars not provided Flush control not on open side Coat hook > 48"	- - 52"	Provide one grab bar on the side wall of the water closet and one on the rear wall. Provide the flush control on the open side of the toilet (transfer side). Ensure that toilet paper is not mounted above the grab bars. Lower coat hook so that it is no higher than 48".	1	711	\$711

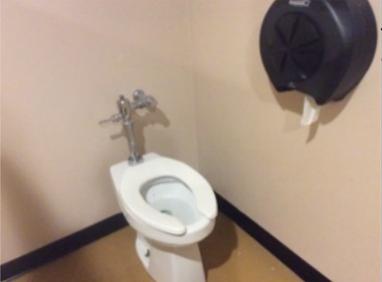
ID	Location	Floor	Room	Element	Type	Photo	Issues	Current Measure	Recommendations	Quantity	Price	Cost Estimation
50	Men's Toilet Room in Gym	1		Toilet Compartment	Accessible Compartment

Grab bars not provided Coat hook > 48"	- 52"	Provide one grab bar on the side wall of the water closet and one on the rear wall. Lower coat hook so that it is no higher than 48". Ensure that toilet paper is not mounted above the grab bars.	1	524	\$524
51	Women's Toilet Room in Lobby (Same in Men's)	1		Toilet Compartment	Accessible Compartment

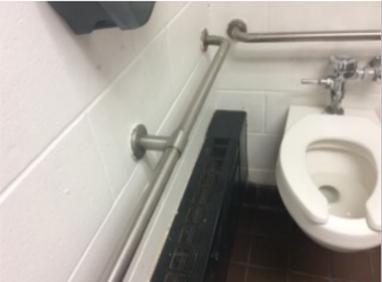
Grab bar is not compliant		Provide a new grab bar that is free of sharp or abrasive elements with rounded edges.	4	449	\$1796
<b>Urinal</b>												
52	Men's Toilet Room in Lobby	1		Urinal	N/A

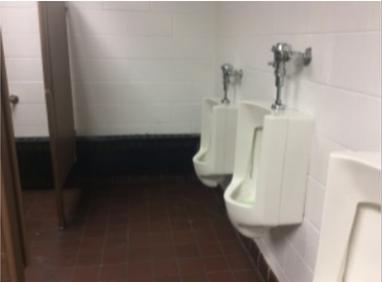
Rim > 17" high	19.5"	Provide at least one urinal with the rim no higher than 17" above the finish floor.	1	1624	\$1624
<b>Dispensers</b>												
53	Women's Toilet Room in Gym	1		Dispensers	Paper Towel Dispenser

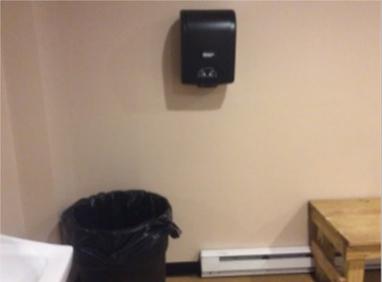
Controls > 42" high	52"	Relocate so the operable part is 42" max. above the finish floor.	1	353	\$353

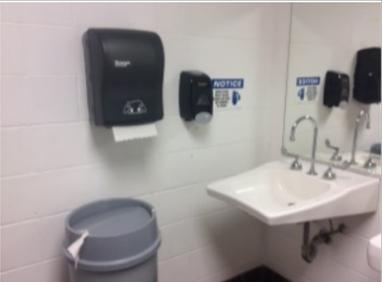
54	Women's Toilet Room in Lobby	1		Dispensers	Soap Dispenser

Controls > 42" high	46.9"	Relocate so the operable part is 42" max. above the finish floor.	1	353	\$353

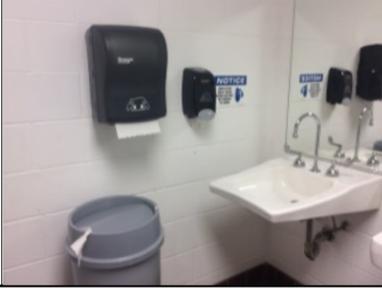
ID	Location	Floor	Room	Element	Type	Photo	Issues	Current Measure	Recommendations	Quantity	Price	Cost Estimation
55	Women's and Men's Toilet Room in Lobby	1		Dispensers	Paper Towel Dispenser

Controls > 42" high Dispenser acts as a protruding object	48"	Relocate so the operable part is 42" max. above the finish floor. Relocate dispenser out of the circulation path.	2	353	\$706
<b>Universal Design</b>												
56	Main Entrance (Steps at the Bottom of Ramp)	Ext.

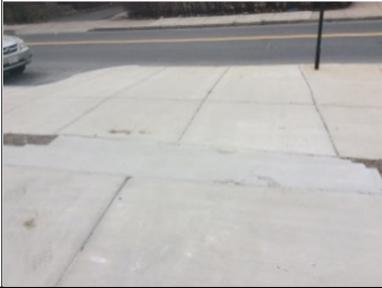
Universal Design: For safety and to prevent falls, consider adding tactile contrast strips and handrails to stairs.	1	-	\$0
57	Signage on Broadway by Old High School	Ext.

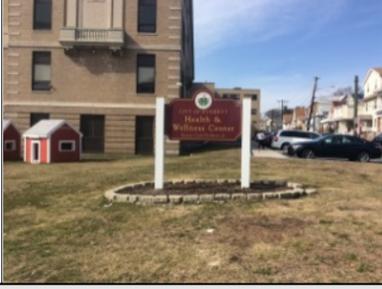
Universal Design: Signage by the old High School may mislead people to think that the Health and Wellness Center is located in the old High School. Consider removing sign or providing a sign directing people to Maple Ave. An online Google search also directs people to the old High School. Correct online information.	1	173	\$173

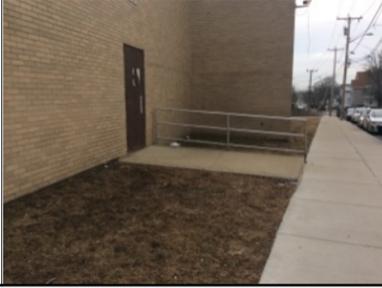
<b>Best Practice</b>												
58	Linden Street Exit From Stairs with Step	Ext.

8"	Best Practice: Consider repaving ramp to remove step. Install compliant handrails. (Cost provided for this solution.) At minimum install a detectable warning to stop people from tripping at this change in level.	1	2468	\$2468
