Memorial Stadium Field House

Town of Everett ADA Transition Plan

June 2018

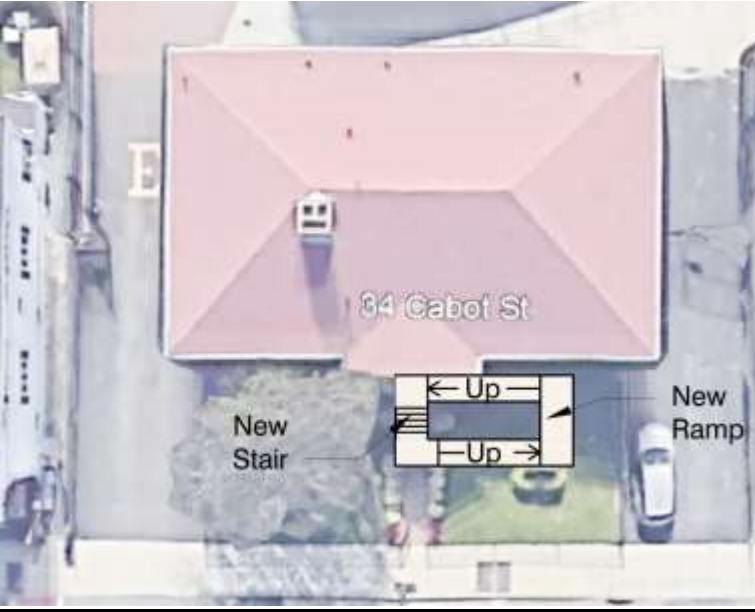
There is no accessible route to the main entrance.

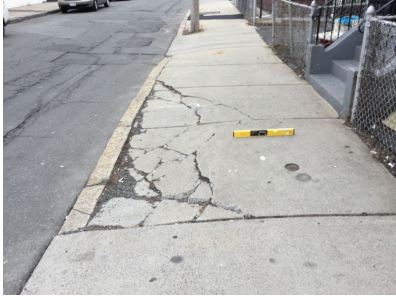
Cross slope > 1:50 (2.00%) Level changes > 1/4"	5.6% 2"	Reduce cross slope to be no steeper than 1:50 (2.00%). Repair sidewalk. Alter change in level to be 1/4" high max.	1	603	\$603
2	Cabot St.	Walking Surface	Sidewalk

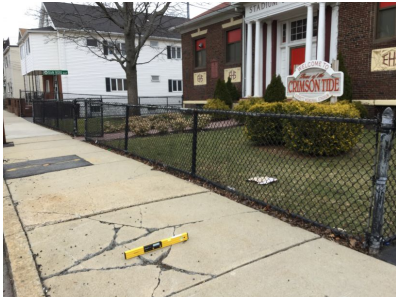
Cross slope > 1:50 (2.00%) Surface not stable, firm and slip-resistant	11% -	Reduce cross slope to be no steeper than 1:50 (2.00%). Repair surface.	1	703	\$703
3	20 Cabot St.	Walking Surface	Sidewalk

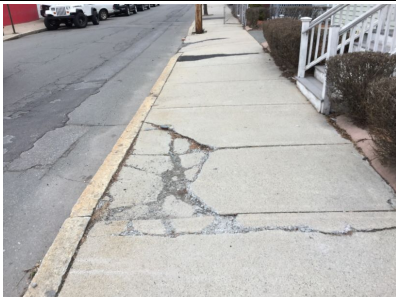
Level changes > 1/4"	2"	Repair sidewalk. Alter change in level to be 1/4" high max.	1	206	\$206
Curb Ramps and Blended Transitions										
Detectable Warnings										
4	Cabot St.	Detectable Warnings	Perpendicular

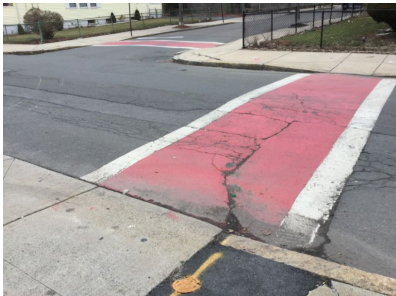
Detectable warnings not provided	-	Provide a detectable warning on curb ramp edge.	2	180	\$360

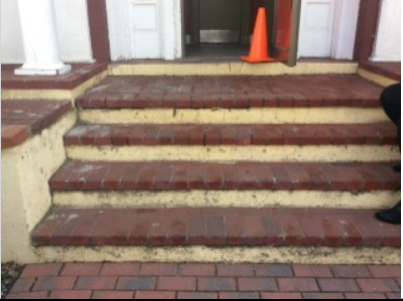
Number of public accessible entrances < 60% Entrance not on an accessible route		Provide a switchback ramp to the side of the main entrance level with the first floor level. (Cost is for pressure treated wood ramp, pressure treated wood stairs and new concrete platform at door.)	1	5851 Labor	\$5851
Emergency Exit												
6	Home and Visiting Team Locker Room Exit	1		Emergency Exit	N/A

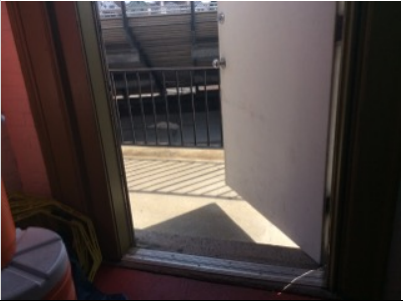
Number of accessible emergency exits < 60% Hardware not operable with a closed fist		Provide hardware that can be operable with one hand and not require tight grasping, pinching, or twisting of the wrist.	2	242	\$484
7	Team Meeting Room	B		Emergency Exit	N/A

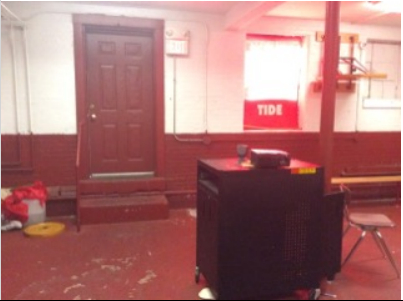
Emergency exit not on an accessible route Hardware not operable with a closed fist		Provide a directional sign indicating the location of the nearest emergency exit. Provide hardware that can be operable with one hand and not require tight grasping, pinching, or twisting of the wrist.	1	358	\$358

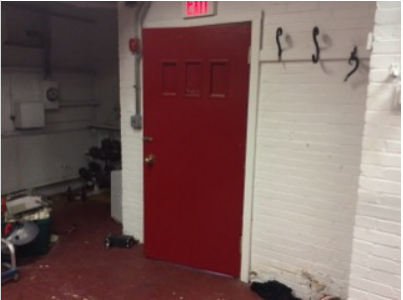
8	Weight Room Exit	B		Emergency Exit

Emergency exit not on an accessible route Hardware not operable with a closed fist		Provide a directional sign indicating the location of the nearest emergency exit. Provide hardware that can be operable with one hand and not require tight grasping, pinching, or twisting of the wrist.	2	358	\$716
Access to Goods and Services

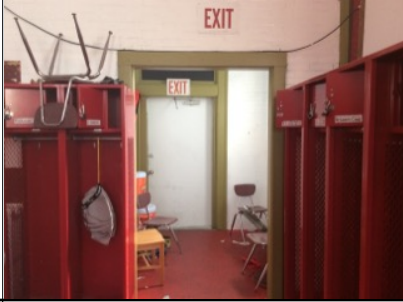
Illuminated exit sign not provided Tactile exit sign not provided		Ensure illuminated exit signs are provided at exits and exit doors. Ensure tactile exit signs with raised characters and braille are provided at exit doors leading to enclosed stairways. Mount signs between 48"-60" above finish floor located on the latch side of the door.	2	216	\$432
10	Home Locker Room Exit	1		Means of Egress	N/A

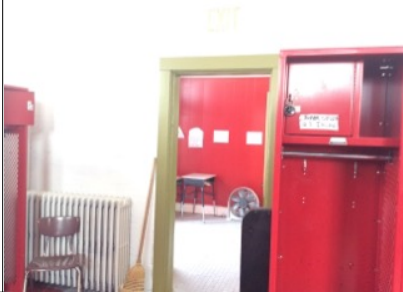
Illuminated exit sign not provided Tactile exit sign not provided		Ensure illuminated exit signs are provided at exits and exit doors. Ensure tactile exit signs with raised characters and braille are provided at exit doors leading to enclosed stairways. Mount signs between 48"-60" above finish floor located on the latch side of the door.	2	216	\$432

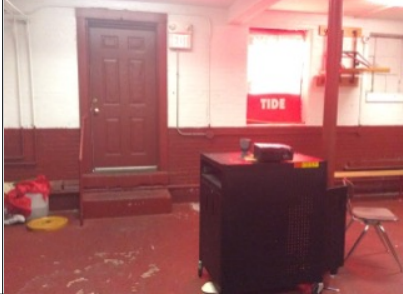
11	Team Meeting Room	B		Means of Egress	N/A

Tactile exit sign not provided		Ensure tactile exit signs with raised characters and braille are provided at exit doors leading to enclosed stairways. Mount signs between 48"-60" above finish floor located on the latch side of the door.	1	116	\$116
Interior Access Route												
12	Team Meeting Room	B		Interior Access Route	N/A

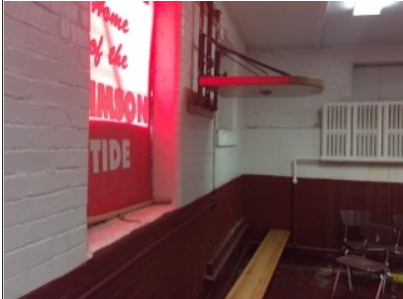
Obstructed by protruding objects	30"	Remove punching bag support if not in use. Otherwise, provide a cane detectable barrier.	1	Labor / 153	\$153
13	Weight Room	B		Interior Access Route	N/A

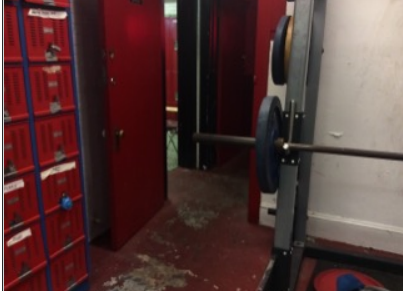
Obstructed by protruding objects		Relocate weight to ensure bar is not projecting into the circulation path.	1	Labor	\$0

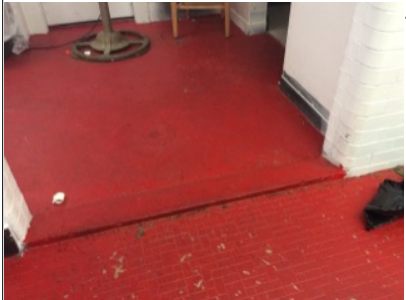
Threshold not beveled Threshold > 1/2" high	- 1"	Bevel threshold. Alter threshold to be 1/2" high max.	1	75	\$75
15	Home Locker Room First Aid Room	1		Doors, Doorways, & Gates	Office

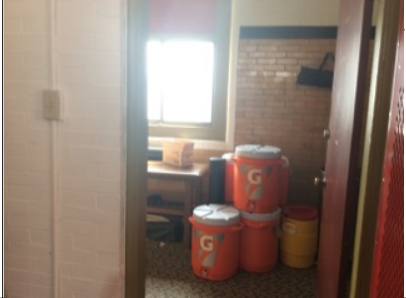
Hardware not operable with a closed fist		Provide hardware that can be operable with one hand and not require tight grasping, pinching, or twisting of the wrist.	1	242	\$242
16	Visitor Locker Room	1		Doors, Doorways, & Gates	Other

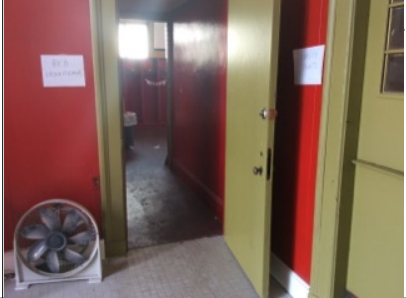
Hardware not operable with a closed fist		Provide hardware that can be operable with one hand and not require tight grasping, pinching, or twisting of the wrist.	1	242	\$242
17	Weight Room	B		Doors, Doorways, & Gates	Other

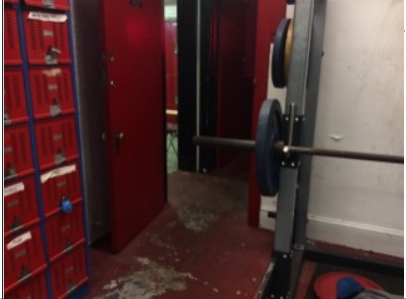
Hardware not operable with a closed fist		Provide hardware that can be operable with one hand and not require tight grasping, pinching, or twisting of the wrist.	1	242	\$242

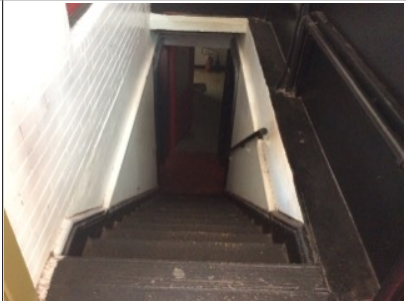
Not connected to an accessible route		Ensure the basement and exit to the Stadium are on an accessible route. Provide a 3 stop Limited Use/Limited Access Lift LULA at the exterior of the rear of the building.	1	110,000	\$110000

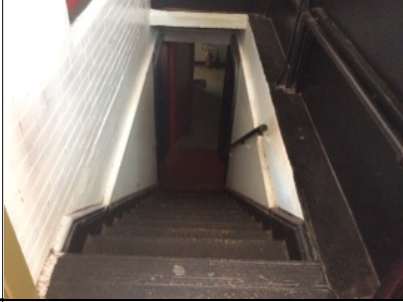
Handrails do not extend 12" from stairs Handrails not continuous where required		Top: Ensure handrails extend horizontally above the landing for 12" min. beginning above the first riser nosing. Bottom: Ensure handrails extend to one tread depth beyond the last riser. Provide continuous handrails on both sides.	2	1110	\$2220
20	Home and Visitor Locker Room Exits	1 Ext.		Stairways	Exterior

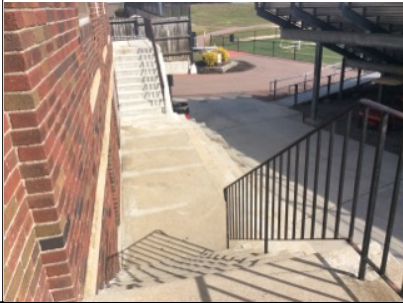
Handrails have non-compliant cross section Handrails not continuous where required		Provide handrails with 1 1/4" - 2" circular cross section. Provide continuous handrails on each side of stair.	4	1110	\$4440
Signage												
21	Home Locker Room First Aid Room	1		Signage	Designation

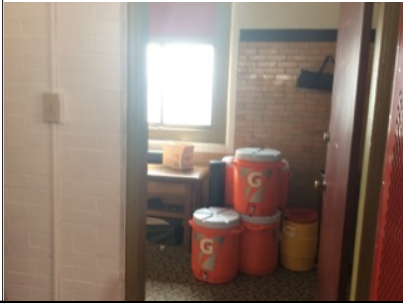
Not provided Raised characters not provided Braille not provided		Provide text with raised characters duplicated in braille. Locate signage alongside the door on the latch side.	1	116	\$116

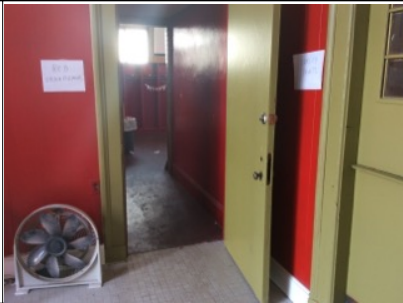
22	Visitor and Home Locker Rooms	1		Signage	Designation

Not provided Raised characters not provided Braille not provided		Locate signage alongside the door on the latch side. Provide text with raised characters duplicated in braille.	2	116	\$232
23	Main Entrance	1		Signage	Egress

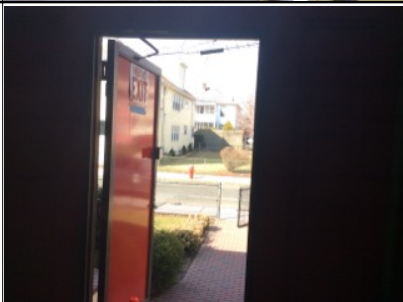
Raised characters not provided Braille not provided		Provide text with raised characters duplicated in braille.	1	116	\$116

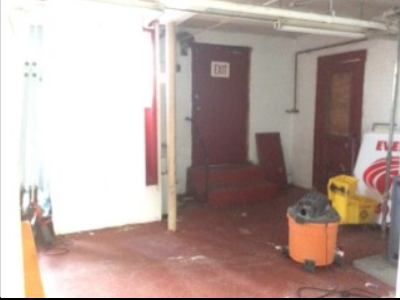
Raised characters not provided Braille not provided		Provide text with raised characters duplicated in braille.	2	116	\$232
Operable Parts												
25	Home Locker Room (Old Shower Room)	1		Operable Parts	Clothes Rod/Hooks

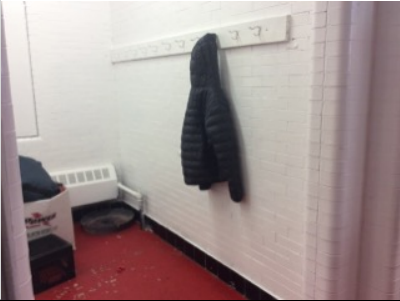
Reach < 15" or > 48"(forward/side approach)	68.1"	Relocate one hook so between 15"- 48" above finish floor.	1	Labor / 128	\$128
Locker Room												
26	Home Locker Room	1		Locker Room	N/A

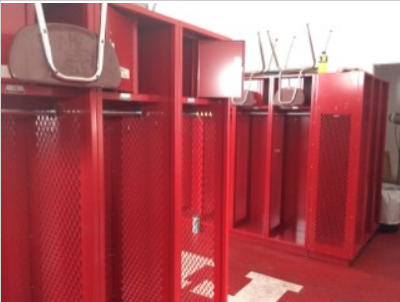
Total # of locker Total # of accessible locker 5% of lockers are not accessible Storage > 48" high Bench not provided	56 0 - 65"	Provide at least 3 accessible lockers (or ensure 5% of all lockers are accessible) . Ensure that at least 5% of lockers are accessible, and no higher than 48 inches above the floor. Provide an accessible bench within the room.	1	1090	\$1090

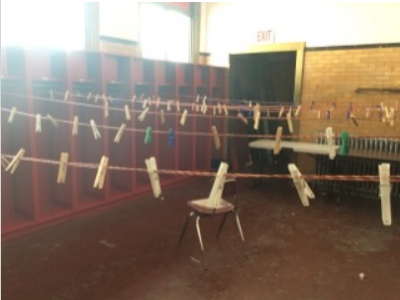
27	Visitor Locker Room	1		Locker Room	Other

Total # of locker Total # of accessible locker 5% of lockers are not accessible Storage > 48" high Bench not provided	24 0 - 65" -	Provide at least 2 accessible lockers (or ensure 5% of all lockers are accessible) . Ensure that at least 5% of lockers are accessible, and no higher than 48 inches above the floor. Provide an accessible bench within the room.	1	760	\$760
Toilet & Bathing Rooms

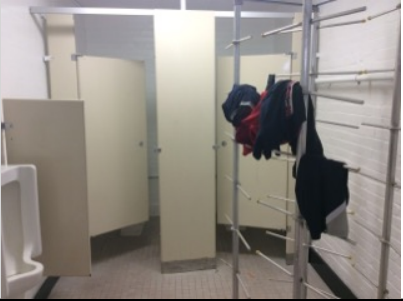
Accessible plumbing fixtures or stalls not provided		Provide one accessible wheelchair stall or add an accessible single-user toilet room.	1	3091	\$3091
29	Visitor Locker Room Toilet Room	1		Overall Access	Toilet Room

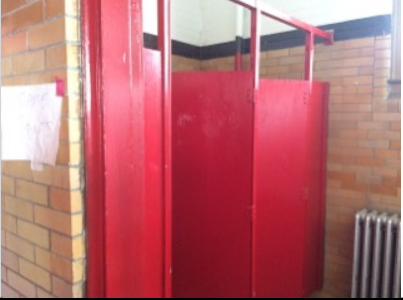
Accessible plumbing fixtures or stalls not provided		Provide one accessible wheelchair stall or add an accessible single-user toilet room.	1	3091	\$3091
Lavatory												
30	Visitor Locker Room Toilet Room	1		Lavatory	N/A

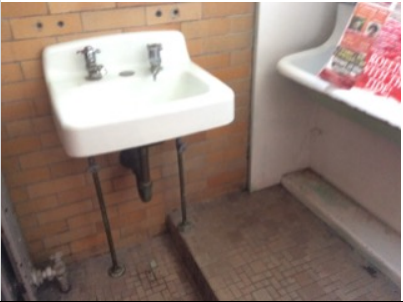
Toe or knee clearances not provided Faucet is not operable with a closed fist Plumbing underneath is exposed		Provide at least one lavatory with knee and toe clearance positioned for a forward approach. Step interferes with knee/toe clearance. Provide a faucet that can be operable with one hand and not require tight grasping, pinching, or twisting of the wrist for at least one lavatory. Insulate or otherwise configure pipes to prevent contact, for at least one lavatory.	1	1382	\$1382

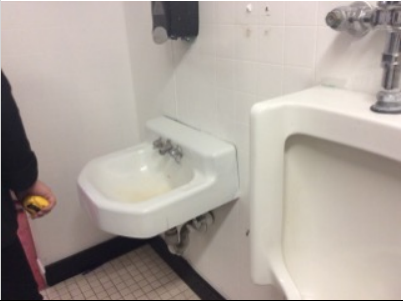
31	Home Locker Room Toilet	1		Lavatory	N/A

Toe or knee clearances not provided Dispensers not within reach range	25.25" 46"	Provide at least one lavatory with knee and toe clearance positioned for a forward approach. Relocate soap dispenser to 42" max. above the floor.	1	1196	\$1196
Urinal												
32	Home Locker Room Toilet	1		Urinal	N/A

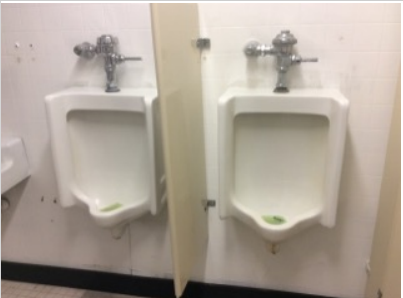
Rim > 17" high Flush control too high or not properly located	25" 49"	Provide at least one urinal with the rim no higher than 17" above the finish floor. Mount flush control at 44" max. above the finish floor.	1	1624	\$1624

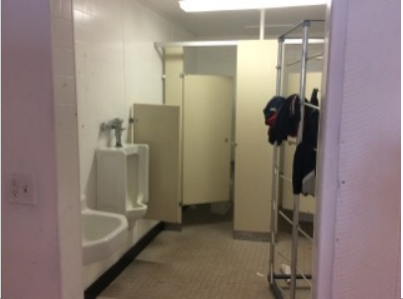
No visible fire alarm provided within room		When fire system is updated, ensure that a visible fire alarm is installed in each room.	10	346	\$3460
Best Practice												
34	Home and Visitor Locker Room Exits	1 Ext.

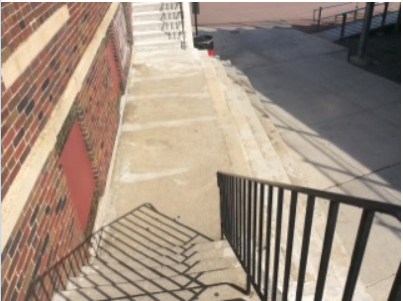
Best Practice		Consider adding tactile detectable contrasting warnings for safety.	2		\$0
