Parlin Memorial Library

City of Everett ADA Transition Plan

July 2018

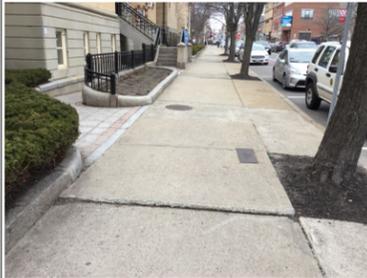
ID	Location	Element	Type	Photo	Issues	Current Measure	Recommendations	Quantity	Price	Cost Estimation
Pedestrian Access Routes										
Walking Surface										
1	Broadway	Walking Surface	Sidewalk

Level changes > 1/4"	2"	Alter change in level to be 1/4" high max.	6	103	\$618
Curb Ramps and Blended Transitions										
Detectable Warnings										
2	School St.	Detectable Warnings	Blended Transition

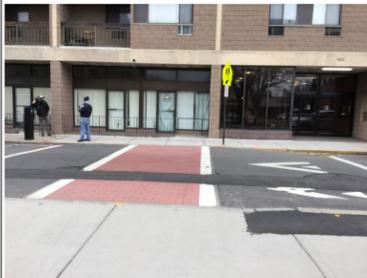
Detectable warnings not provided	-	Provide a detectable warning on curb ramps.	2	180	\$360
3	Broadway	Detectable Warnings	Perpendicular

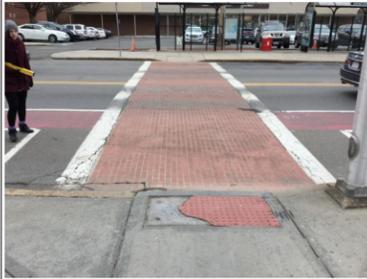
Detectable warnings not provided Detectable warnings not compliant	- -	Provide a detectable warning on curb ramp. Replace 1 existing worn detectable warning.	2	180	\$360
On-Street Parking										
Parking Space										
4	Broadway	Parking Space	N/A

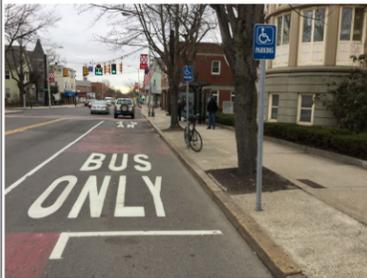
Total # of designated accessible parking spaces per block Total # of parking spaces per block Accessible space does not adjoin an accessible route	16 1 -	Provide at least 1 accessible spaces per block. Current accessible space is not ideal because there are times when it is a bus route only. Also, the space is not located near a curb ramp. Relocate the accessible space and ensure it adjoins an accessible route.	1	406	\$406

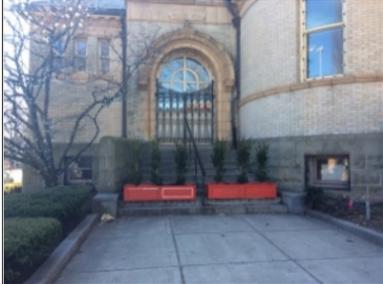
ID	Location	Floor	Room	Element	Type	Photo	Issues	Current Measure	Recommendations	Quantity	Price	Cost Estimation
A. Approach and Entrance												
E. Entrance												
5	Side Entrance (Not in Use)	Ext.		Entrance	Other

Directional sign to accessible entrance not provided	-	Provide a directional sign indicating the location of the nearest accessible entrance.	1	173	\$173
6	Main Entrance	Ext.		Entrance	Main Entrance

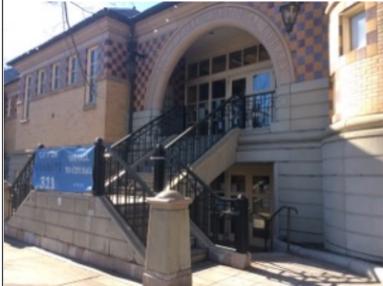
Directional sign to accessible entrance not provided		Provide a directional sign indicating the location of the nearest accessible entrance.	1	173	\$173
7	Ramp to Lower Level Entrance	Ext.		Entrance	Main Entrance

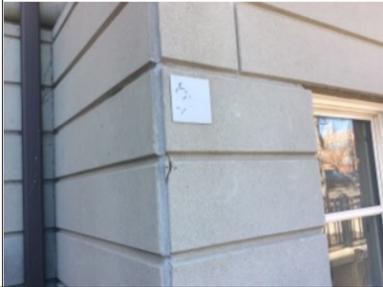
International Symbol of Acc. not provided	-	Provide the International Symbol of Accessibility.	1	173	\$173

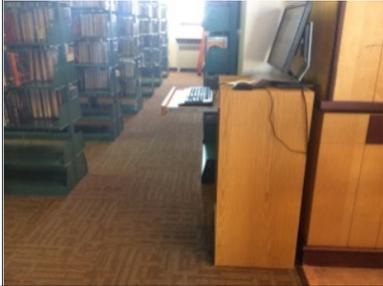
B. Access to Goods and Services												
B. Interior Access Route												
8	Near Welcome Desk	UL		Interior Access Route	N/A

Obstructed by protruding objects	11"	Relocate or repair standing computer desk so that keyboard tray is not protruding into the circulation path.	1	Labor	\$0

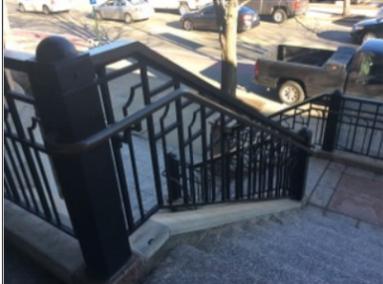
ID	Location	Floor	Room	Element	Type	Photo	Issues	Current Measure	Recommendations	Quantity	Price	Cost Estimation
E. Stairways												
9	Main Entrance	UL		Stairways	Exterior

Handrail height < 34" or > 38"	32"	Alter so the handrails are 34"- 38" high above the floor.	1	Labor	\$0
10	Stairs to Lower Level	UL		Stairways	Interior

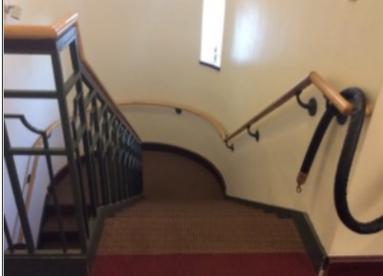
Handrail height < 34" or > 38"	32"	Alter so the handrails are 34"- 38" high above the floor.	1	Labor	\$0
11	Stairs at Lower Level	UL		Stairways	Interior

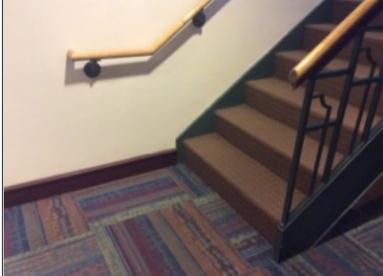
Handrails do not extend 12" from stairs	-	Bottom: Handrails shall extend at the slope of the stair flight for a horizontal distance at least equal to one tread depth beyond the last riser nosing. Extension shall return to a wall, guard or the landing surface.	1	166	\$166

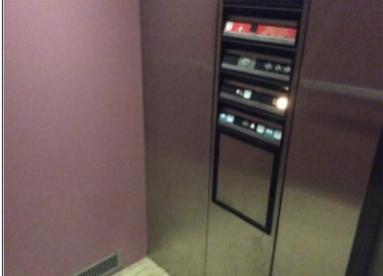
G. Elevator												
12	Elevator	LL		Elevator	Interior

Audible & visible car position indicators not provided	-	Install audible and visible car position indicators.	1	1700	\$1700

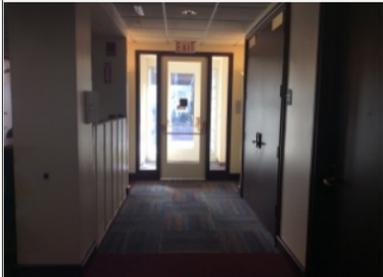
H. Signage												
13	Emergency Exit by Craft Area	LL		Signage	Egress

Raised characters not provided Braille not provided	- -	Provide text with raised characters duplicated in braille.	1	116	\$116

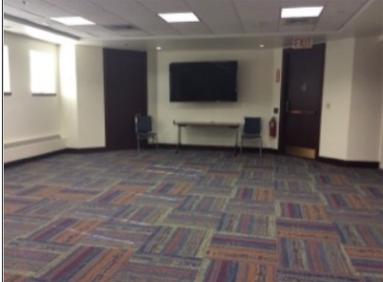
ID	Location	Floor	Room	Element	Type	Photo	Issues	Current Measure	Recommendations	Quantity	Price	Cost Estimation
14	Meeting Room	LL		Signage	Egress

Raised characters not provided Braille not provided	- -	Provide text with raised characters duplicated in braille.	1	116	\$116
15	Staff Exit by Homework Center	LL		Signage	Egress

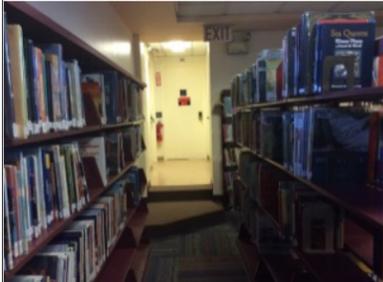
Raised characters not provided Braille not provided	- -	Provide text with raised characters duplicated in braille.	1	116	\$116

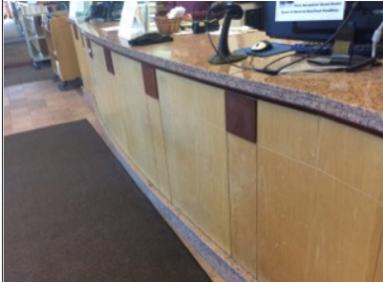
J. Service Counter												
16	Welcome Desk	UL		Service Counter	N/A

Counter > 36" high	38"	Provide a counter that is 36" max. above the ground or finish floor.	1	440	\$440

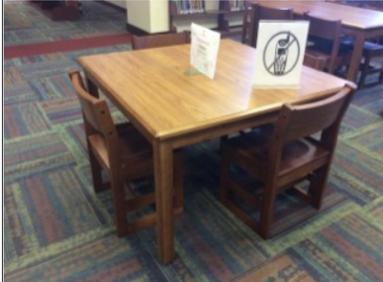
M. Dining or Work Surfaces												
17	Homework Center, Craft Area, Reading/Activity Area Near Computer Tables	LL		Dining or Work Surfaces	Work Surface

At least one or 5% accessible tables not provided Knee or toe clearance not provided	- 23"	For children: Ensure that at least one dining or work surface is accessible. Provide at least 1 dining or work surface with 24" min. knee and toe clearance at each unique program area.	3	350	\$1050
18	Quiet Area by Alcove, Work Area by iMac Computer Tables	UL		Dining or Work Surfaces	Work Surface

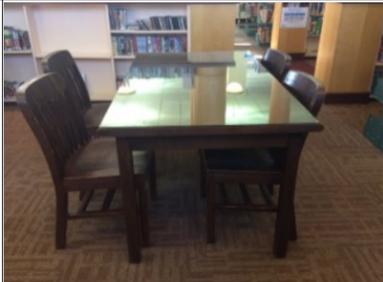
At least one or 5% accessible tables not provided Knee or toe clearance not provided	- 24"	Ensure that at least one dining or work surface is accessible. Provide at least 1 dining or work surface with 27" min. knee and toe clearance at each unique program area.	2	350	\$700

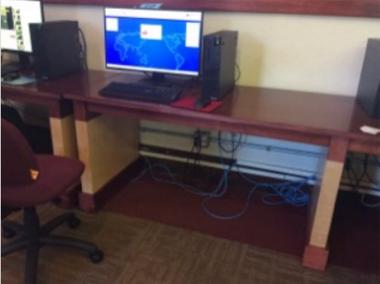
ID	Location	Floor	Room	Element	Type	Photo	Issues	Current Measure	Recommendations	Quantity	Price	Cost Estimation
19	Computer Area	UL		Dining or Work Surfaces	Work Surface

Knee or toe clearance not provided	26"	Provide at least 1 dining or work surface with 27" min. knee and toe clearance.	1	350	\$350

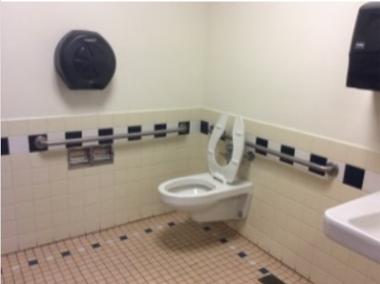
C. Toilet & Bathing Rooms												
C. Single-User Toilet												
20	Adult Men's Toilet Room Downstairs and Upstairs	LL, UL		Single-User Toilet	N/A

Flush control not on open side Centerline < or > 18" (MAAB) Side or rear grab bar < 33" or > 36" high Audible and visible alarms not provided Toilet paper dispenser is not compliant	- 19" 30" - -	When fire system is updated, ensure that a visible and audible fire alarm is installed. Relocate the flush control to the open side. Mount grab bars to 33"- 36" above the floor. Relocate toilet paper so that it is 15" min high, located under the grab bar, and between 7" and 9" from the front of the toilet. Ensure nothing is mounted over the grab bars. Centerline is not compliant but is usable.	2	1014	\$2028
21	Adult Women's Toilet Room Downstairs and Upstairs	LL, UL		Single-User Toilet	N/A

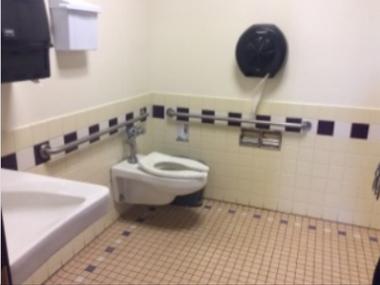
Centerline < or > 18" (MAAB) Side grab bar < 54" from back wall Side or rear grab bar < 33" or > 36" high Audible and visible alarms not provided Toilet paper dispenser is not compliant	19" 49" 30" - -	When fire system is updated, ensure that a visible and audible fire alarm is installed. Mount grab bars to 33"- 36" above the floor. Relocate toilet paper so that it is 15" min high, located under the grab bar, and between 7" and 9" from the front of the toilet. Ensure nothing is mounted over the grab bars. Centerline is not compliant but is usable.	2	827	\$1654

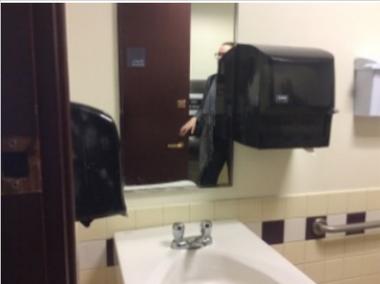
F. Dispensers												
22	Adult Men's and Women's Toilet Rooms Downstairs and Upstairs	LL, UL		Dispensers	Paper Towel Dispenser

Controls > 42" high Dispenser acts as a protruding object	51" 10"	Relocate the paper towel dispenser so that the controls are 42" max. above the finish floor and out of the circulation path.	4	353	\$1412

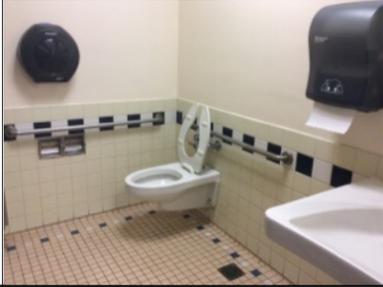
ID	Location	Floor	Room	Element	Type	Photo	Issues	Current Measure	Recommendations	Quantity	Price	Cost Estimation
J. Single-User Toilet												
23	Boy's Toilet Room	LL		Single-User Toilet	N/A

Flush control not on open side Centerline < or > 18" (MAAB) Side or rear grab bar < 33" or > 36" high Audible and visible alarms not provided Toilet paper dispenser is not compliant	- 19" 30" - -	When fire system is updated, ensure that a visible and audible fire alarm is installed. Relocate the flush control to the open side. Mount grab bars to 33"- 36" above the floor or to a children's height based on age. Relocate toilet paper so that it is 15" min high, located under the grab bar, and between 7" and 9" from the front of the toilet. Centerline is not compliant but is usable.	1	1014	\$1014
24	Girl's Toilet Room	LL		Single-User Toilet	N/A

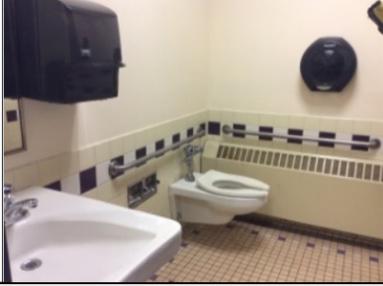
Centerline < or > 18" (MAAB) Side grab bar < 54" from back wall Side or rear grab bar < 33" or > 36" high Audible and visible alarms not provided Toilet paper dispenser is not compliant	19" 49" 30" - -	When fire system is updated, ensure that a visible and audible fire alarm is installed. Relocate the flush control to the open side. Mount grab bars to 33"- 36" above the floor or to a children's height based on age. Relocate toilet paper so that it is 15" min high, located under the grab bar, and between 7" and 9" from the front of the toilet. Centerline is not compliant but is usable.	1	827	\$827

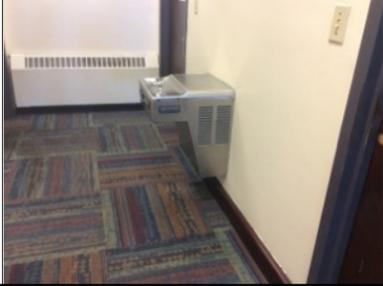
E. Additional Access												
A. Drinking Fountains												
25	Near Children's Toilet Rooms	LL		Drinking Fountains	Low

Knee or toe clearance not provided	23"	Provide knee and toe clearance, 27" min. high at drinking fountain for seated users.	1	1014	\$1014

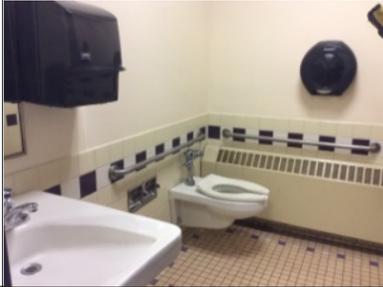
- The heater alongside the toilet in the girl's toilet room may pose a safety issue to people transferring to the toilet. Consider relocating heater for this reason and because it obstructs the proper location of the toilet paper.

Z. Best Practice												
26	Girl's Toilet Room	LL

Safety Issue	-	Safety Issue: Heater alongside the toilet may pose a safety issue to people transferring to the toilet. Consider relocating heater for this reason and because it obstructs the proper location of the toilet paper.	1	-	\$0
