## City of Everett ADA Transition Plan

July 2018

Institute for Human Centered Design

## Recreation Center

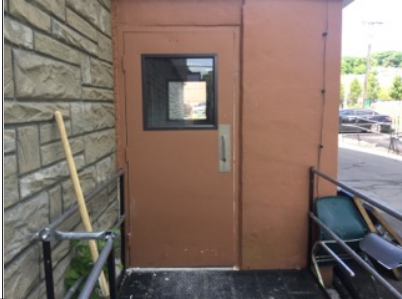
Automatic door opener not operable	16 lbs	Repair or replace the door opener.	1	1530	\$1530
<b>Emergency Exit</b>												
2	Western Exit in Gymnasium	1		Emergency Exit	N/A

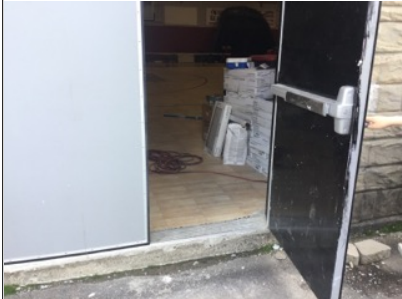
Emergency exit not on an accessible route Threshold > 3/4" high	- 6.5"	Provide a directional sign indicating the location of the nearest emergency exit.	1	116	\$116
3	Northeastern Exit in Gymnasium	1		Emergency Exit	N/A

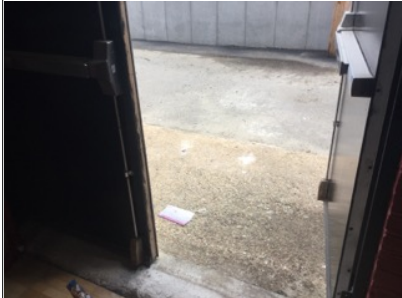
Threshold > 3/4" high	2.5"	Alter threshold to be 3/4" high max.	1	125	\$125
<b>Access to Goods and Services</b>												
<b>Interior Access Route</b>												
4	Men's Accessible Toilet Room	1		Interior Access Route	N/A

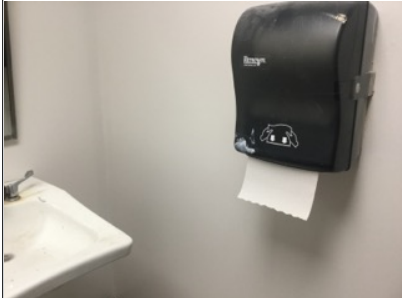
Obstructed by protruding objects	8.5"	Relocate dispenser out of the circulation path.	1	153	\$153

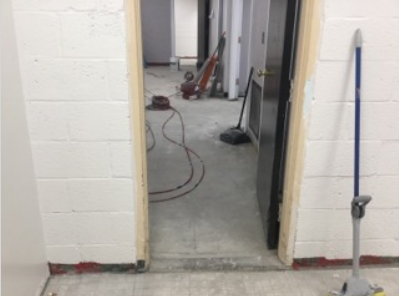
Threshold not beveled Threshold > 1/2" high	- .6"	Alter threshold to be 1/2" high max. and beveled.	1	75	\$75
6	Entrance to Boy's Locker Room	1		Doors, Doorways, & Gates	Toilet Room

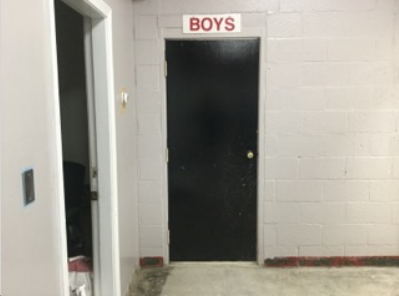
Hardware not operable with a closed fist	-	Provide hardware that can be operable with one hand and not require tight grasping, pinching, or twisting of the wrist.	1	242	\$242
<b>Ramps</b>												
7	Ramp to Lot From Elm St.	Ext.		Ramps	Exterior

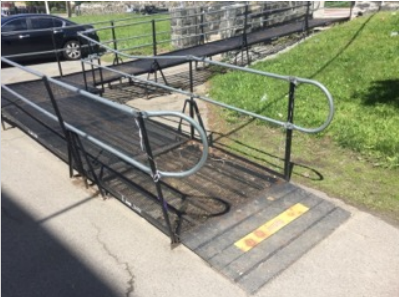
The ramp that allows access between the sidewalk and the lot is not in operable condition due to broken/bent railings and lack of edge protection. It is an unstable temporary metal ramp currently held in place with sand. The stairway is also inaccessible due to lack of railings on each side. The main entrance to the recreation center had an automatic opener installed but was not operational when the survey was conducted.

Handrails < 34" or > 38" above ramp surface Handrails do not extend 12" past top & bottom Edge protection < 4" high Not maintained in operable working condition	-	Ensure the ramp is maintained in operable working condition. Alter handrails to extend horizontally above the landing for 12" min. beyond the top and bottom of ramp runs. Provide edge protection that prevents the passage of a 4" diameter sphere, where any portion of the sphere is within 4" of the finish ground surface. (Cost estimate is for a new pressure treated wood ramp 48 feet long.)	1	5914	\$5914

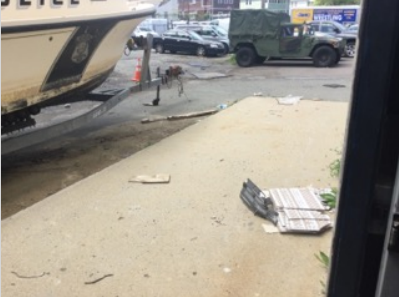
8	Southern Exit in Gymnasium	1		Ramps	Exterior

Three of the four emergency exits are not accessible, and while the southern exit had a ramp to allow accessible egress, it lacked necessary railings.

Handrails not provided at both sides if rise is > 6"	9"	Provide handrails on both sides.	2	407	\$814
<b>Stairways</b>												
9	Stairway to Lot From Elm St.	Ext.		Stairways	Exterior

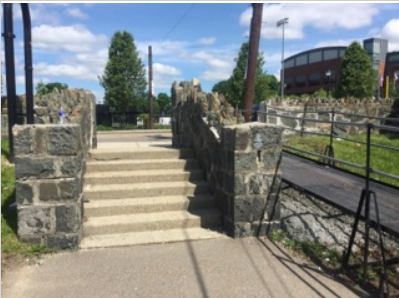
Handrail not provided on both sides	-	Provide handrails on both sides.	2	555	\$1110

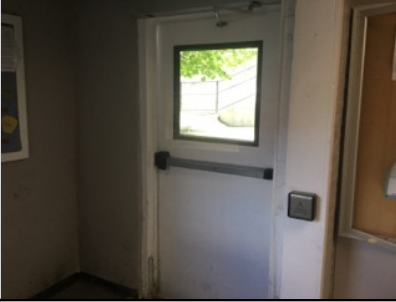
Not provided	-	Locate signage alongside the door on the latch side.	1	116	\$116
11	Men's Accessible Toilet Room	1		Signage	Designation

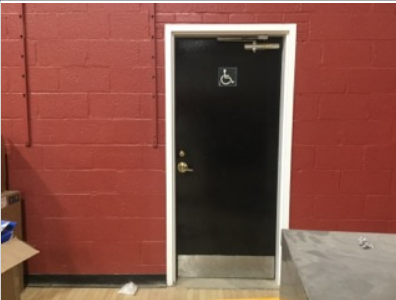
Not provided	-	Locate signage that designates this room as the men's accessible toilet alongside the door on the latch side.	2	116	\$232
12	Women's Accessible Toilet Room	1		Signage	Designation

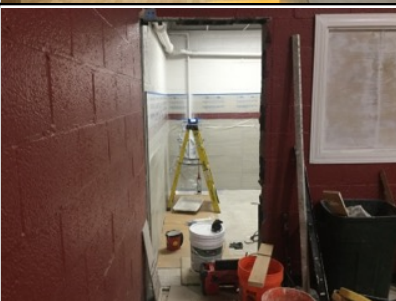
Not provided	-	Locate signage alongside the door on the latch side. Provide text with raised characters duplicated in braille.	1	116	\$116
13	Exit to Foyer	1		Signage	Egress

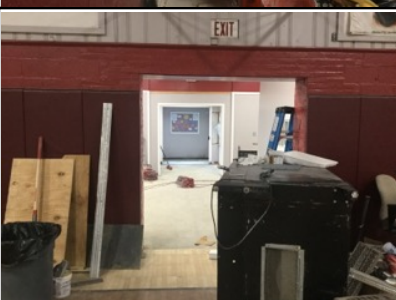
Raised characters not provided	-	Provide text with raised characters duplicated in braille.	1	116	\$116
14	Northeastern Exit in Gymnasium	1		Signage	Egress

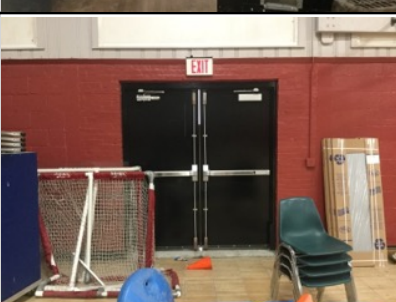
Raised characters not provided	-	Provide text with raised characters duplicated in braille.	1	116	\$116

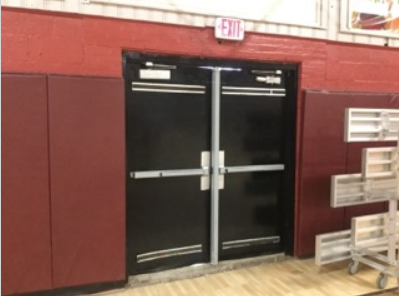
Raised characters not provided	-	Provide text with raised characters duplicated in braille.	1	116	\$116
16	Western Exit in Gymnasium	1		Signage	Egress

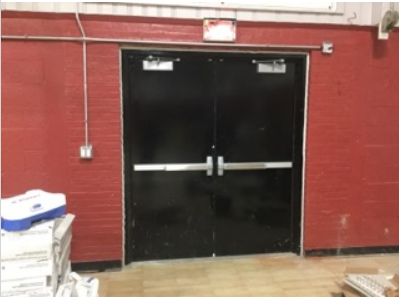
Raised characters not provided	-	Provide text with raised characters duplicated in braille.	1	116	\$116
17	Entrance to Boy's Locker Room	1		Signage	Designation

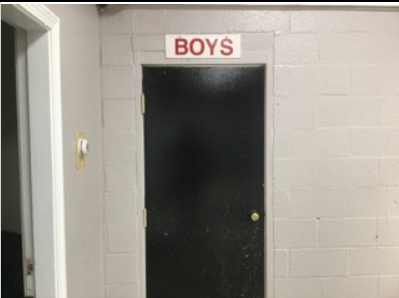
Raised characters not provided Braille not provided	-	Provide text with raised characters duplicated in braille.	1	116	\$116
18	Entrance to Girl's Locker Room	1		Signage	Designation

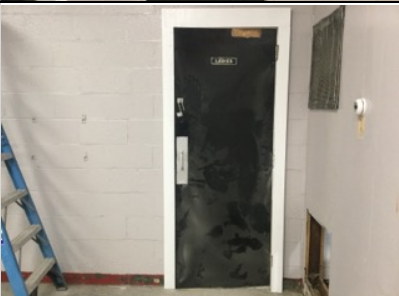
Raised characters not provided Braille not provided	- -	Provide text with raised characters duplicated in braille.	1	116	\$116
<b>Service Counter</b>												
19	Ticketing Window	1		Service Counter	Service Window

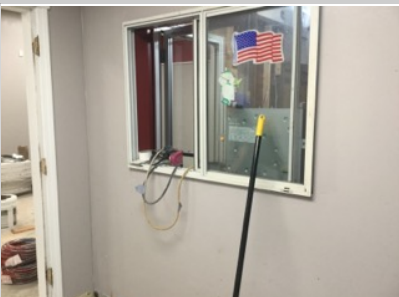
The service/ticketing window near the entrance of the facility is more than 36 inches above the finished floor.

Counter > 36" high	45"	Lower service window to be no more than 36" above the finished floor	1	440	\$440

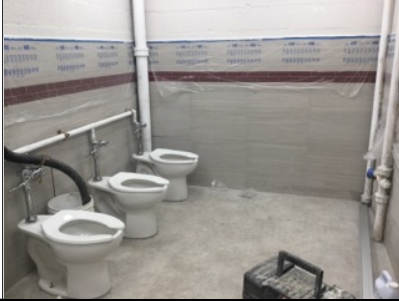
Accessible plumbing fixtures or stalls not provided Audible and visible alarms not provided	- -	When fire system is updated, ensure that a visible and audible fire alarm is installed. Toilets are not currently spaced to allow an accessible toilet compartment in the locker room. Provide an accessible toilet compartment.	1	3437	\$3437
21	Toilet Room in Girl's Locker Room	1		Overall Access	Toilet Room

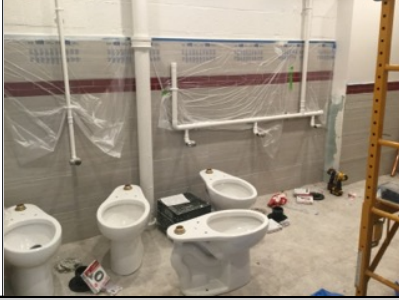
Accessible plumbing fixtures or stalls not provided Audible and visible alarms not provided	-	Provide one accessible wheelchair stall. When fire system is updated, ensure that a visible and audible fire alarm is installed.	1	3437	\$3437
<b>Lavatory</b>												
22	Toilet Room in Boy's and Girl's Locker Room	1		Lavatory	N/A

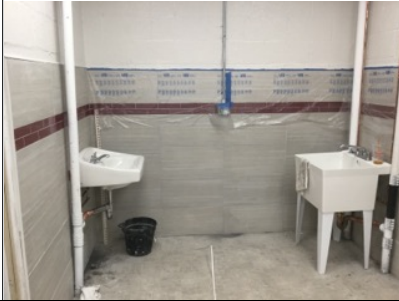
Plumbing underneath is exposed	-	Insulate or otherwise configure pipes to prevent contact, for at least one lavatory.	2	46	\$92

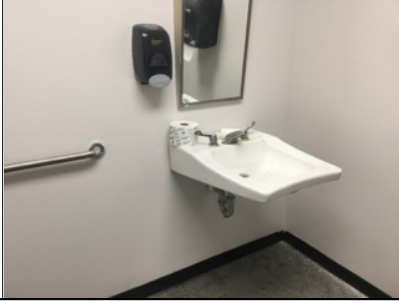
23	Men's Accessible Toilet Room	1		Lavatory	N/A

Plumbing underneath is exposed Dispensers not within reach range	- 47"	Insulate or otherwise configure pipes to prevent contact, for at least one lavatory.  Relocate dispenser to 42" max. above the floor.	1	399	\$399
<b>Single-User Toilet</b>												
24	Men's Accessible Toilet Room	1		Single-User Toilet	N/A

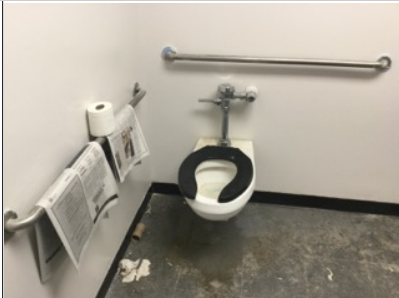
Flush control not on open side Side or rear grab bar < 33" or > 36" high	- 31"	Relocate the flush control to the open side. Mount grab bars to 33"- 36" above the floor.	1	443	\$443

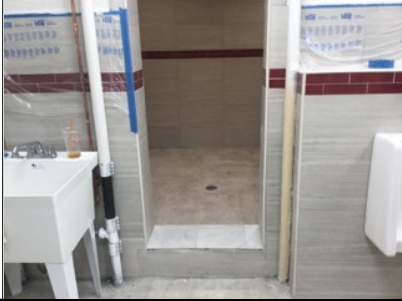
Shower not on an accessible route	-	Locate the accessible shower on an accessible route. Remove step. Provide a roll-in shower. Provide a roll-in shower with grab bars.	1	5319	\$5319
26	Girl's Locker Room Gang Shower	1		Shower Compartment	Gang Shower

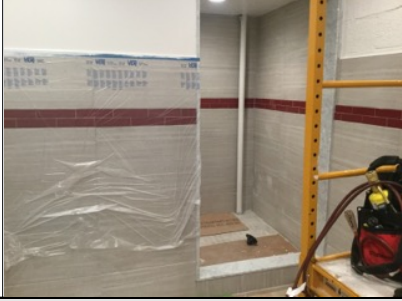
Shower not on an accessible route	-	Locate the accessible shower on an accessible route. Remove step. Provide a roll-in shower. Provide a roll-in shower with grab bars.	1	5319	\$5319
<b>Best Practice</b>												
27	Computer Room	1

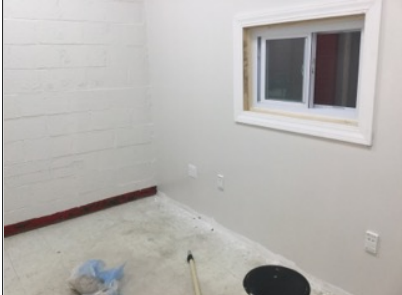
Best Practice		When computers and tables are installed, the window will be out of reach range. Consider reconfiguring the room to provide universal access to the window.	1	0	\$0
