# Sacramone Park

## City of Everett ADA Transition Plan

August 2018

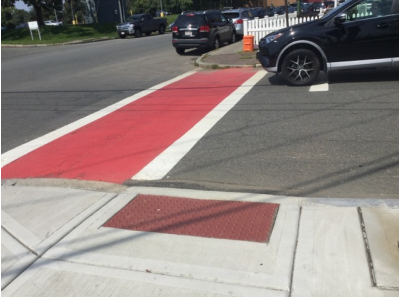
Curb ramp not provided Curb ramp not contained in street crossing		Provide a curb ramp on the north side of Tileston Street. Repaint the crosswalk so that the curb ramp is contained wholly within the width of the pedestrian street crossing served.	1	1298	\$1298
2	Entrance Gate by Best Buy Parking	Ext.		Curb Ramp	Perpendicular

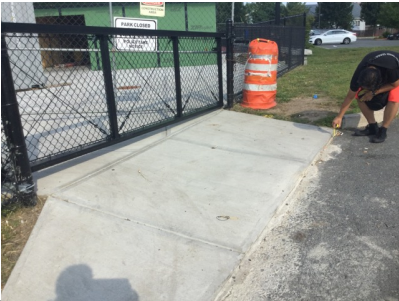
Transition from curb ramp to street not flush	1.5"	Ensure transition from curb ramp to street is flush or free of changes in level.	1	85	\$85
3	Crossing at Best Buy	Ext.		Curb Ramp	Parallel

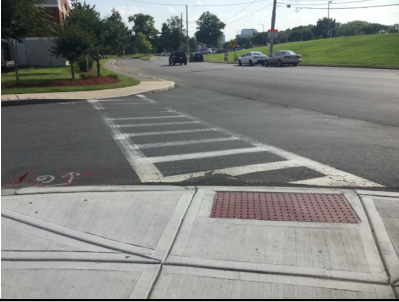
Detectable warning not provided		Provide a detectable warning on the curb ramp.	1	180	\$180
<b>Entrance</b>												
4	Entrance From Santilli Highway	Ext.		Entrance	Secondary Entrance

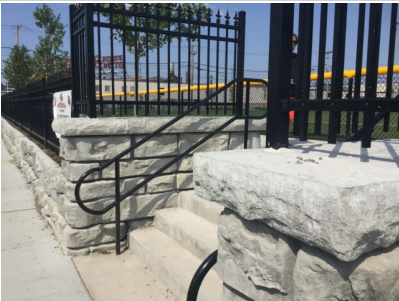
Directional sign to accessible entrance not provided		Provide a directional sign indicating the location of the nearest accessible entrance.	1	173	\$173

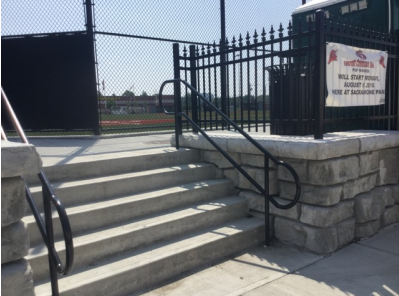
5	Tileston Street Northeast Entrance	Ext.		Entrance	Secondary Entrance

Directional sign to accessible entrance not provided		Provide a directional sign indicating the location of the nearest accessible entrance.	1	173	\$173

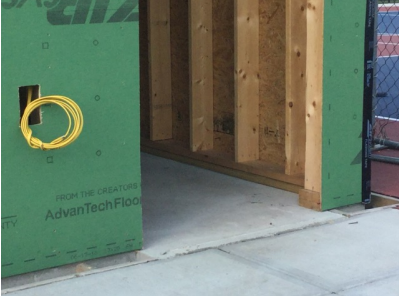
Maneuvering clearance(s) not provided		From floor plans, doors are drawn to swing into the toilet rooms. If the doors have both a latch and a closer, ensure that there is a 12" wide 48" deep level clear space on the latch side of the door. Currently, there is a deep drainage trench in this area alongside the door.	2	Labor	\$0
7	Playground Gate	Ext.		Doors, Doorways, & Gates	Other

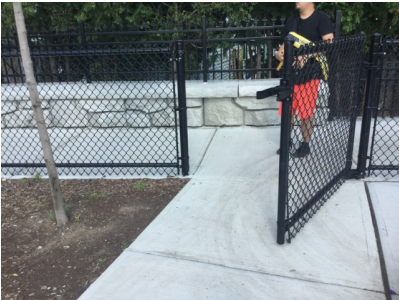
Maneuvering clearance(s) not provided	0"	Pour an 18" wide by 60" deep concrete pad on the latch pull side of the gate.	1	48	\$48
8	Gates to Field	Ext.		Doors, Doorways, & Gates	N/A

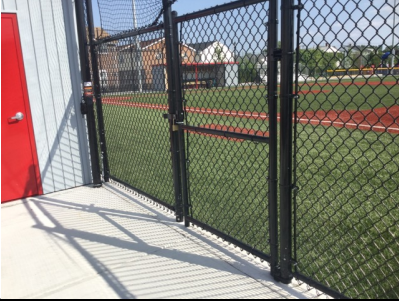
10" solid surface not provided		Swinging door and gate surfaces within 10 inches of the finish floor or ground measured vertically shall have a smooth surface on the push side extending the full width of the door or gate.	8	158	\$1264

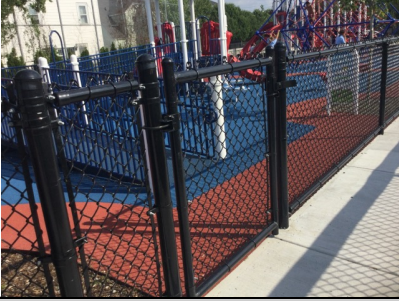
9	Playground Gates	Ext.		Doors, Doorways, & Gates	N/A

10" solid surface not provided		Swinging door and gate surfaces within 10 inches of the finish floor or ground measured vertically shall have a smooth surface on the push side extending the full width of the door or gate.	4	158	\$632
Service Counter												
10	Concessions Stand Counter	Ext.		Service Counter	N/A

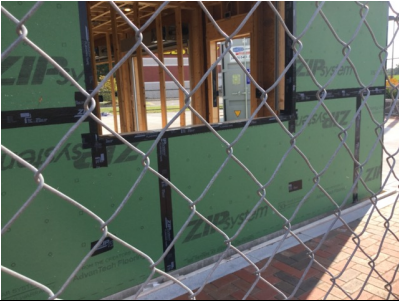
Counter > 36" high	42"	Provide a counter on the exterior of the building that is 36" max. above the ground.	1	440	\$440

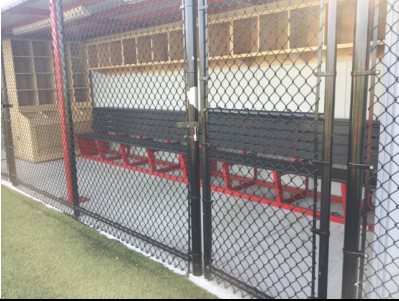
Accessible spaces are not provided at team seating		Provide a 36" x 48" clear floor space at team seating. Remove a 36" wide section of bench at each dugout.	4	Labor	\$0
Bleachers												
12	Santilli Highway Side Bleacher	Ext.		Bleachers	N/A

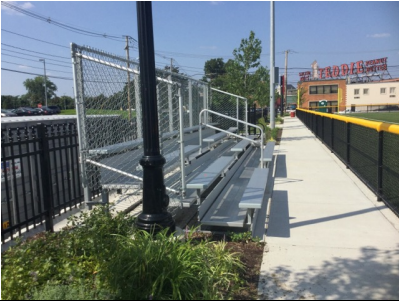
Total number of seats in the facility Min. # of designated wheelchair spaces not provided	44 0	Provide the space for at least one accessible space at this bleacher. In front of the lamp post, provide a concrete area that is 36" wide and goes back 12" from the back of the first bench to allow a wheelchair user to sit shoulder to shoulder with a companion.	1	46	\$46
13	Tileston Street Bleacher	Ext.		Bleachers	N/A

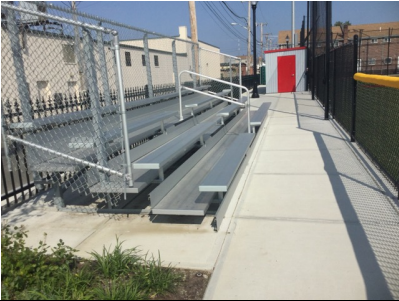
Total number of seats in the facility Min. # of designated wheelchair spaces not provided	44 1	Ensure that a 36" wide section of concrete is provided along each side of the bleachers for wheelchair spaces. Currently there is only a compliant accessible space along one side. Ensure the concrete area extends back 12" from the back of the first bench to allow a wheelchair user to sit shoulder to shoulder with a companion.	1	46	\$46

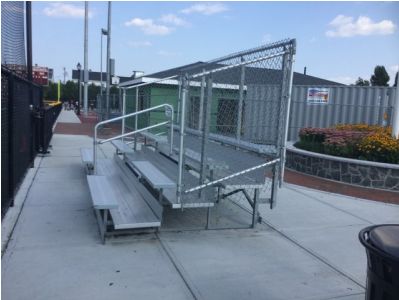
14	South Bleacher	Ext.		Bleachers	N/A

Total number of seats in the facility Min. # of designated wheelchair spaces not provided Shoulder alignment not provided at companion seats Wheelchair seats overlap circulation paths	24 0 - 46.5"	Relocate bleacher so the back of the first bench is 72" min. from the fence or nearest obstruction. Provide a 36" accessible route that does not overlap with seating area. Provide shoulder alignment with the adjacent wheelchair space. The shoulder alignment of the wheelchair space shall be measured 36" from the front of the wheelchair space. See diagram attached to report for clarification.	1	Labor	\$0
Best Practice

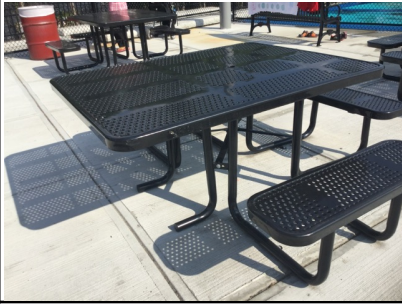
18"	Picnic table is MAAB compliant but not ADA compliant. In the future, purchase accessible picnic tables that are 30" wide for 17" minimum deep. Current supports only have a clear width of 18" and are located approximately 13" deep from the edge of the table.	1		\$0
