Everett Public Schools

Middle School Conversion (Former Everett High School)

Facility Assessment Study - Feasibility Report

July 22, 2024

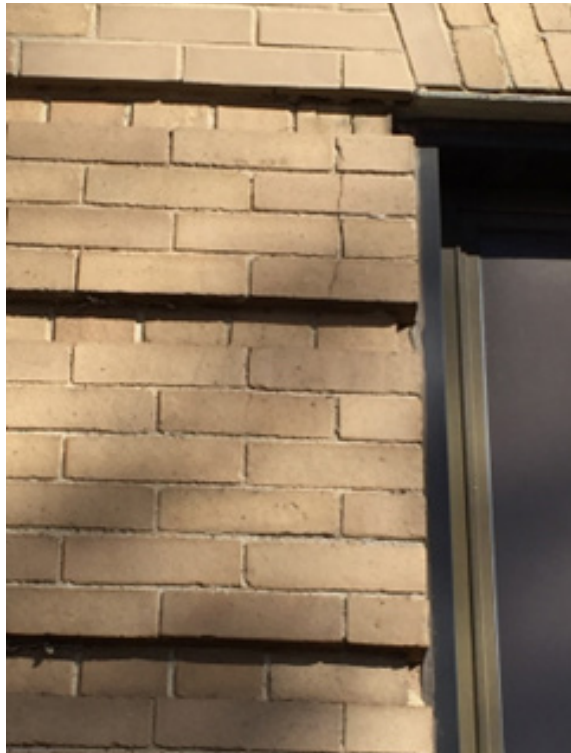
Masonry cracks and re-pointing required

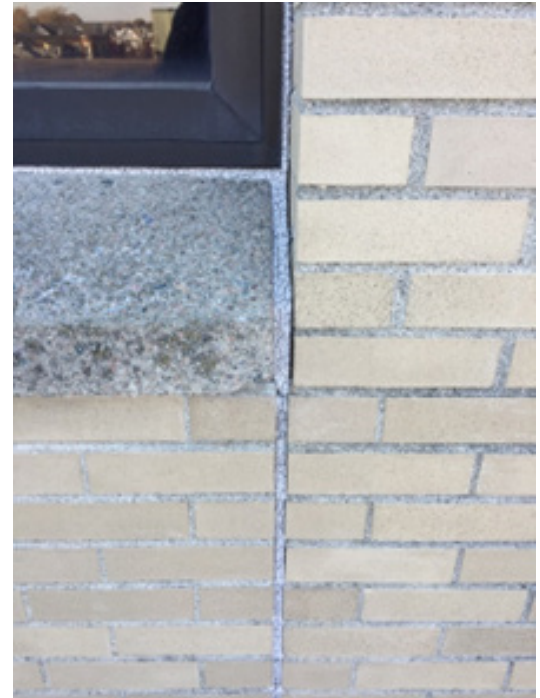
Masonry and window openings require repointing and caulking

The copper cap at the top of the 1920's original building, along with all related wood blocking, should be replaced in its entirety. The brick veneer of the building should be cleaned in its entirety. The cast stone should be repointed and ornamental balconies should be lined with a membrane or water proof material as the standing water is damaging the integrity of the cast stone.

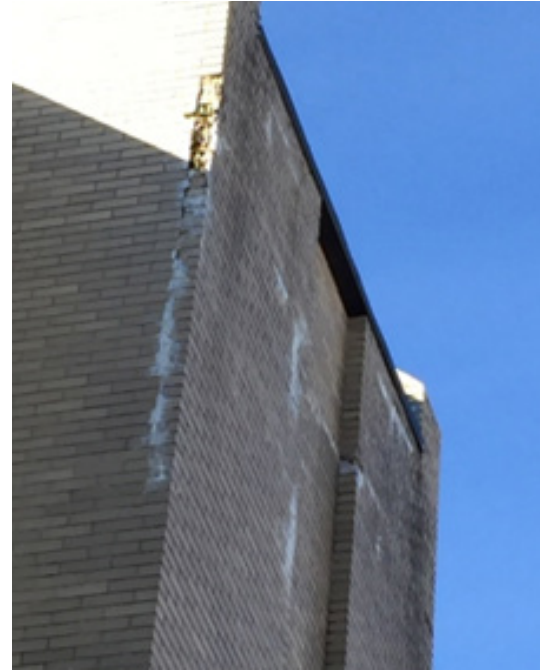
Masonry deterioration at 1970's addition

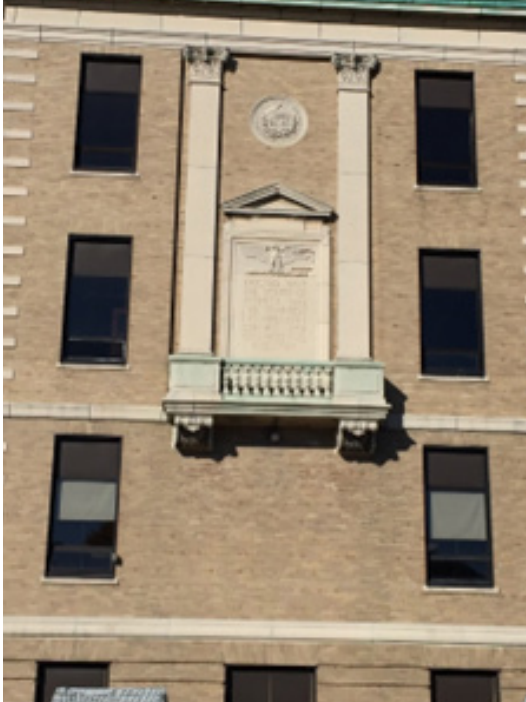
Copper cornice flashings deteriorating

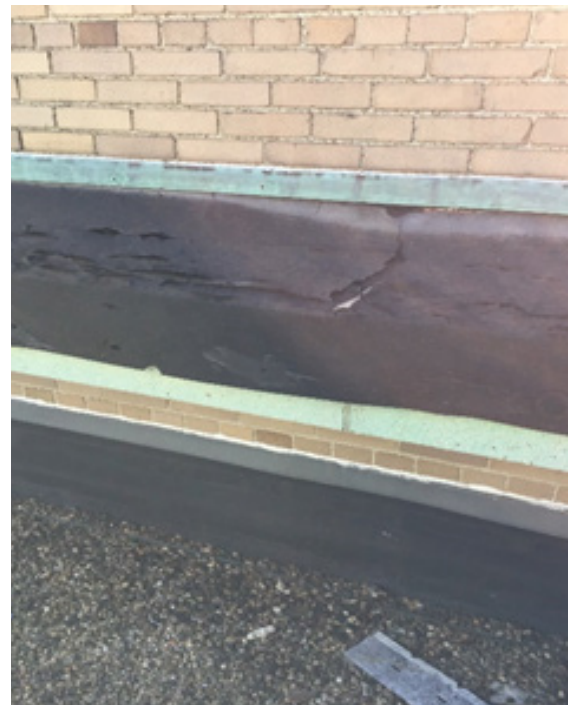
Deteriorated flashings, both copper and membrane

The entire roof system on both the original 1920's building and the 1970's addition, are in poor to failed conditions. There are numerous soft spots on the roof, metal and membrane flashings have failed.

As part of any addition/renovation project, it is recommended that all existing roof systems and associated components be replaced in their entirety.

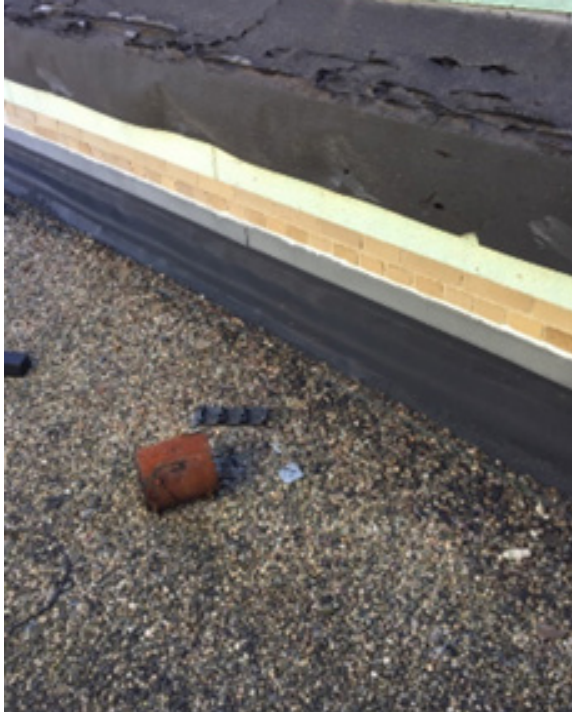
Flashings deteriorated and useless

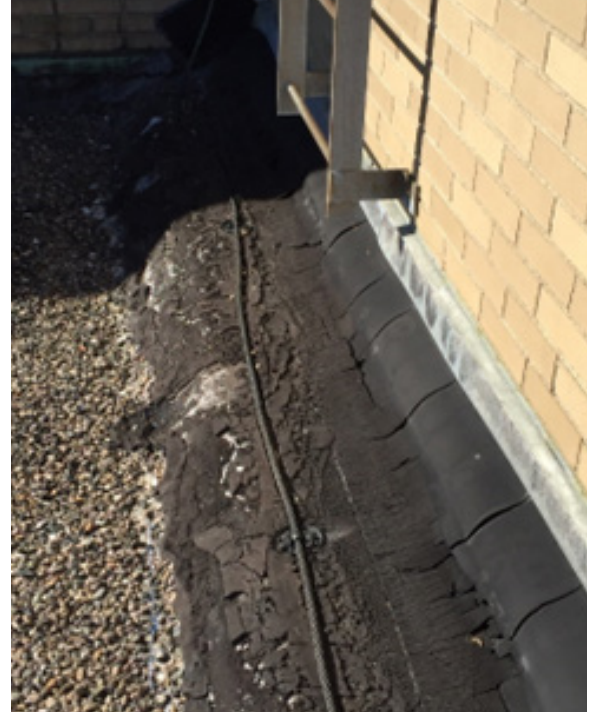
Flashings deteriorated and useless

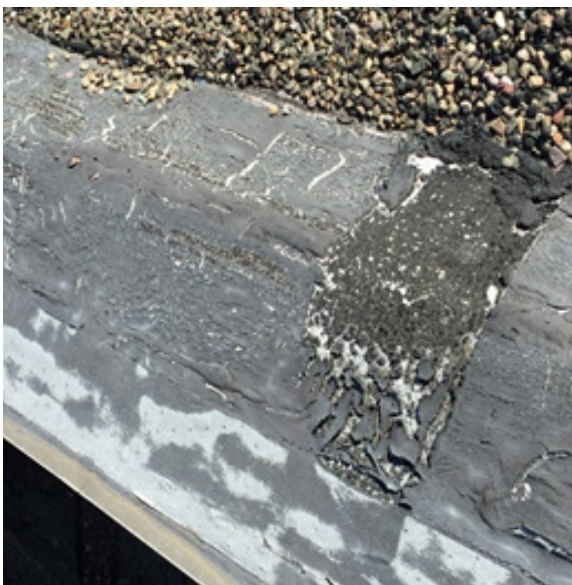
Original Edge of roof gravel stop & flashings deteriorated

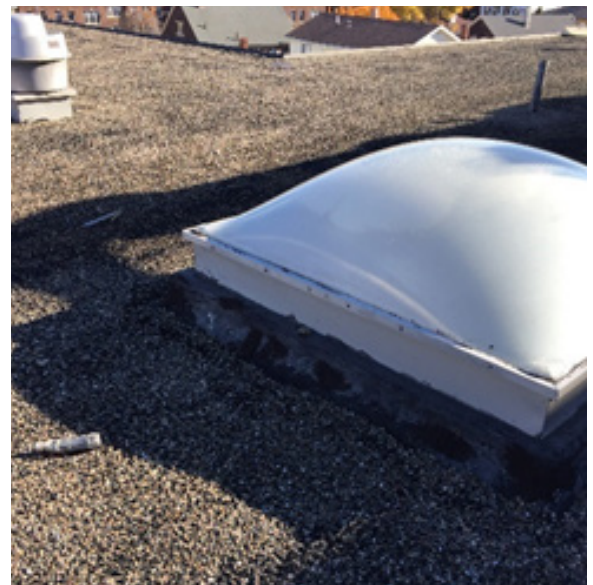
Flashings at skylights, roof fans & equipment deteriorated

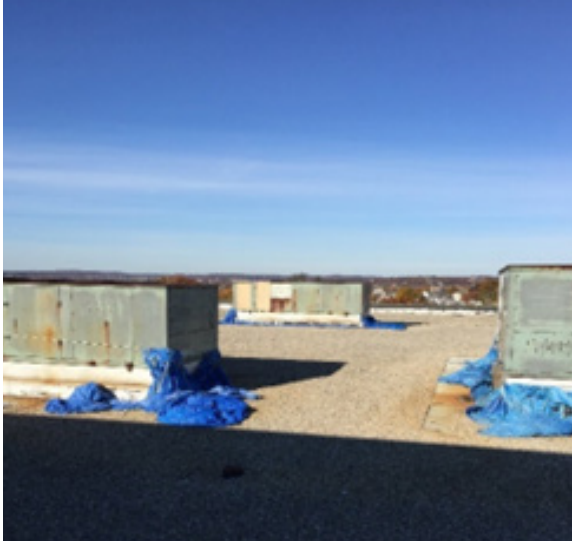
Failed and deteriorating mechanical units

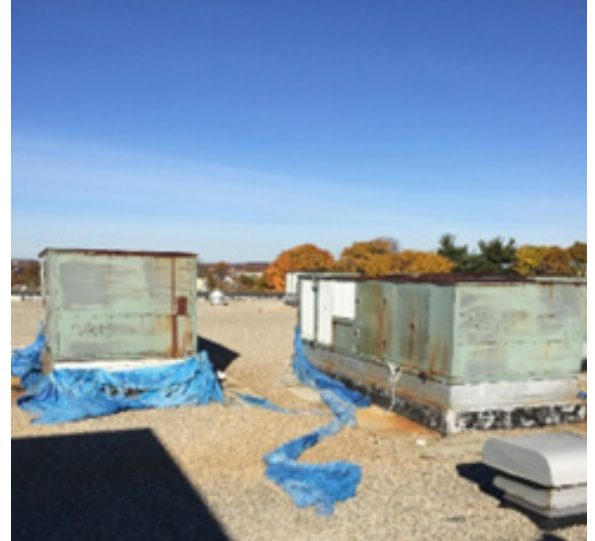
Failed and deteriorating mechanical units

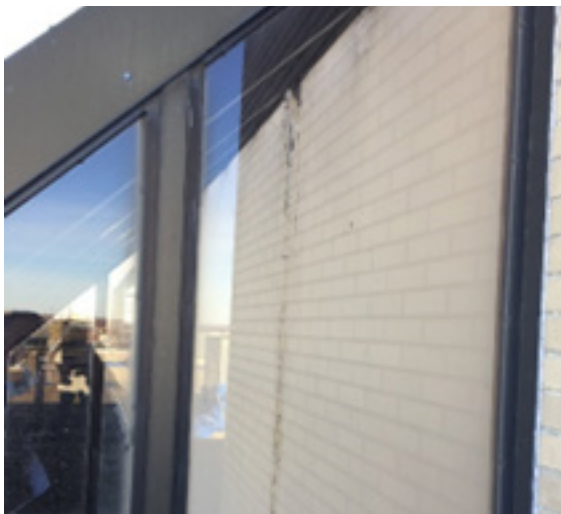
Exterior wall light leaking at inside

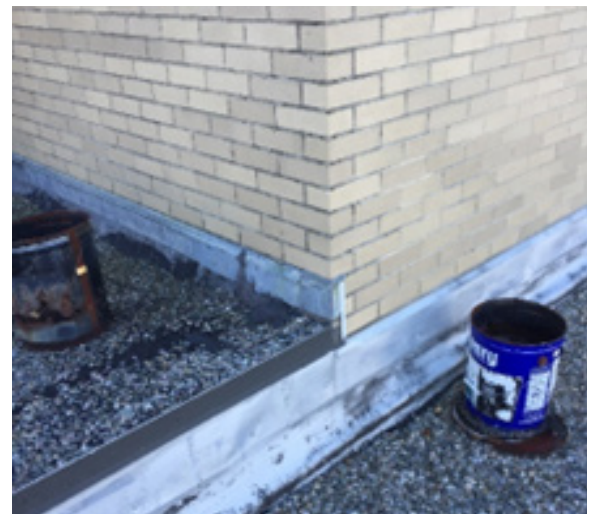
Flashing deteriorating

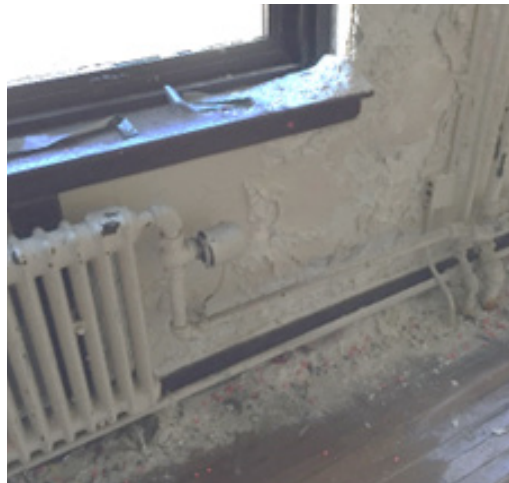
Water migration and damage to interior surfaces

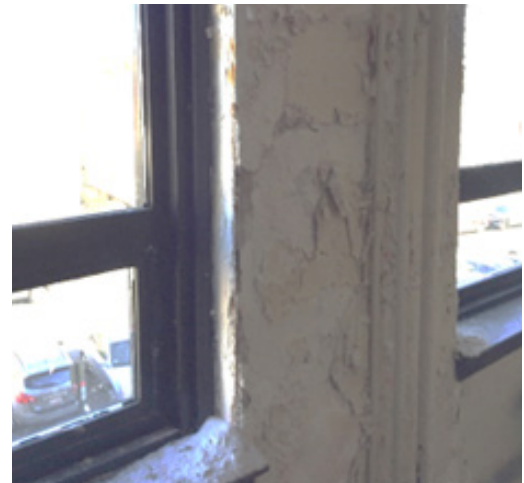
Water infiltration, wall deterioration

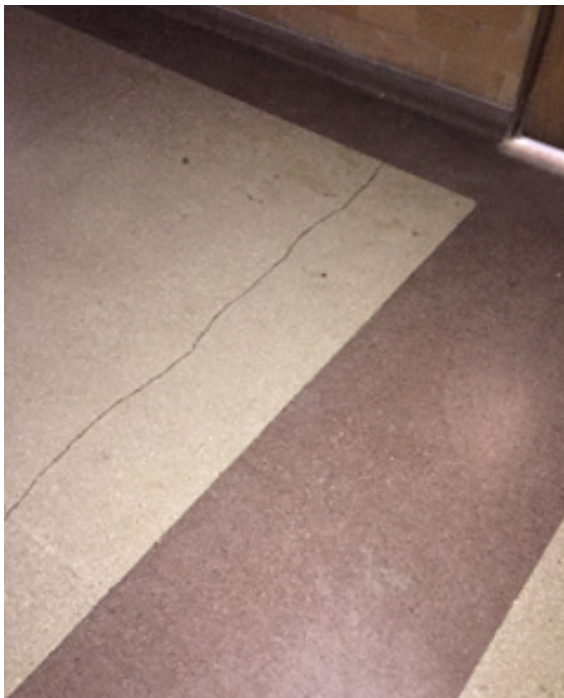
Existing terrazzo floors and cracking

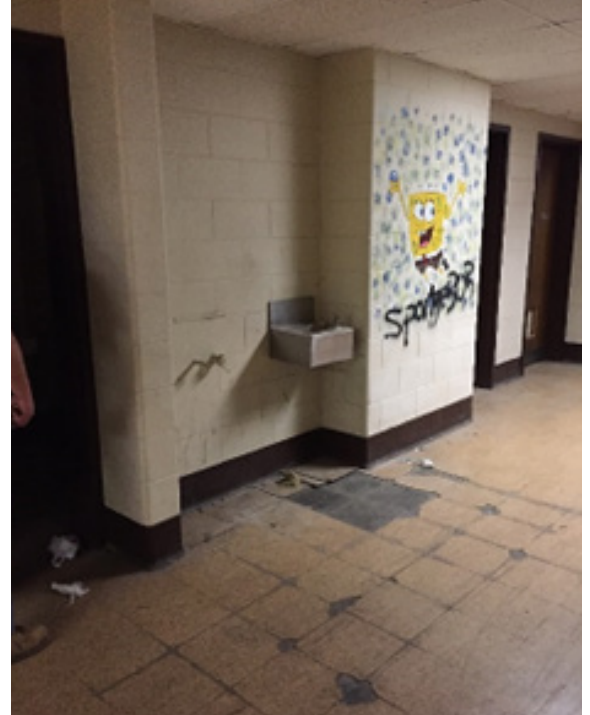
Deteriorated VAT in corridors

As part of any proposed addition/renovation, all existing floor finishes must be removed and replaced in their entirety.

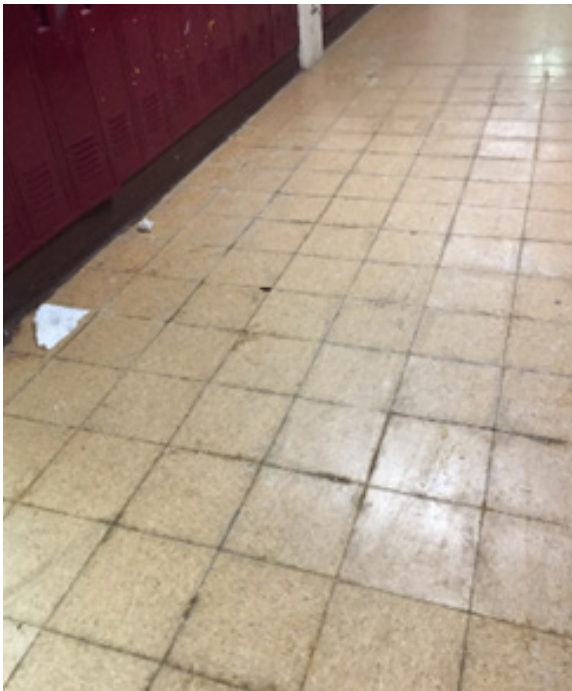
Existing floor finishes throughout the existing building are in poor condition, exhibiting varying degrees of deterioration beyond what could be considered normal wear and tear and are at the end of their useful life. See Hazardous Materials study for areas containing asbestos.

VAT & VCT worn throughout school

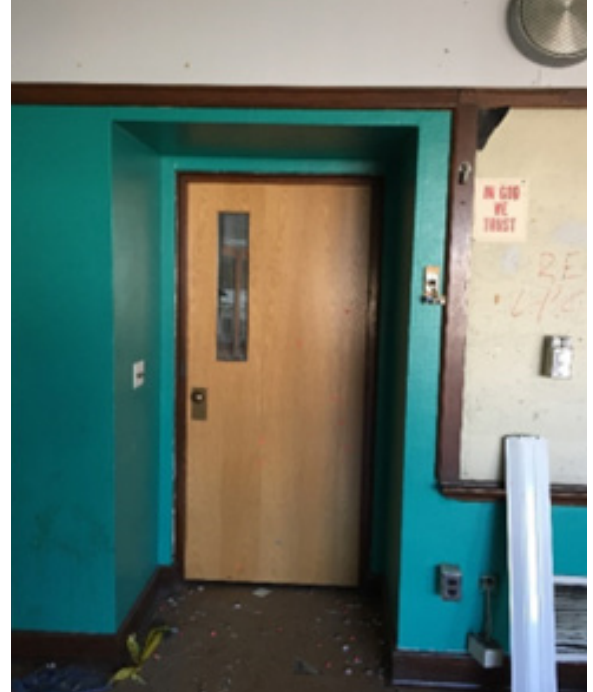
Original wood door systems in corridors and into classrooms with some hardware upgrades required

As part of any proposed addition/renovation, all existing interior doors and hardware must be replaced, as required to comply with current ADA, MAAB, and Building code requirements.

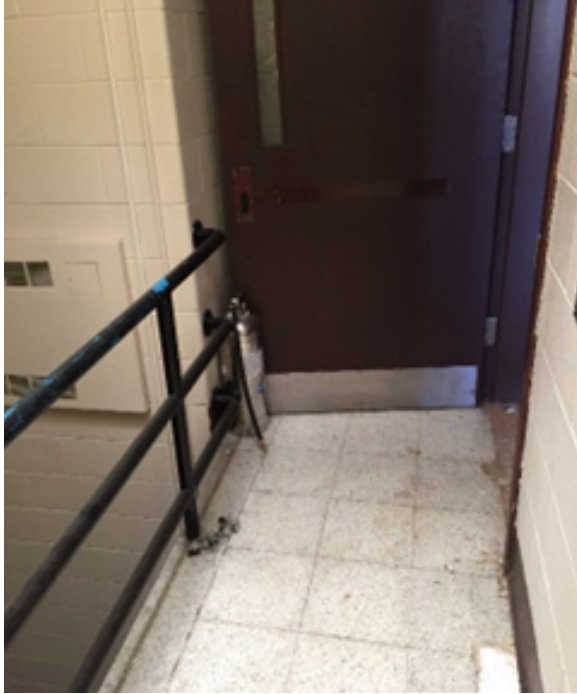
The majority of interior doors throughout the building are in fair to poor condition, exhibiting varying degrees of functional and operational deficiencies, including damaged, missing, or obsolete hardware. In addition, the non-rated nature of existing doors opening into corridors fail to comply with current building and life safety code requirements. All interior doors and hardware are at the end of their useful life and would require replacement in their entirety. An abundance of interior door configurations would have to be reconfigured for accessibility.

Stairwell door hardware missing

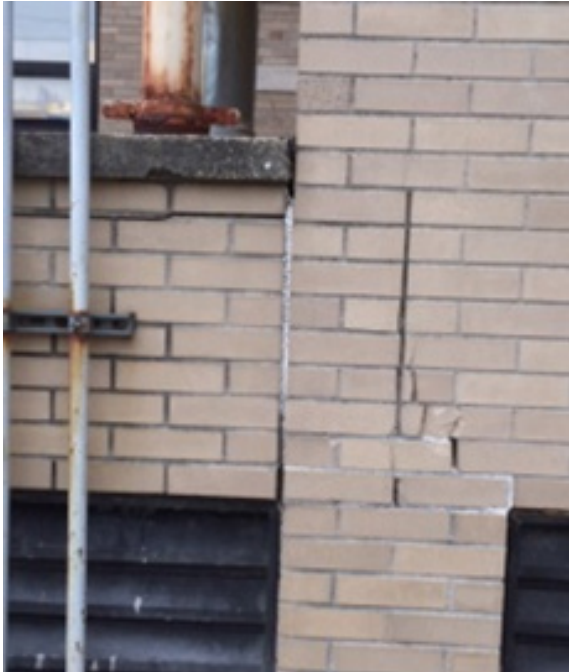
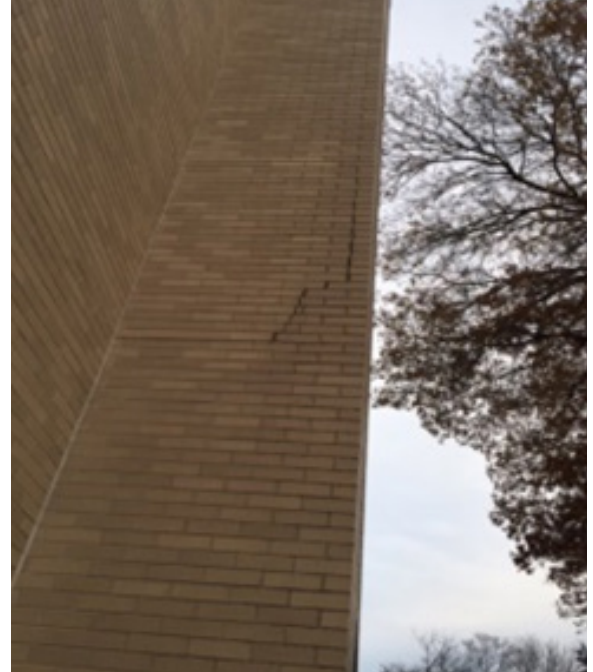
The existing Everett High School building is in relatively decent structural condition. There are several moderate-sized stress cracks in the building's concrete foundation walls and in the exterior masonry walls, particularly in the original 1922 structure (see photos).

Some of the existing steel lintels were observed to be moderately rusted over window openings and the mortar joints at the ends of the loose steel lintels have spalled and show signs of gaps.

- Structural deficiencies such as cracked masonry, corroded / rusted loose steel lintels, and brick repointing will need to be structurally repaired in order to comply with the MSBC. Several of the existing steel lintels will require removal and replacement with new galvanized steel lintels. Where the brick veneer was observed to be cracked, re-bricking and / or repointing of the brick will be required. There are several moderate stress cracks in the building's concrete foundation walls and in the exterior masonry walls, particularly in the original 1922 structure (see attached photos). Some of the existing steel lintels were observed to be moderately rusted over window openings and the mortar joints at the ends of the loose steel lintels have spalled and show signs of gaps. The exterior site walls at the side entrance are severely deteriorated and will require removal and replacement. The joints between each stone cornice and bands appear to be open, which allows water to infiltrate into the exterior wall system. During the winter months, the water will freeze and may cause jacking stresses resulting in cracking and spalling of the exterior wall system. Furthermore, in the 1975 structure, the caulking material in the expansion joints in the exterior brick system is severely deteriorated. The above-mentioned structural deficiencies will require structural repairs.

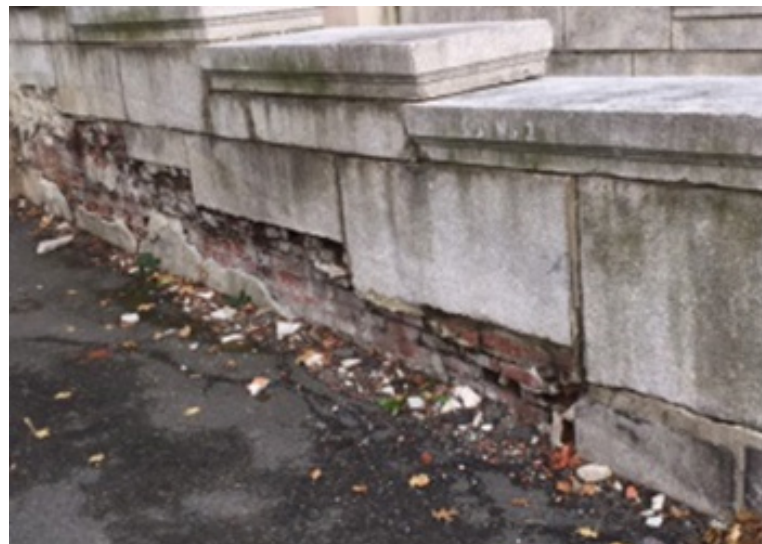
The exterior site walls at the side entrance are severely deteriorated and will require removal and replacement.

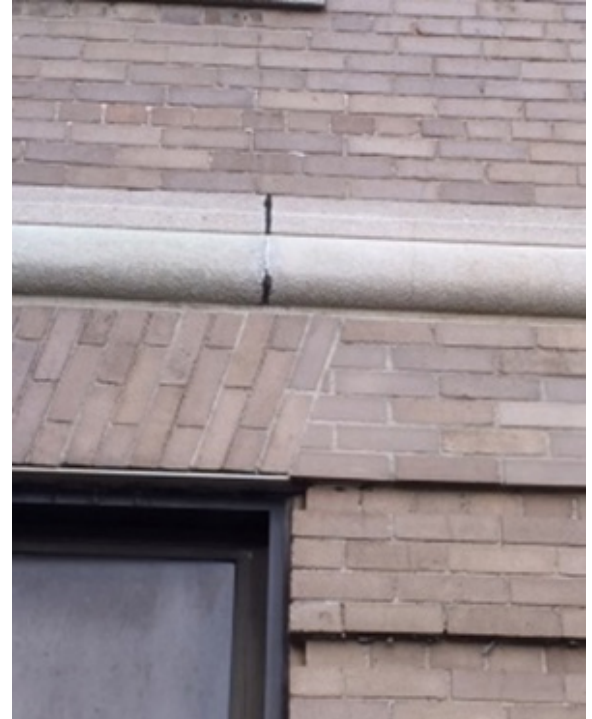
The joints between each stone cornice and bands appear to be open, which allows water to infiltrate into the exterior wall system. During the winter months, the water will freeze and may cause jacking stresses resulting in cracking and spalling of the exterior wall system (see photo).

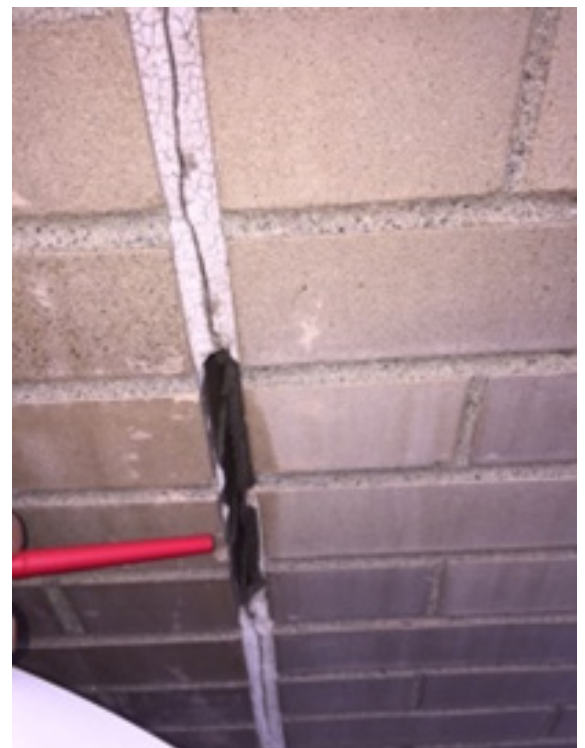
In the 1975 structure, the caulking material in the expansion joints in the exterior brick system is severely deteriorated (see photo below).

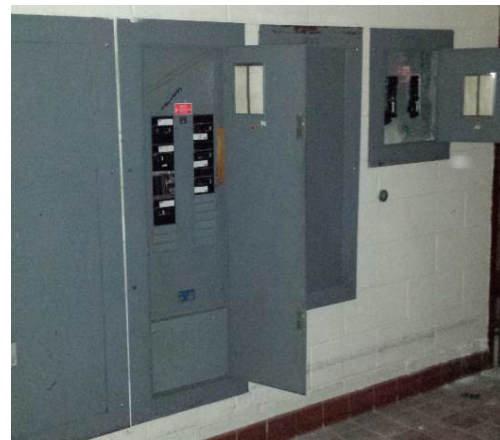
All of the electrical distribution equipment is in poor to fair condition at best and is beyond its useful life period of 25 to 30 years.

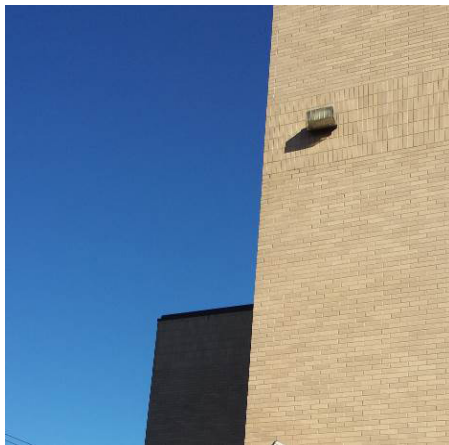
There are a few building-mounted wall pack lights that provide perimeter lighting around the building, these fixtures appear to be in poor condition. The front street entrance to the original building has architectural streetlights on either side of the entrance stairs, these appear to be in fair to good condition.

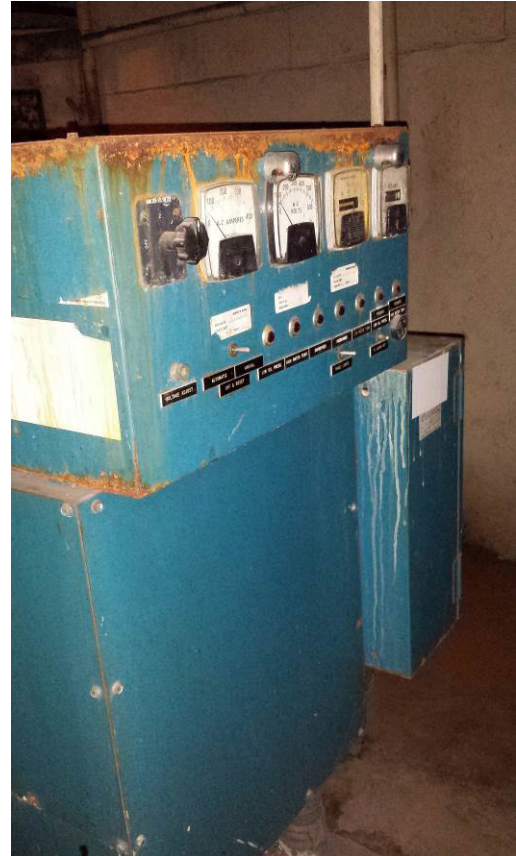
The emergency power system is in poor condition and is beyond its useful life period of 25 to 30 years. The gas generator is not properly vented. The system does not comply with current electrical and life safety code requirements. Separation between Life Safety and Standby power is required.

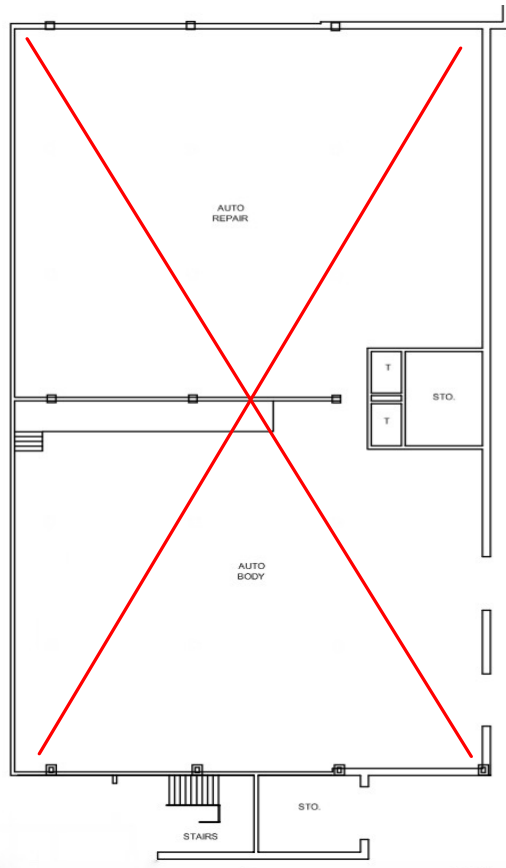
This section of the building is currently being used for shipping and receiving.

Due to the bays being open for extended periods of time for deliveries, these two sections were NOT tested.
