**CITY OF EVERETT
REQUEST FOR BIDS NO. MUN-26-97
ADDENDUM NO. 01**

Date Issued: April 1, 2026

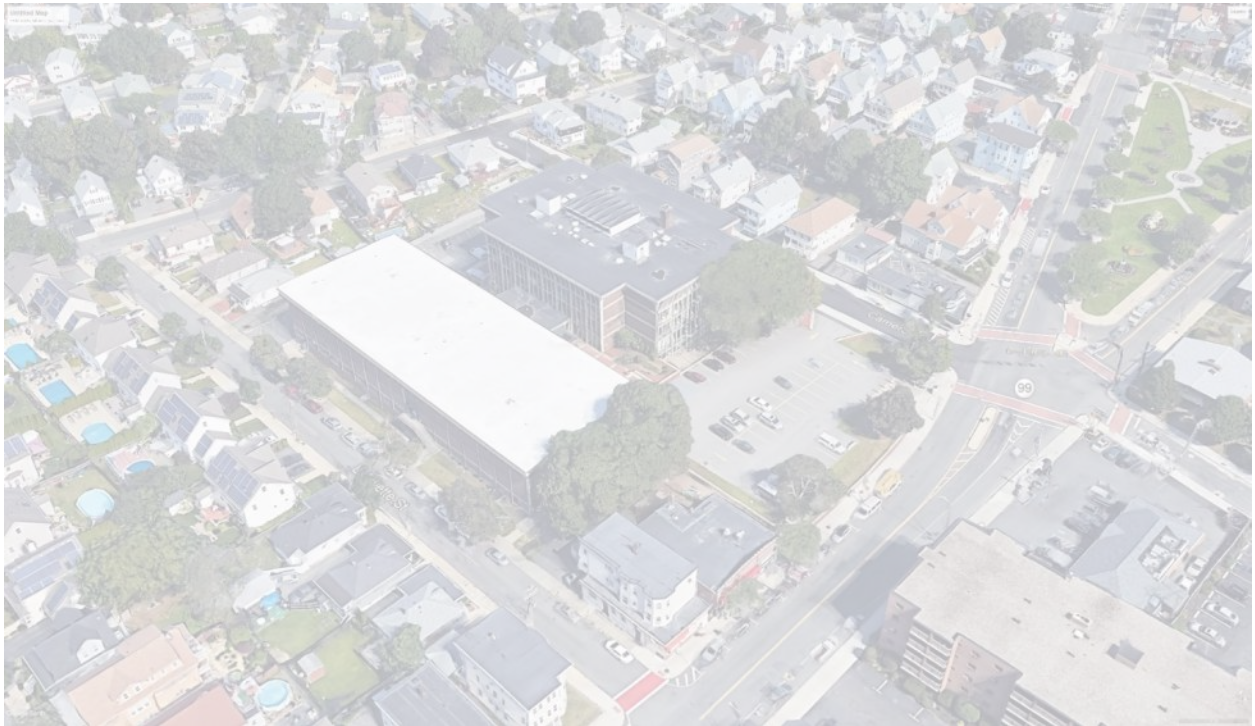
TAB 2 SUMMARY OF BUILDING CODE EGRESS REQUIREMENTS

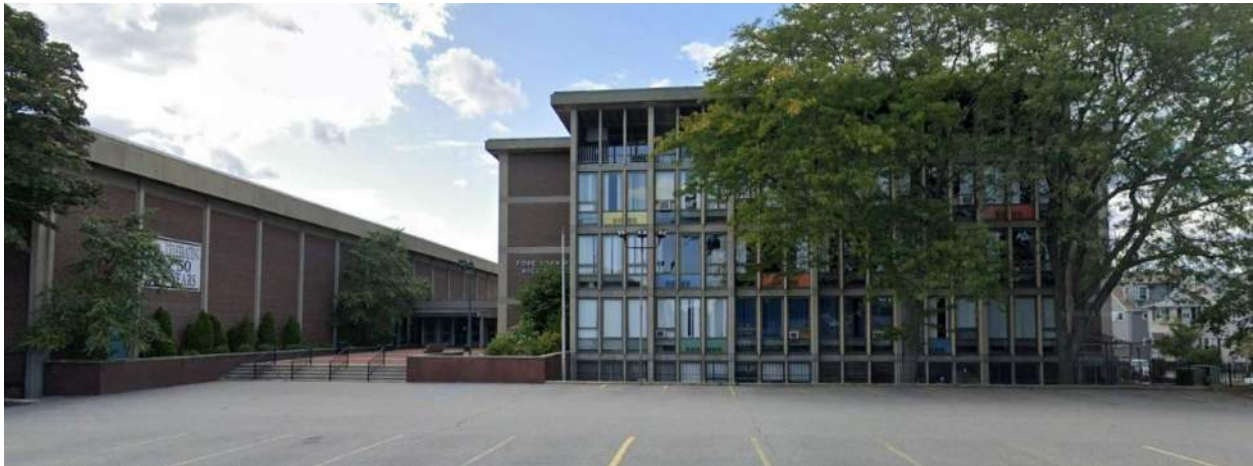
East elevation at main parking lot

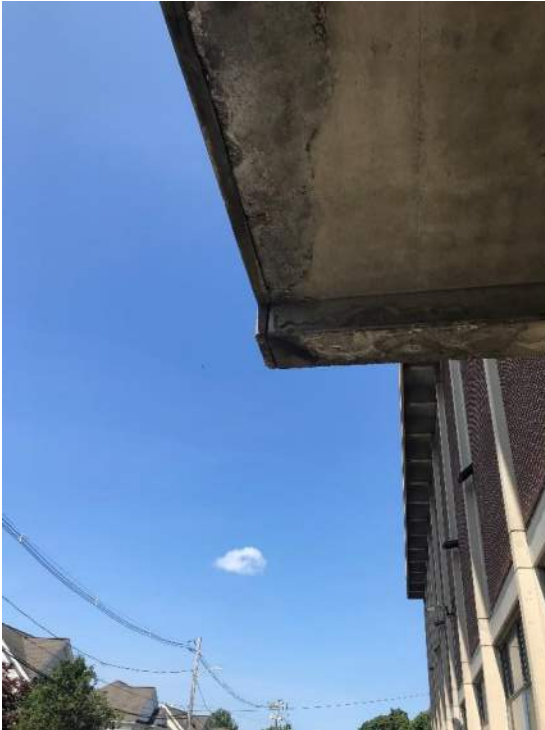
Concrete soffit spalling

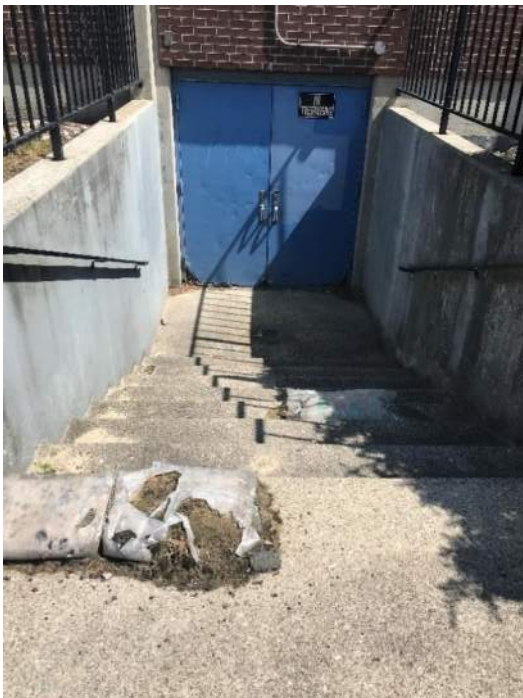
Exterior stairs to stair well

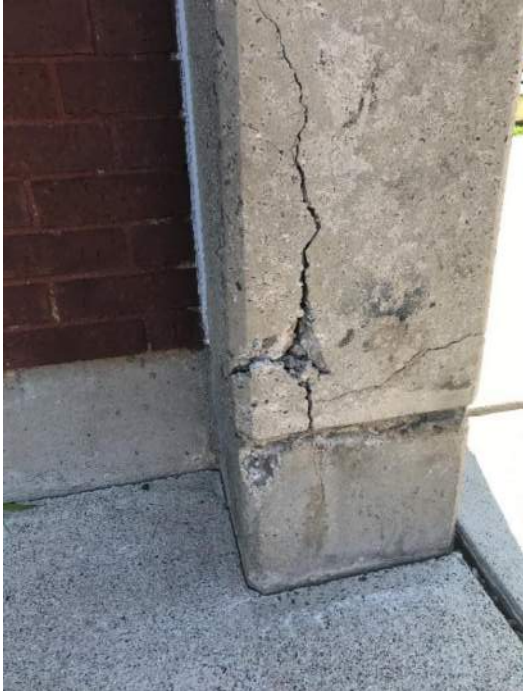
Exterior vertical concrete column cracked at base

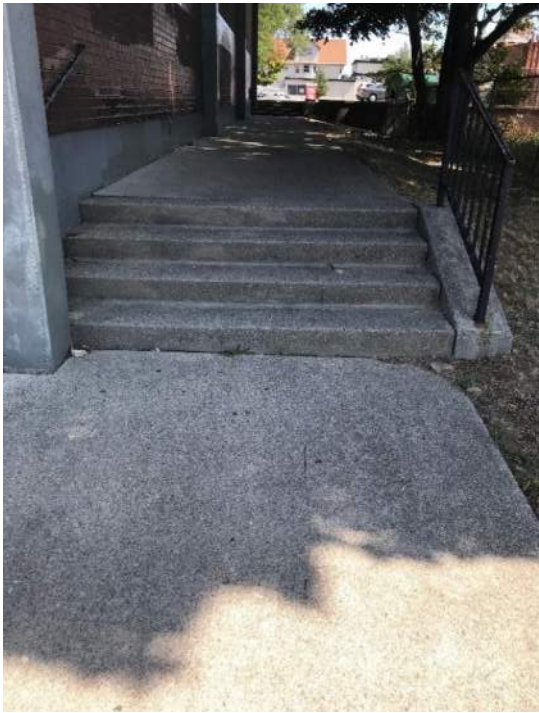
Concrete site stair and rail

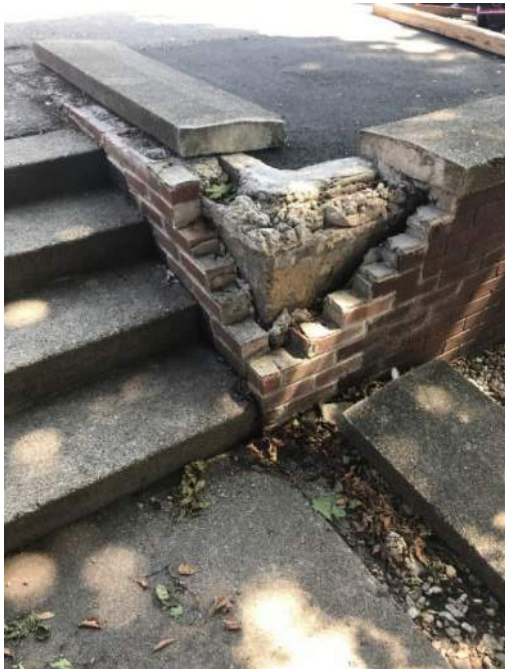
Exterior site stair/wall needs repair

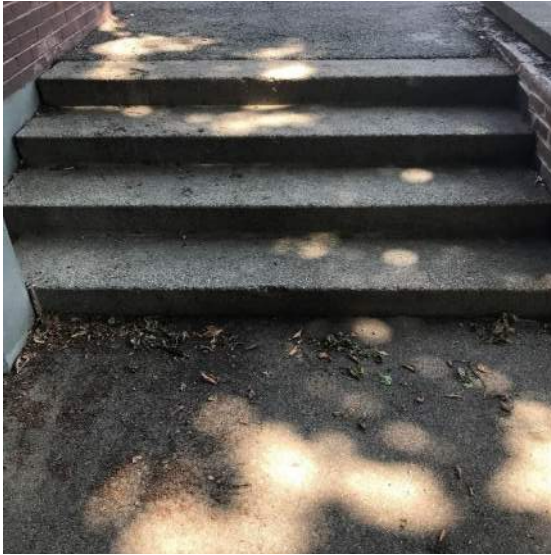
Concrete site stair/Accessibility

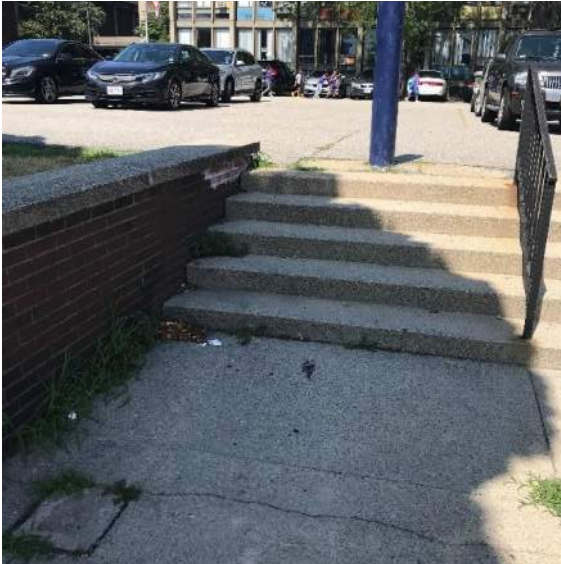
**POPE JOHN XXIII HIGH SCHOOL
888 BROADWAY
EVERETT, MA**

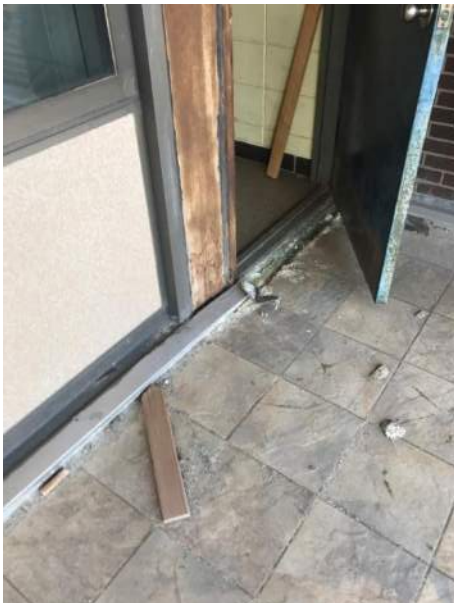
Door sill deteriorating at exterior covered walk

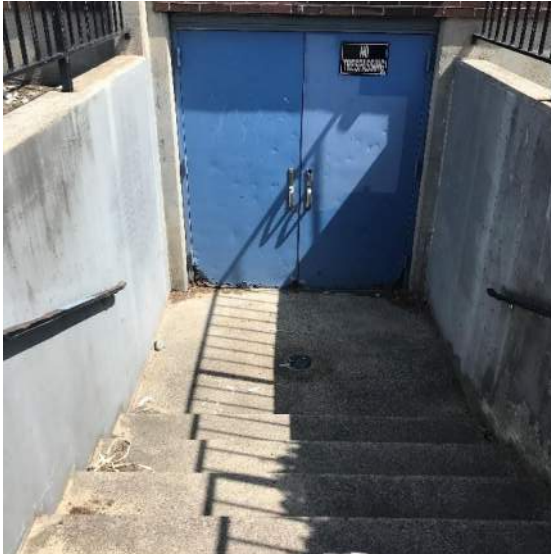
Doors at base of exterior stair rusting and dented

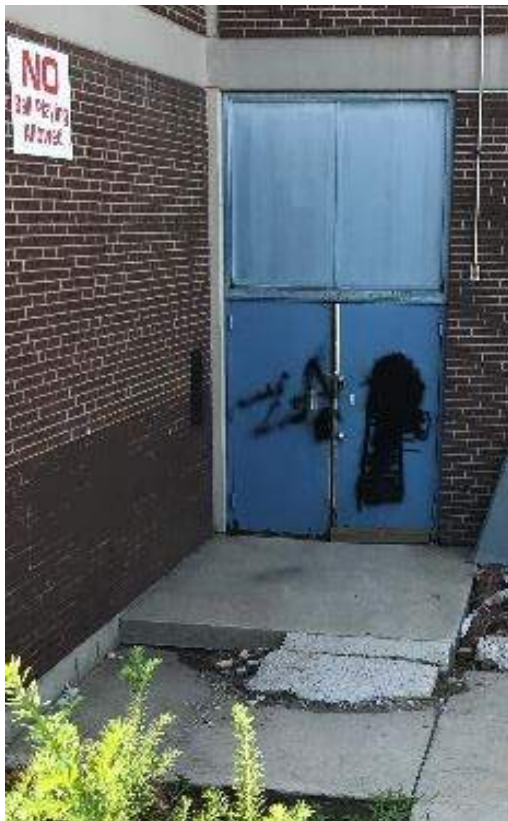
Doors and frame in poor condition/no accessibility

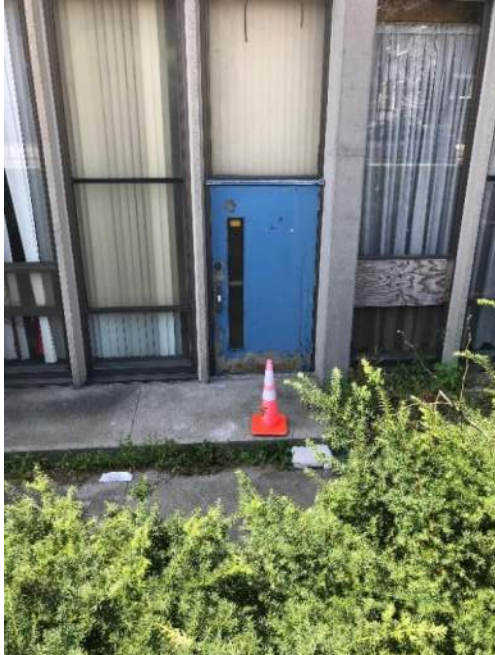
*Metal door and frame in poor condition, concrete pad exit
No accessibility.*

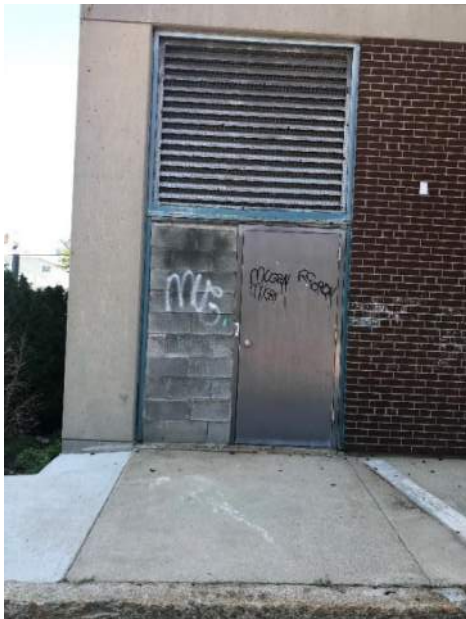
Metal door and frame and louver in poor condition, concrete pad exit

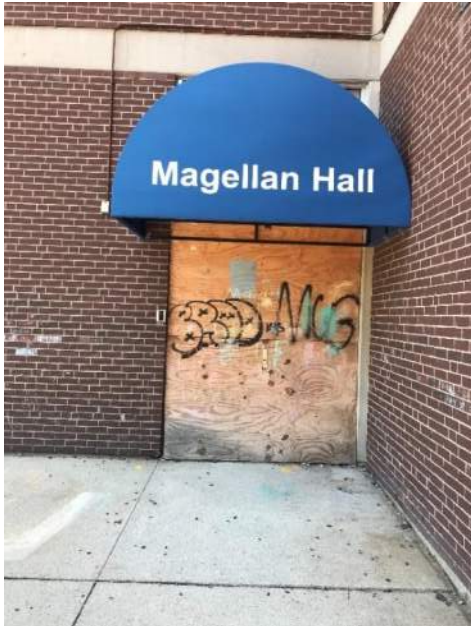
Existing entry boarded

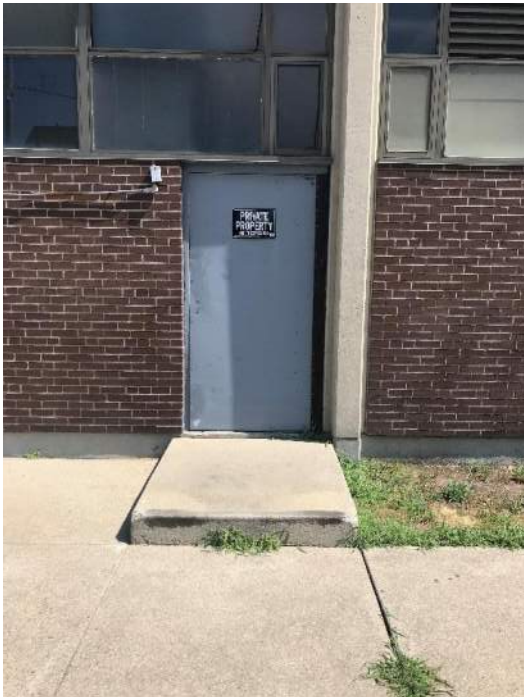
Metal egress door, windows and frames in poor condition

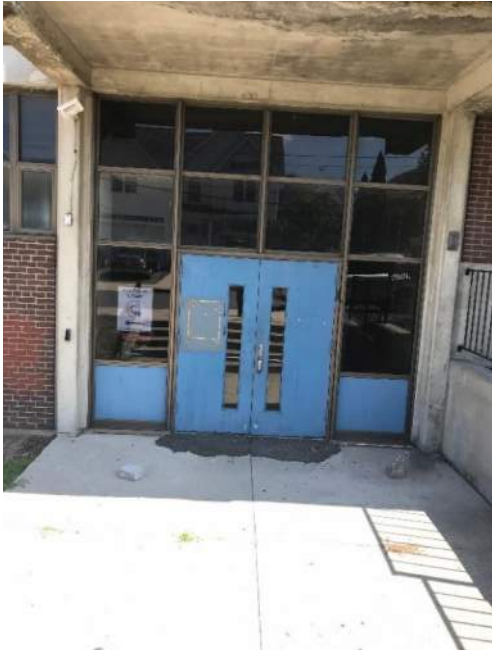
Existing metal doors and frames in poor condition

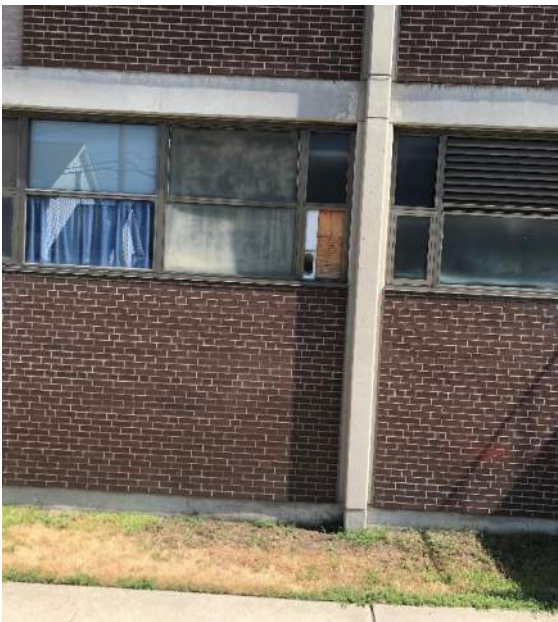
*Existing windows original to building, sealants
To be replaced*

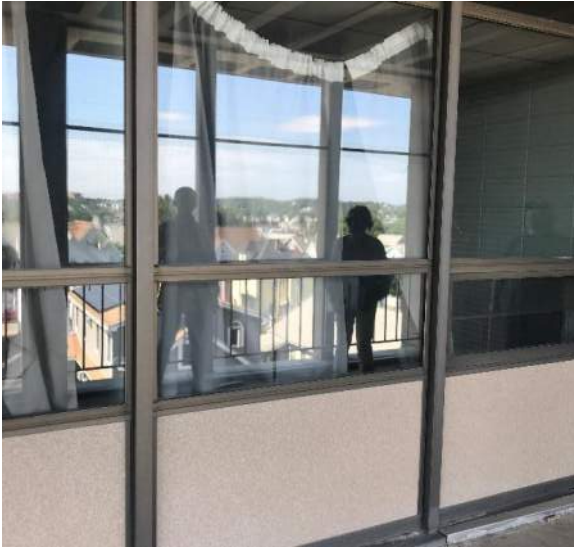
*Typical single pane metal windows and panel base
At covered patio area*

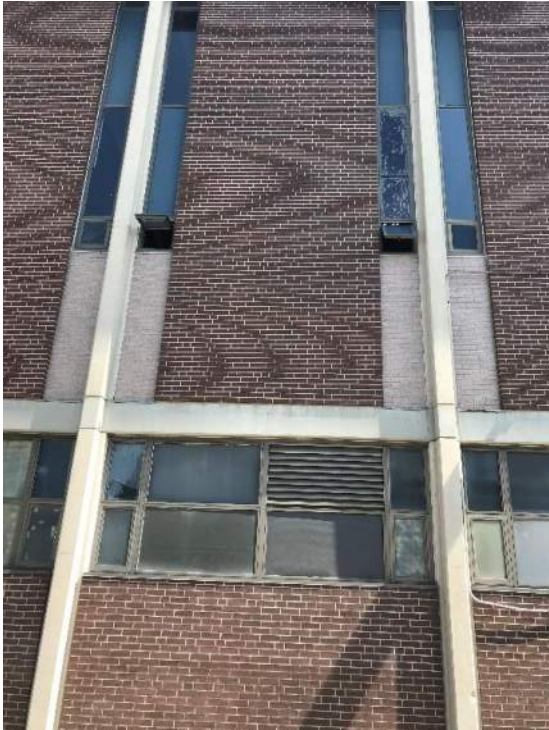
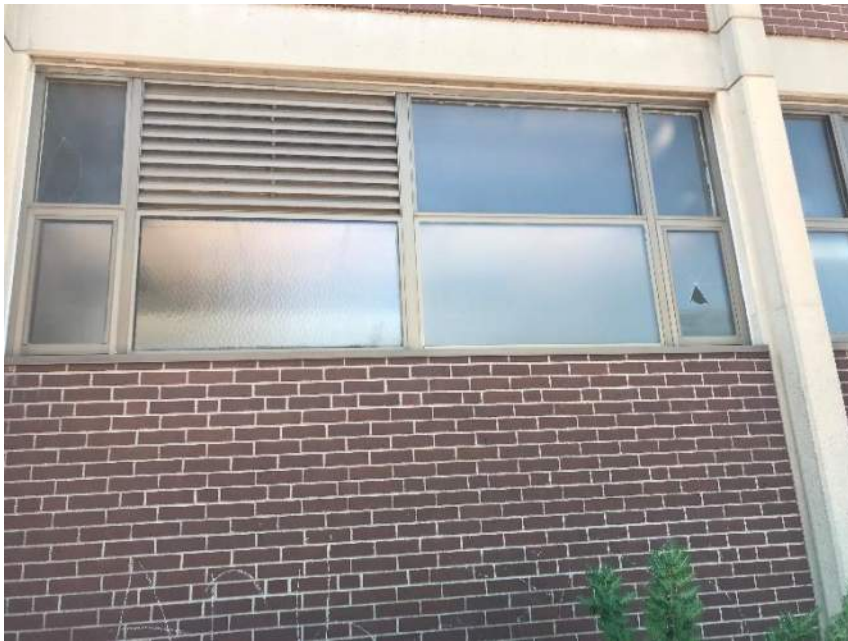
**POPE JOHN XXIII HIGH SCHOOL
888 BROADWAY
EVERETT, MA**

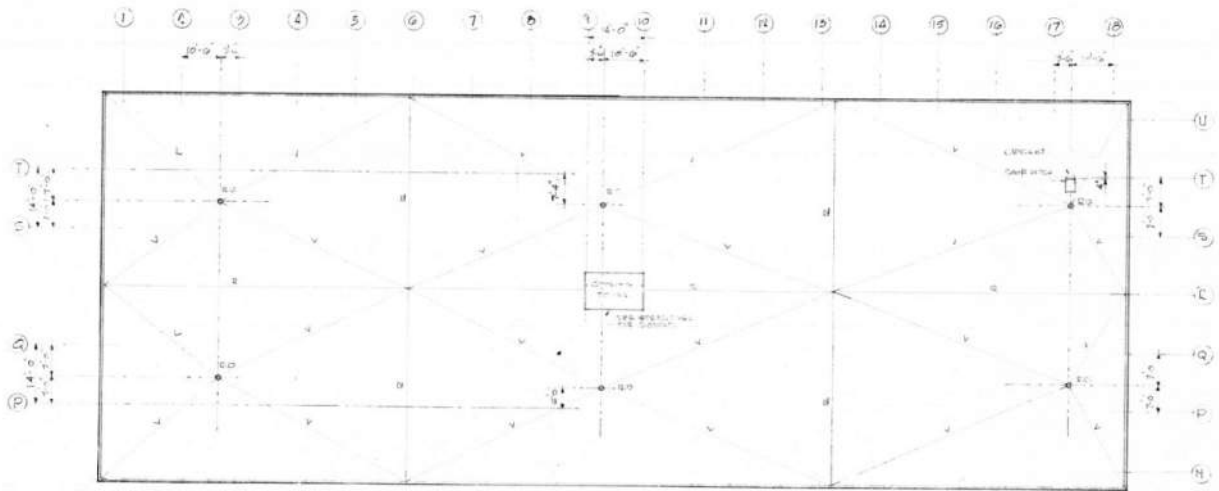
**POPE JOHN XXIII HIGH SCHOOL
888 BROADWAY
EVERETT, MA**

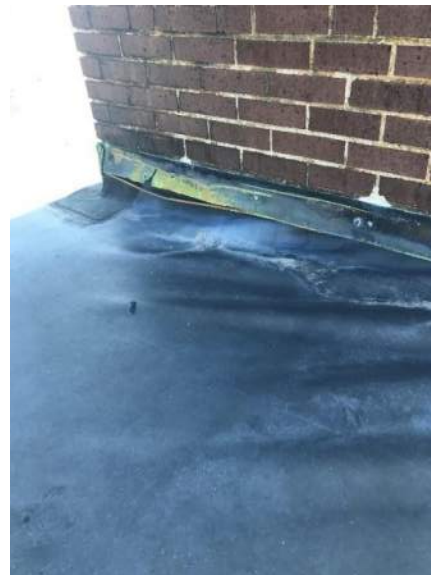
*Roofing buckling at wall termination
and metal broken from wall*

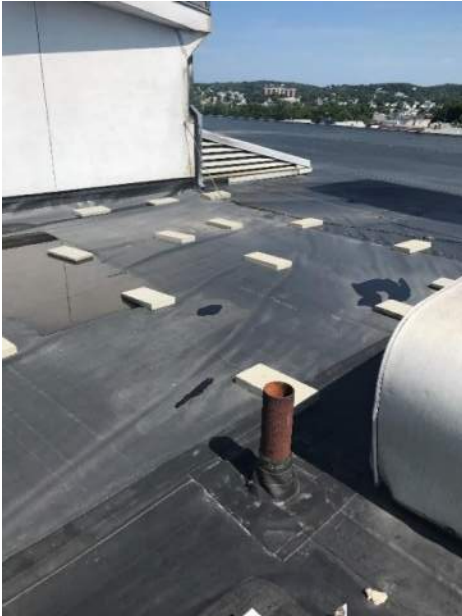
EPDM temporary patch

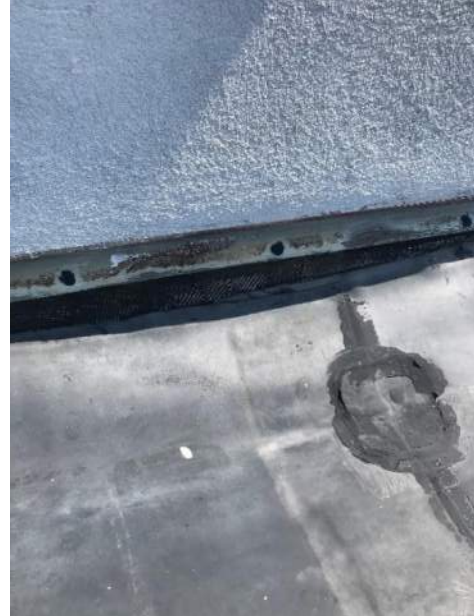
Termination bar/membrane failing

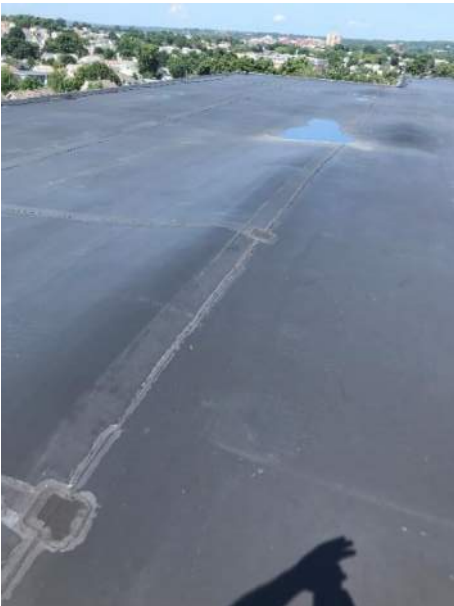
Insulation and membrane ballooning

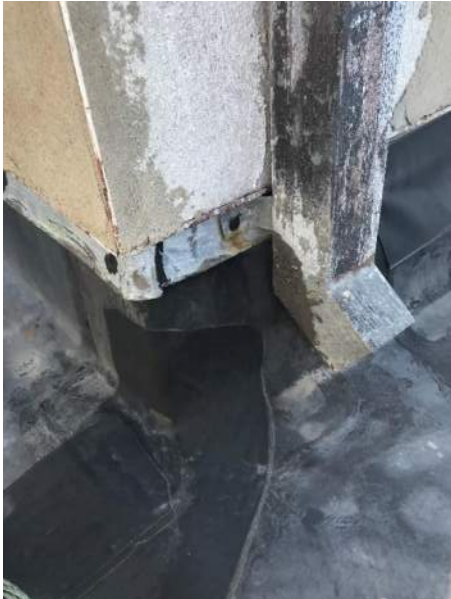
Downspout deteriorating, plaster spalling

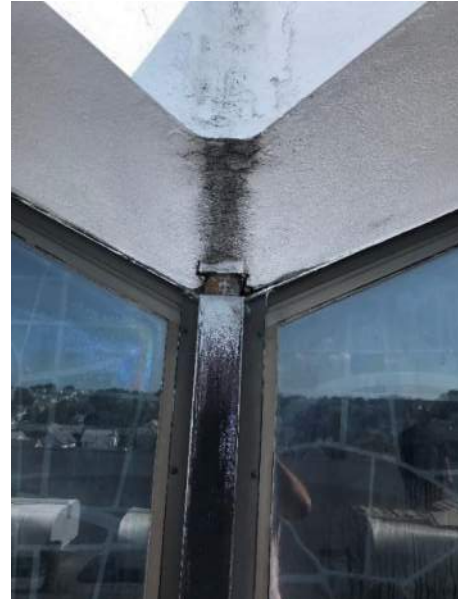
Corner downspout between windows

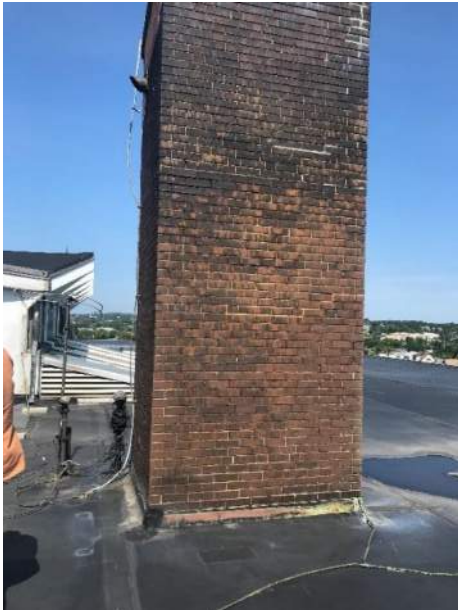
Boiler chimney, requires repointing and Structural repairs

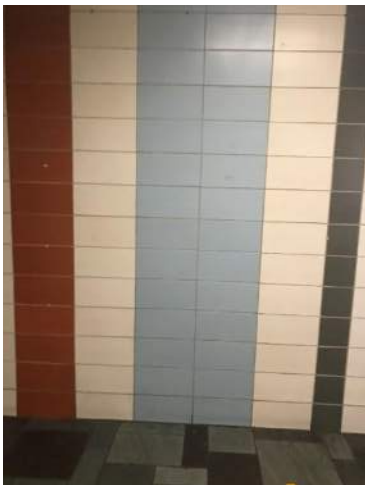
Stack bond structural glazed block

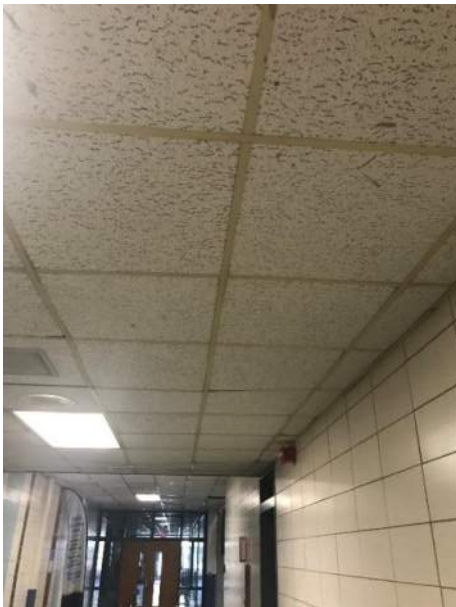
2 x 4 ceiling tile in corridor area

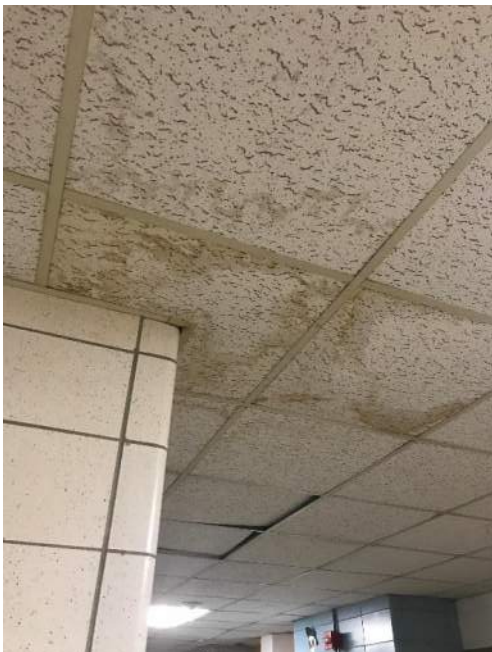
Typical ceiling tiles

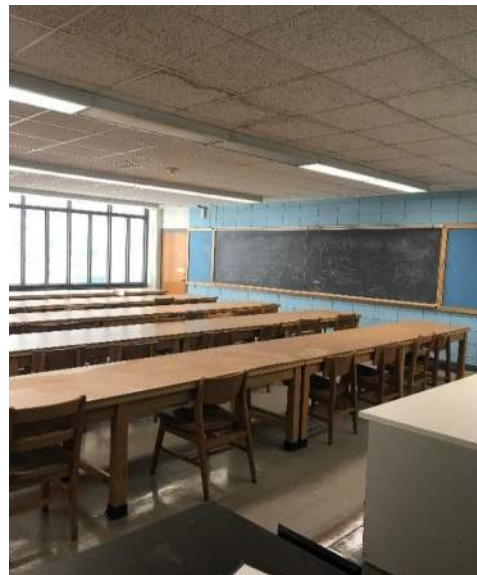
*Typical classroom tiles with surface
mounted fixtures. Water damage*

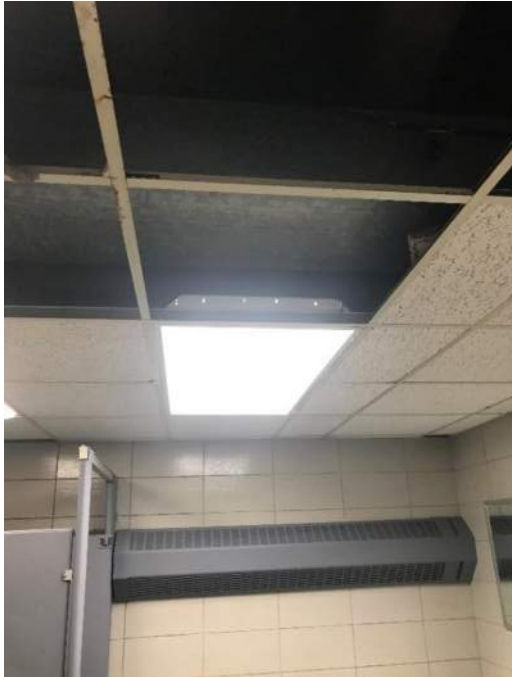
2 x 4 tiles and grid in toilets. Tiles missing

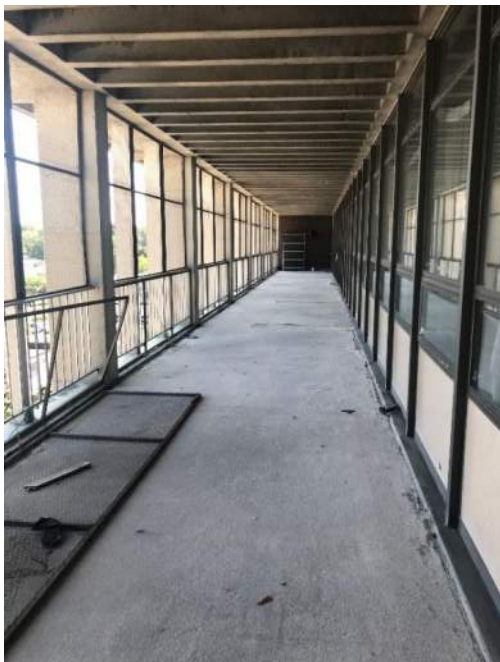
Exposed structure at covered area

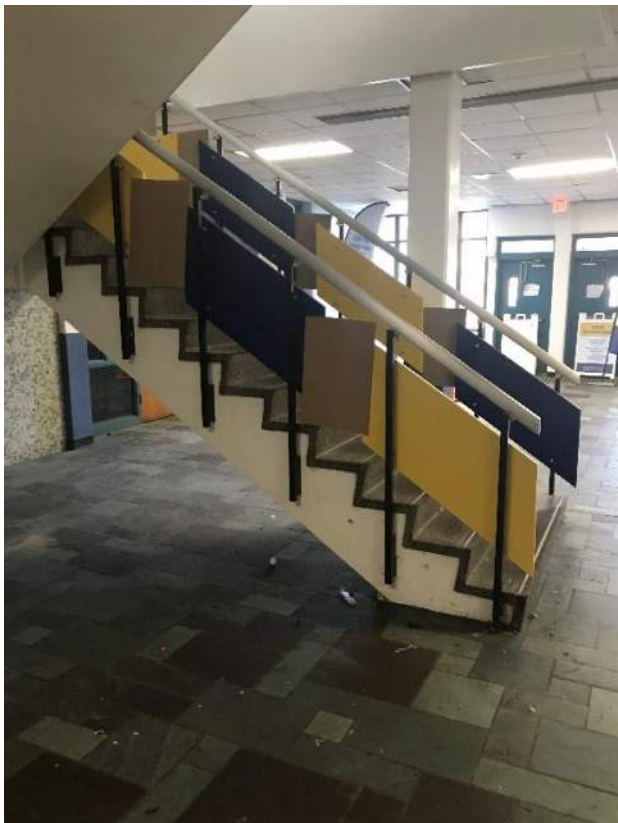
Random pattern bluestone pavers in Lobby

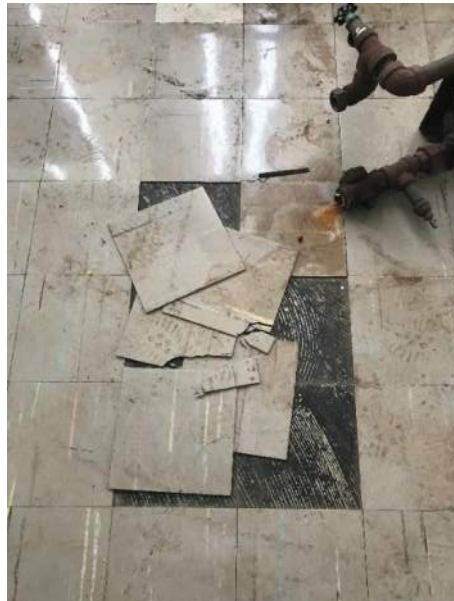
Water damaged VAT flooring

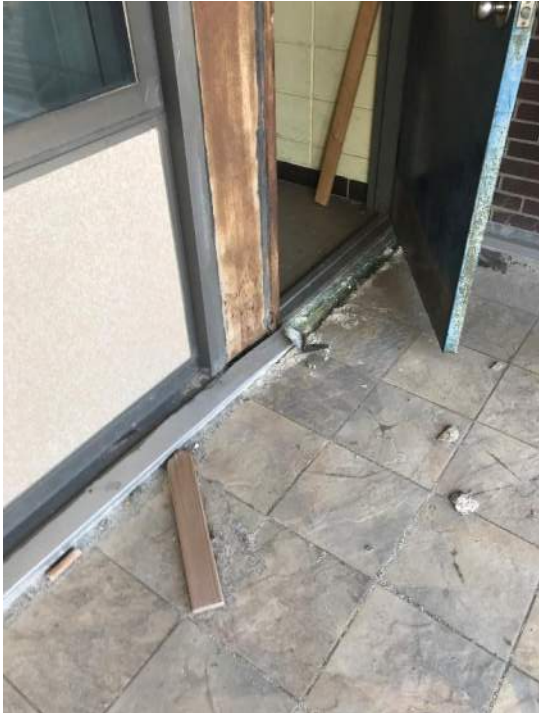
Stone pavers at exterior covered area

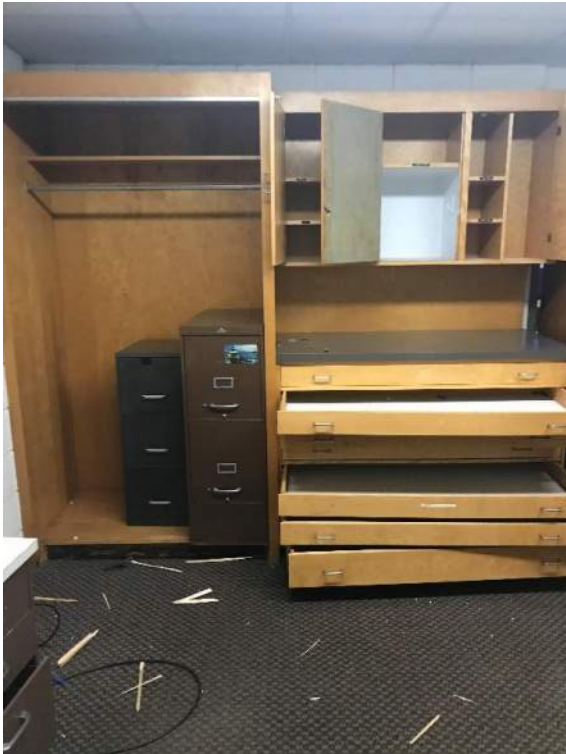
Carpeting in convent areas

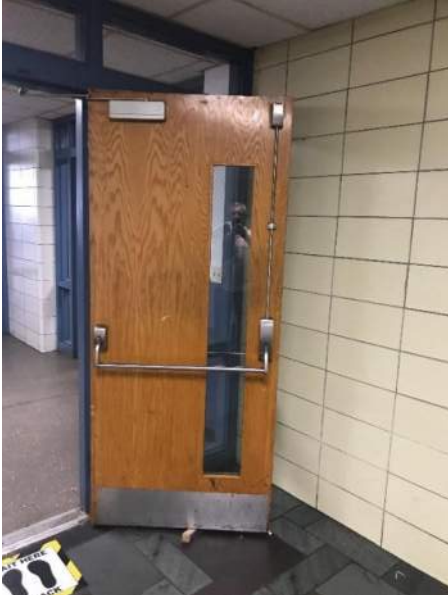
Typical glazed light corridor door

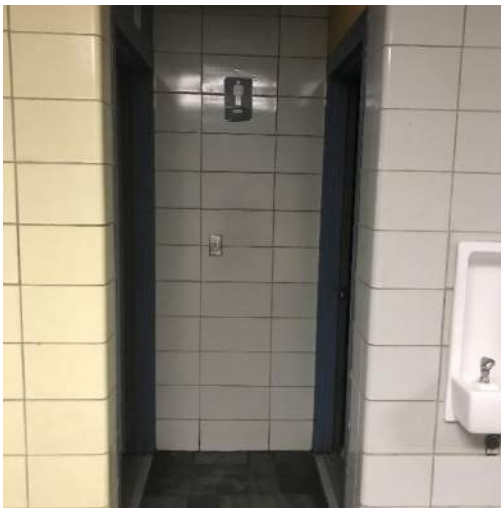
Entry to toilet rooms / Not a handicap accessible entry

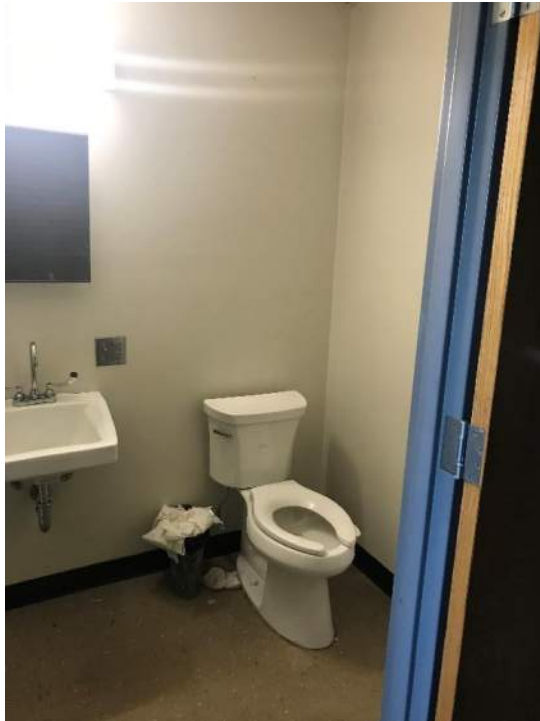
Single user toilet not handicap accessible

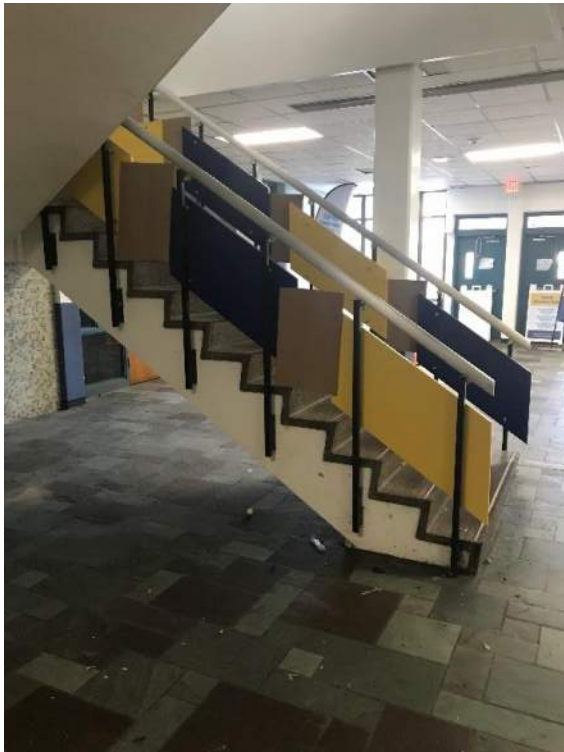
**POPE JOHN XXIII HIGH SCHOOL
888 BROADWAY
EVERETT, MA**

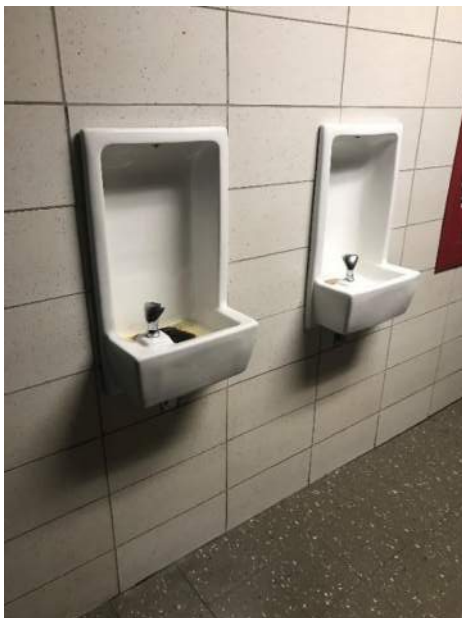
Existing drinking fountains throughout should be replaced with new and handicap accessible units

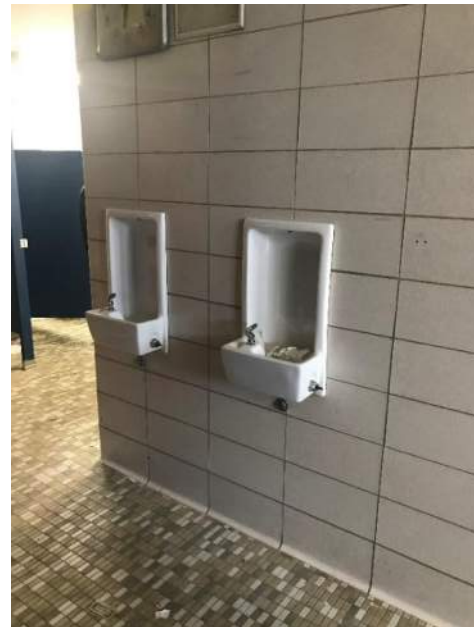
Existing drinking fountains to be replaced

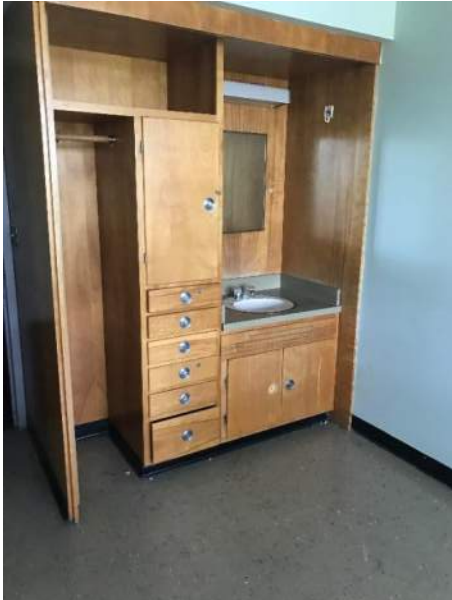
*Dressing unit and sink in the convent area
Sink should comply w/ ADA if it is to remain*

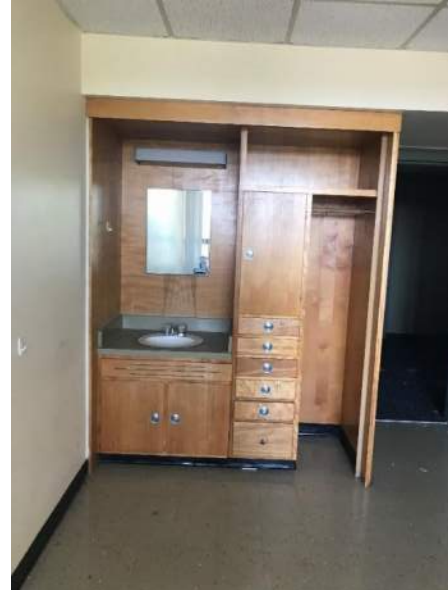
Sink to be ADA if it is to remain

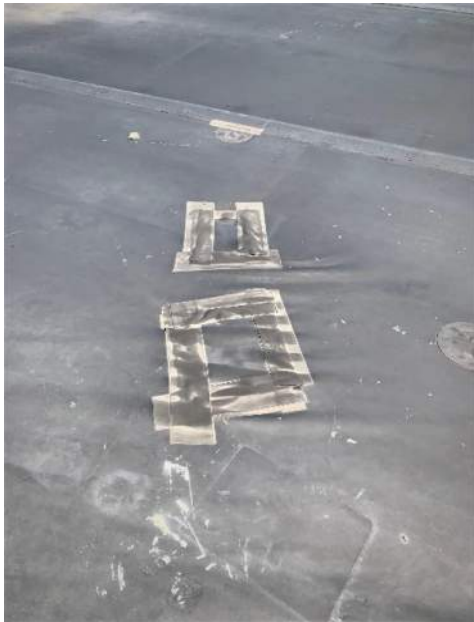
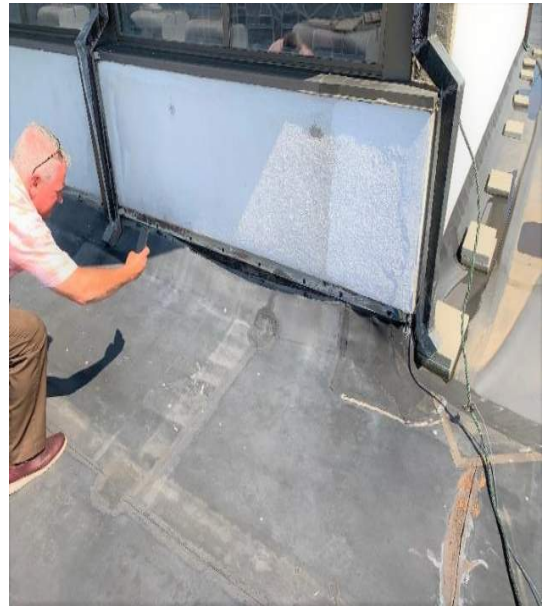
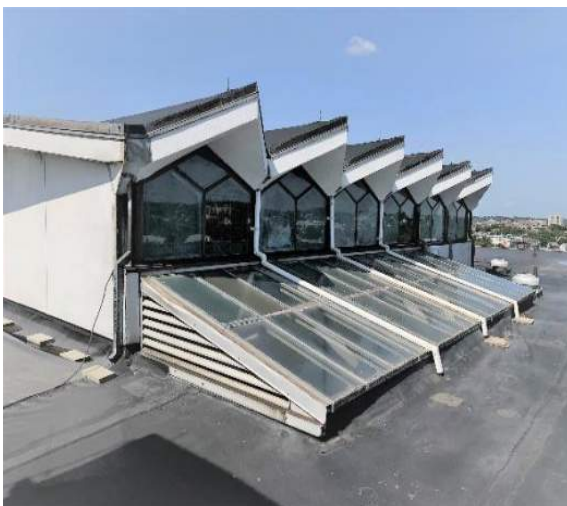
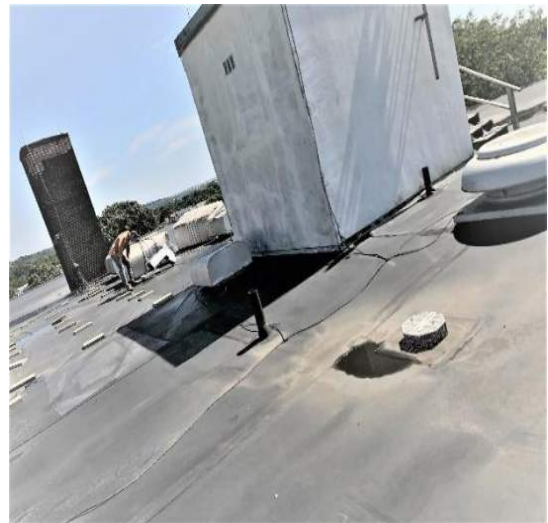
View of previous roof repairs and loose flashing adjacent to base of Chapel wall, skylights, elevator over-run, and at other areas of main roof level.

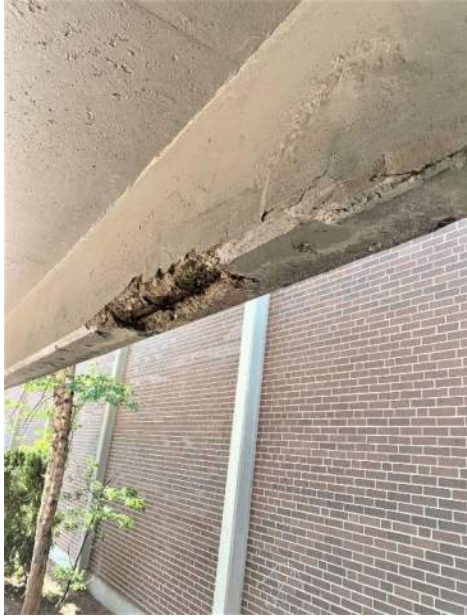
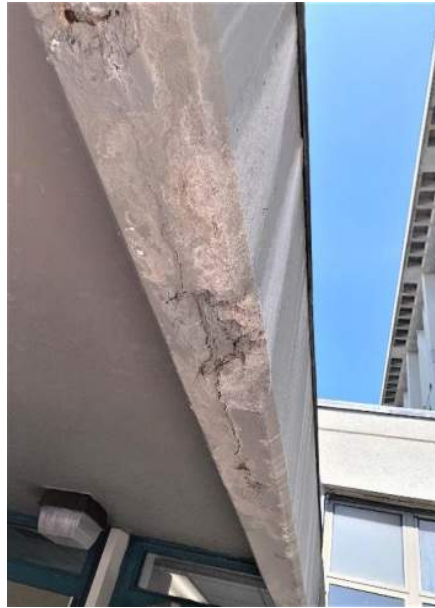
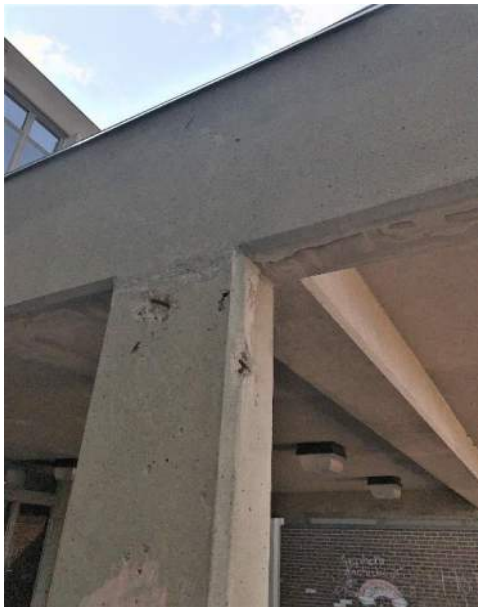
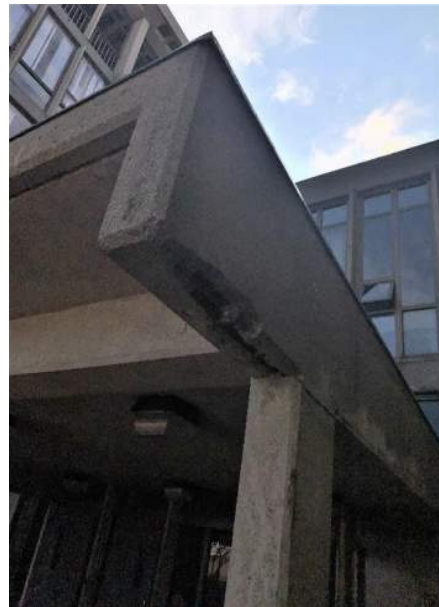
View of significant cracks, spalls, and delaminating sections of concrete elements and exposed rebar at entrance canopies, which will require structural repairs.

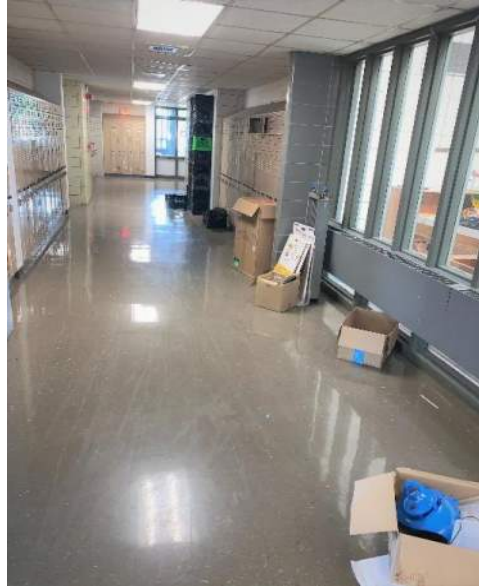
View of area of slab in Part B of building, adjacent to skylight area, where it appeared that floor slab Delaminated concrete and exposed rebar at underside of concrete beam at canopy.

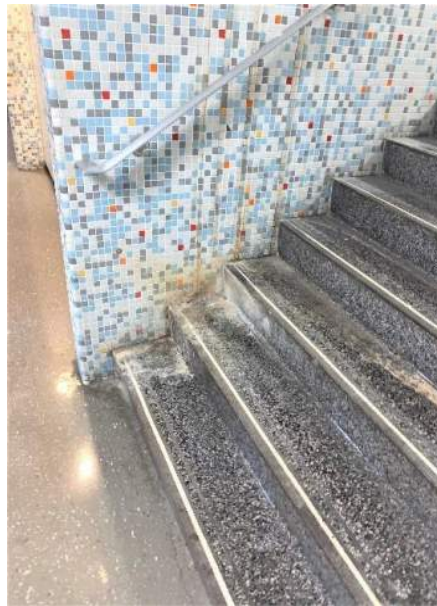
Water damage / mold along interior stair wall.

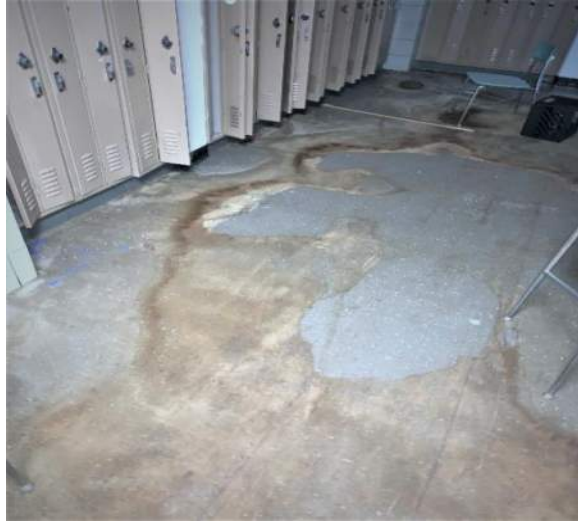
Signs of water staining on first floor slab-on-grade, which is evident of a previous leak.

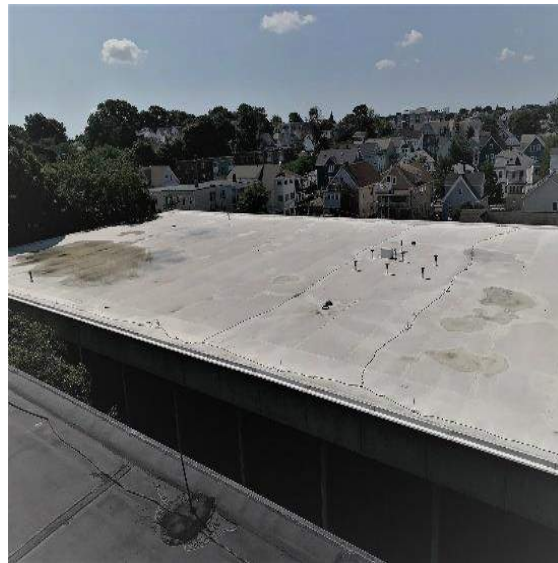
View of roof of Part A where previous steel dunnage platform for cooling towers was removed, but remnants of steel pipe columns remain in place. Roof should be checked for leaks and existing stub columns should be addressed to ensure they are capped at top to prevent water infiltration.

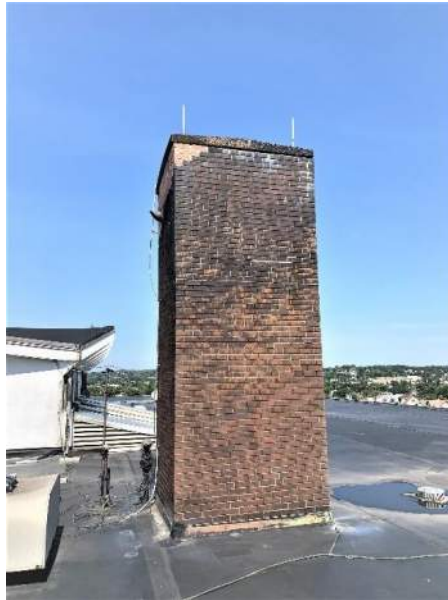
View of brick chimney that will require structural repairs / repointing.

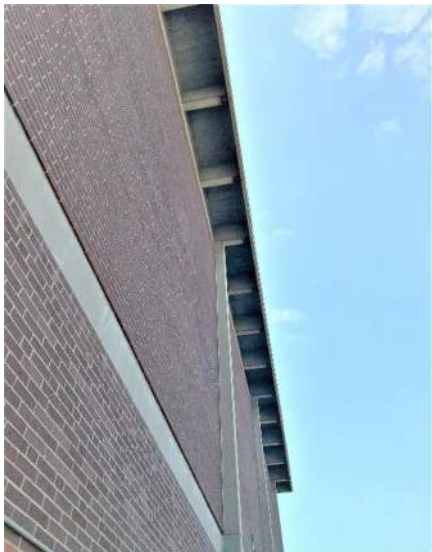
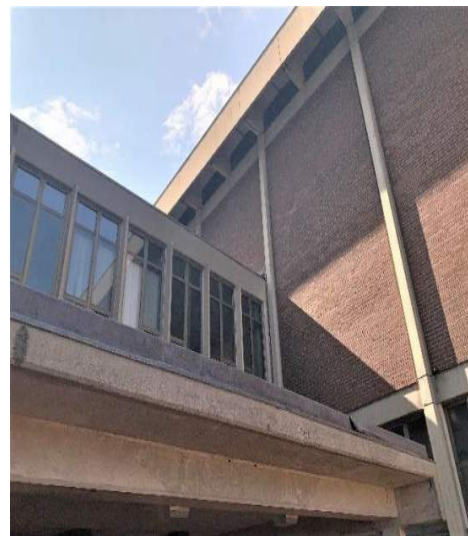
View of precast prestressed single-tees at roof over gymnasium that will require structural repairs at localized areas where spalls / exposed rebar are present.

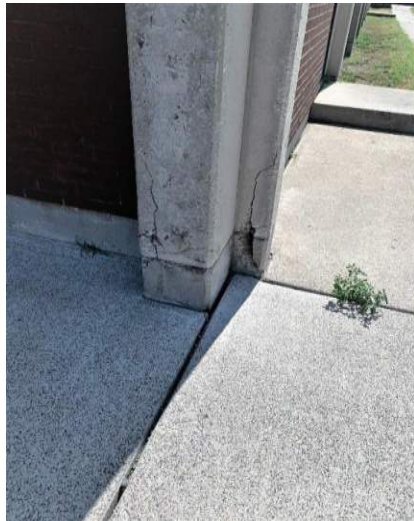
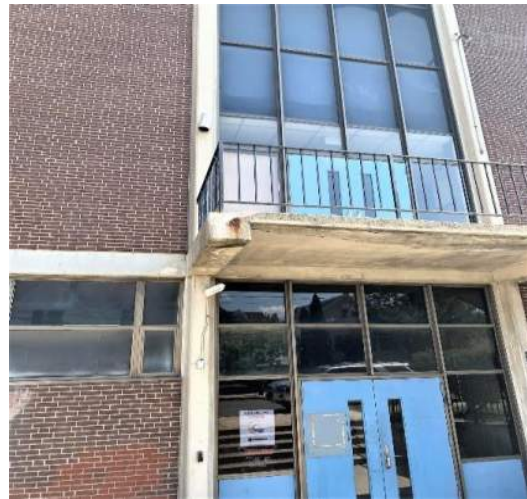
Spalled concrete at base of concrete column and at exposed concrete canopy.

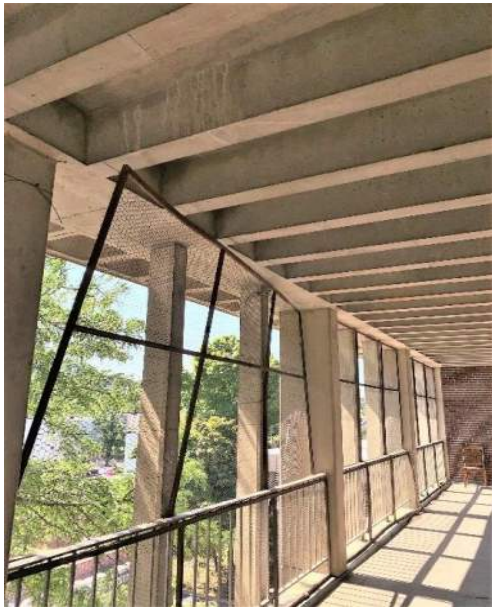
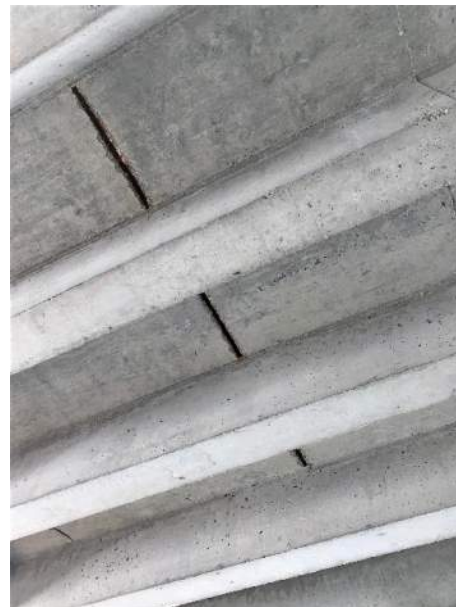
View of exposed concrete elements at underside of outside porch areas. Exposed rebar and spalled concrete were observed in a few areas, which will require structural repairs.
