**CITY OF EVERETT
REQUEST FOR BIDS NO. MUN-26-97
ADDENDUM NO. 01**

Date Issued: April 1, 2026

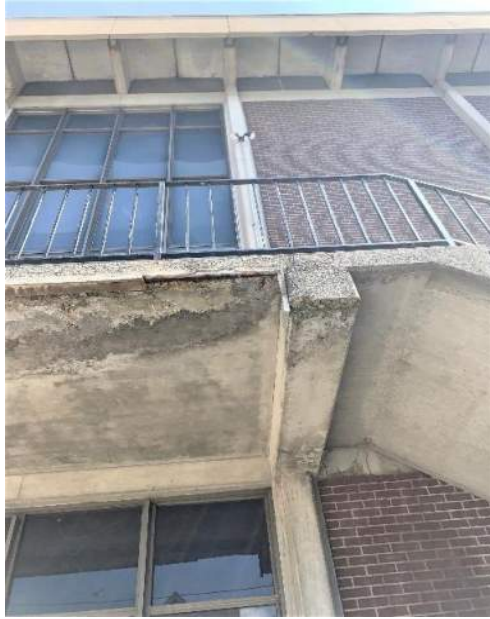
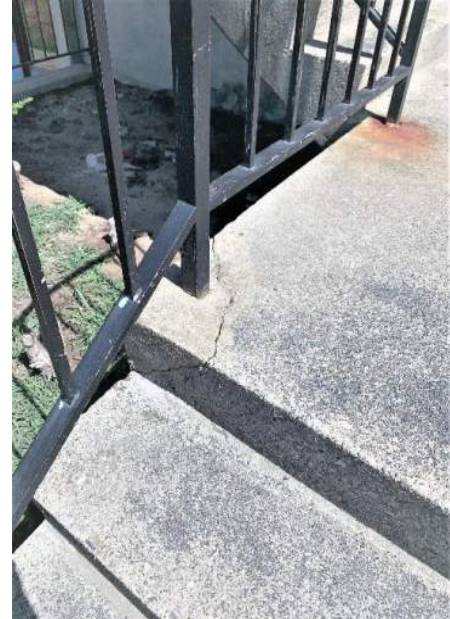
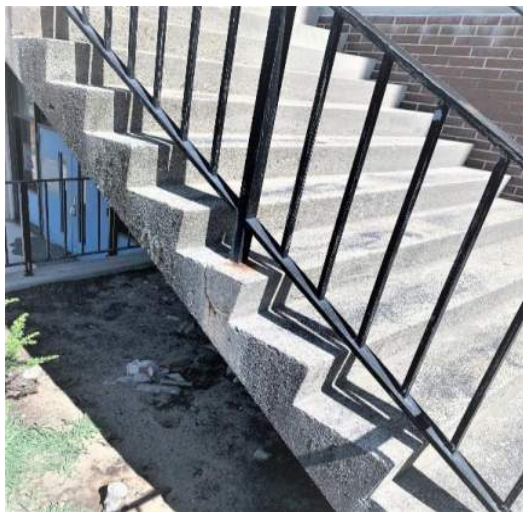
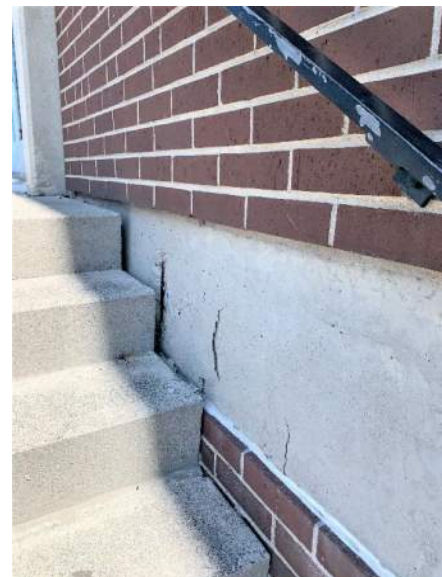
Spalled concrete at exterior concrete stair along south side of Part A. Structural concrete repairs will be required at these deteriorated locations.

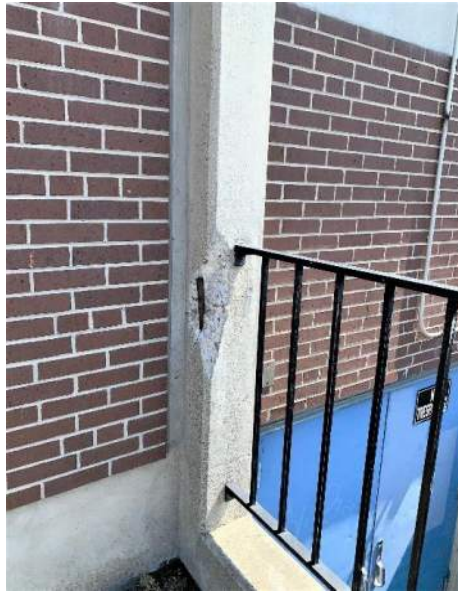
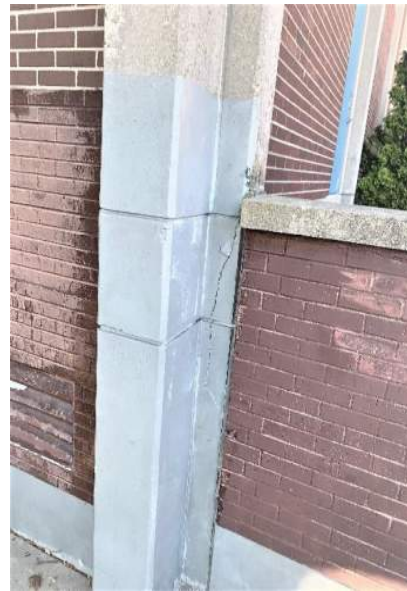
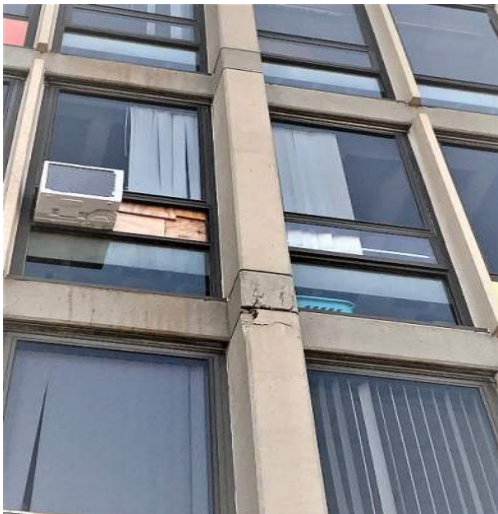
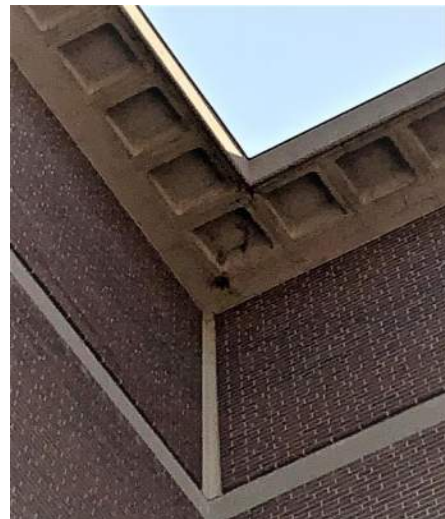
View of exposed rebar and delaminated concrete elements that will require concrete repairs.

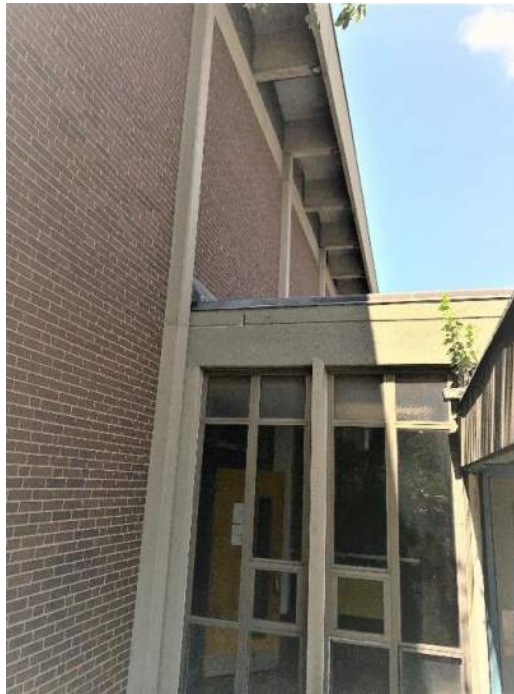
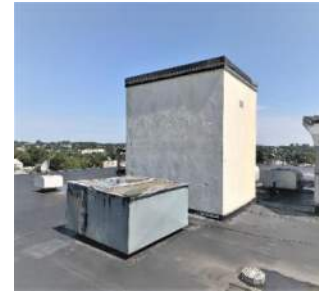
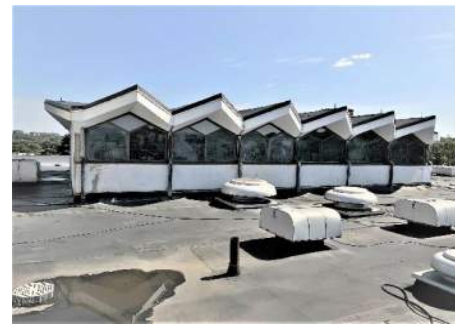
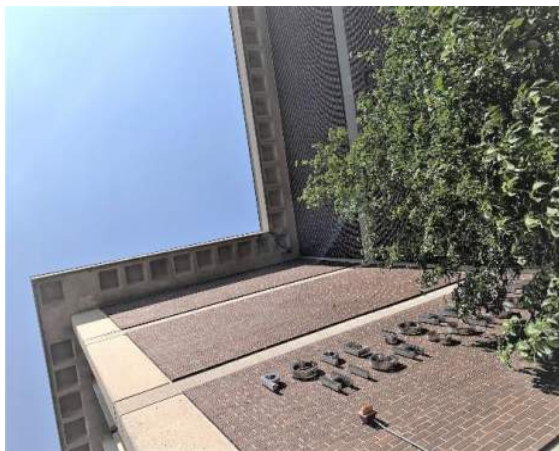
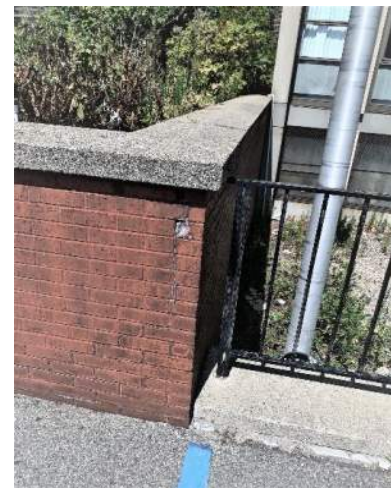
Clockwise from upper left: View of connector between Part A and B, elevator over-run, chapel wall and saw-tooth roof, exterior masonry site retaining wall, and front elevation of school building (with school name) showing brick veneer system.

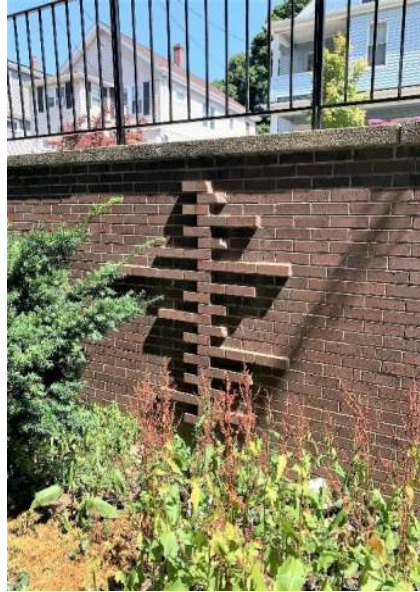
View of exterior masonry site retaining wall at north side of site that shows deteriorated / spalled brick.

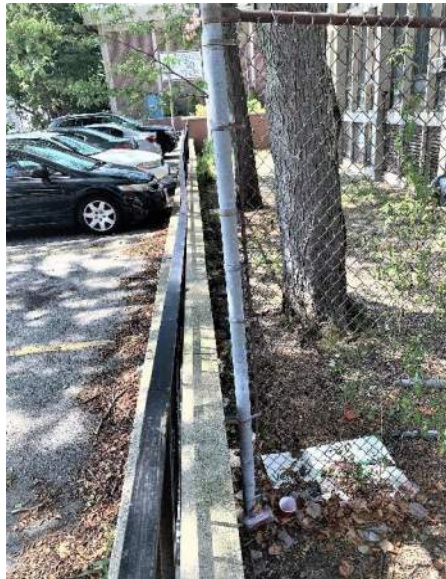
View of site retaining wall that has deteriorated and appears bowed, which will require structural repairs.

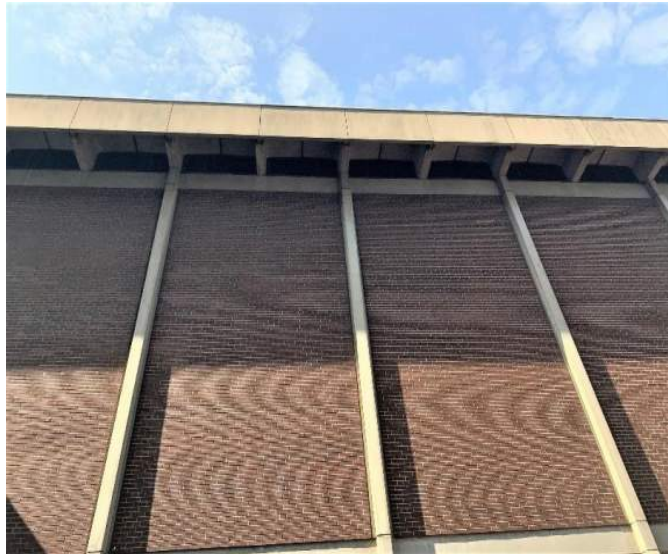
View of exterior masonry wall adjacent to gymnasium in Part A that shows cantilevered precast prestressed concrete single-tees at the roof level.

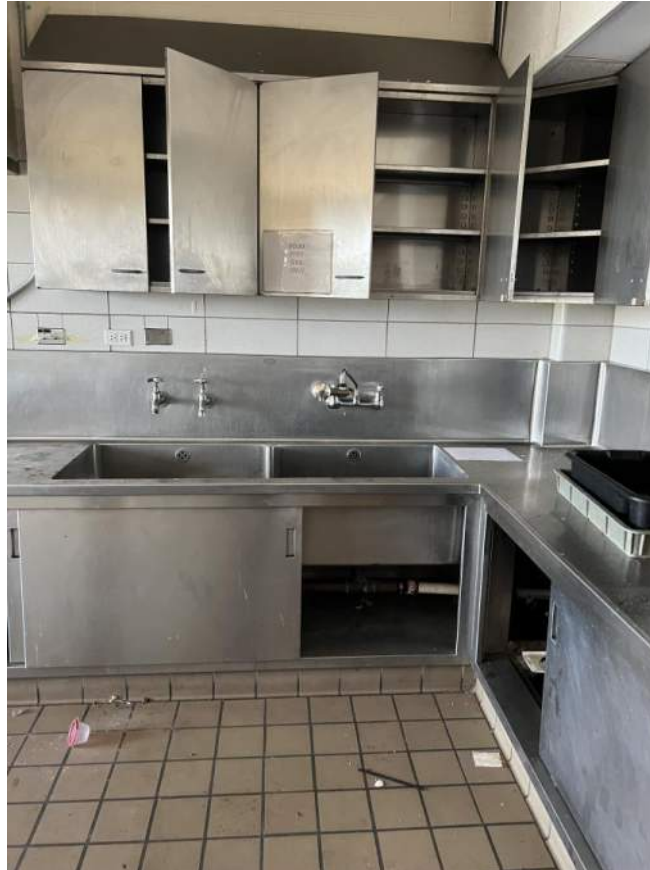
Prep. Sink with PVC repair (not indirectly wasted)

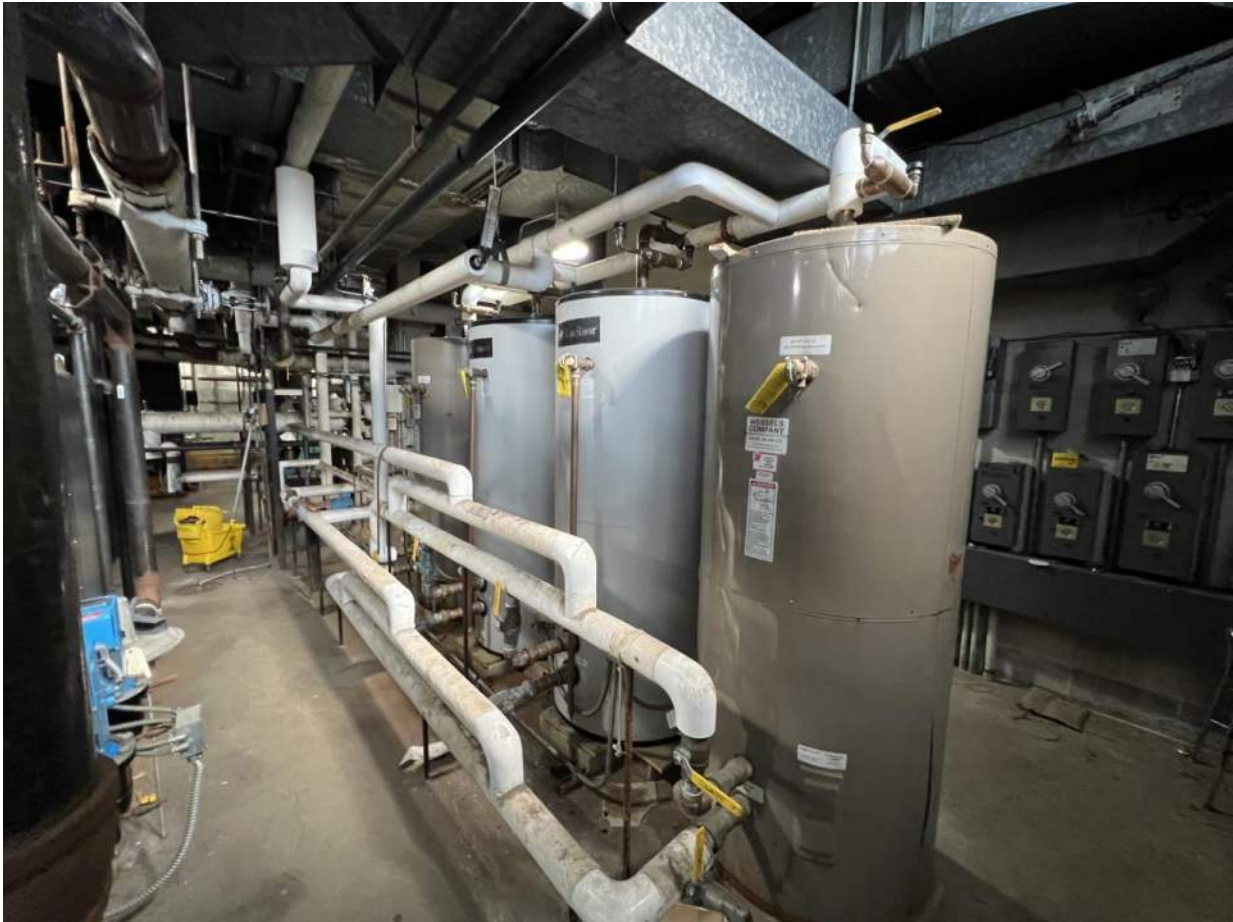
Domestic Hot Water Tanks

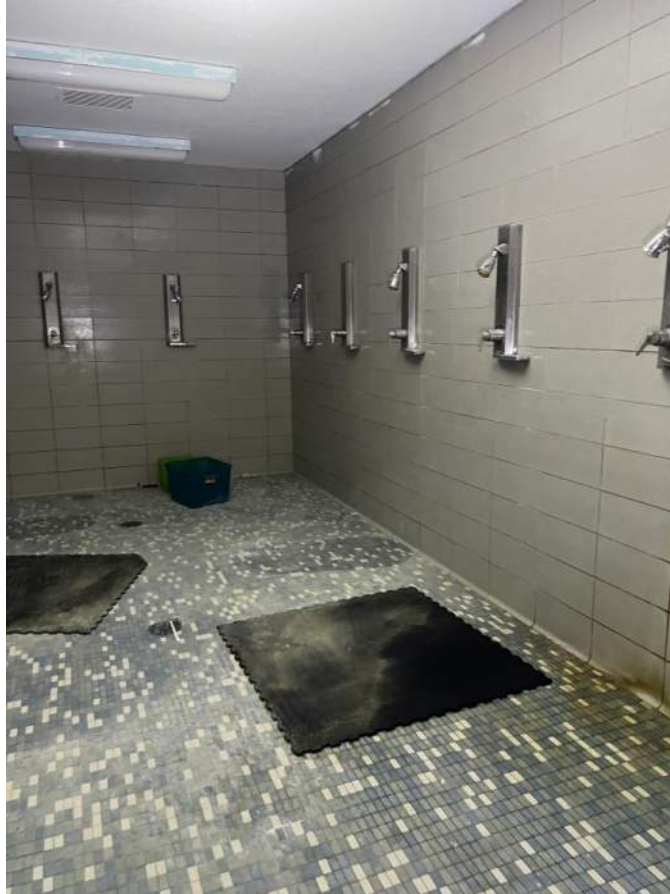
Boys Shower with central drains

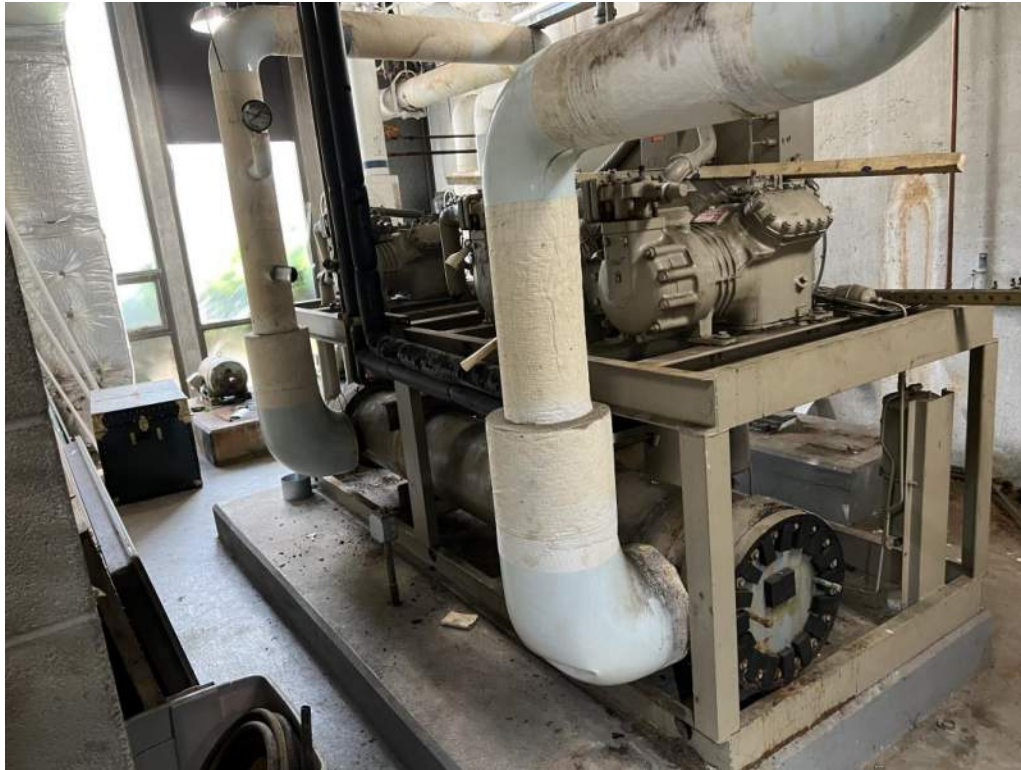
Remote Air-Cooled Chiller

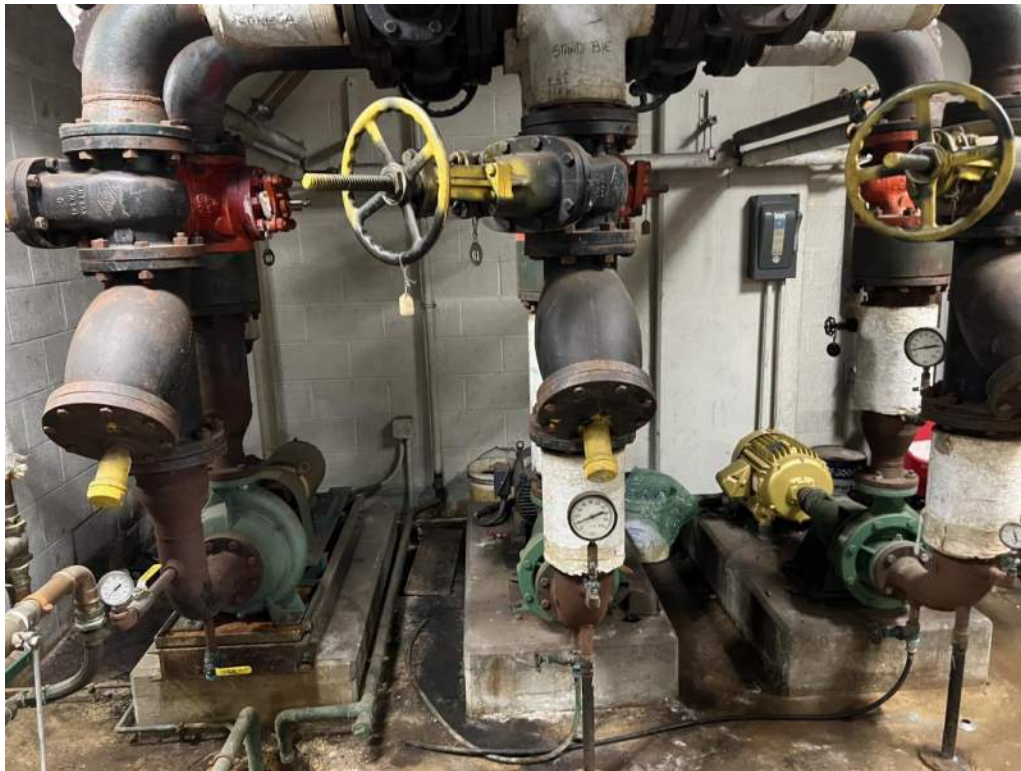
The pumps are all manufactured by Taco and appear to be in fair operational order with signs of bearing assembly and motor replacement. Some pumps do show signs of external corrosion. P-1 through P-3 appear to have been replaced within the last 20 years whereas the chilled and chilled/hot pumps appear to be of older vintage (40 +/- years). All the pumps are at or nearing the end of their useful service life of 20-years as defined in ASHRAE and as such are prime candidates for replacement. We would recommend serious consideration be given to upgrading the pumps for variable flow to save pump energy.

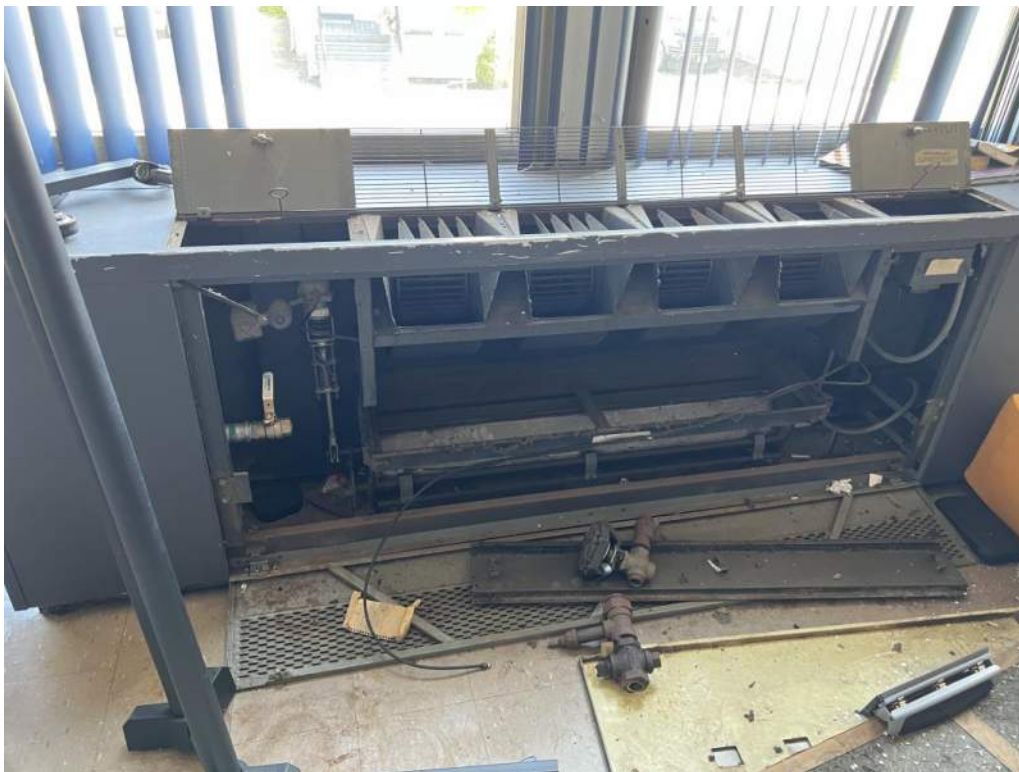
Unit Vent – Draw Thru Style (coil in process of being replaced)

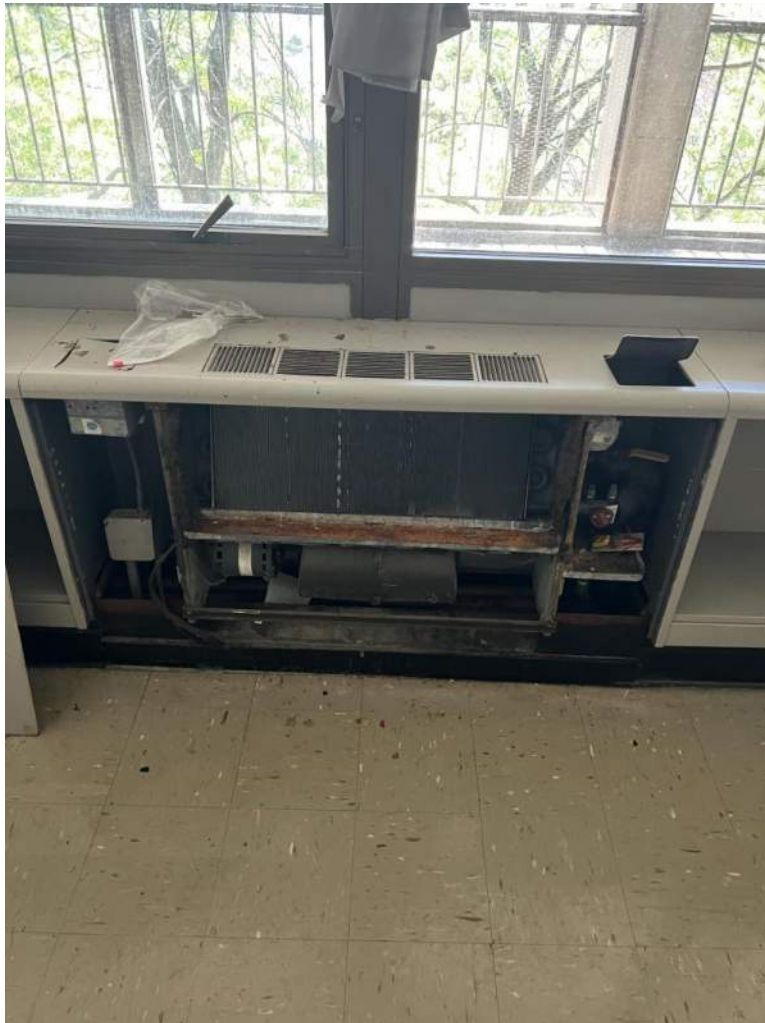
Unit Vent – Blow Thru Style

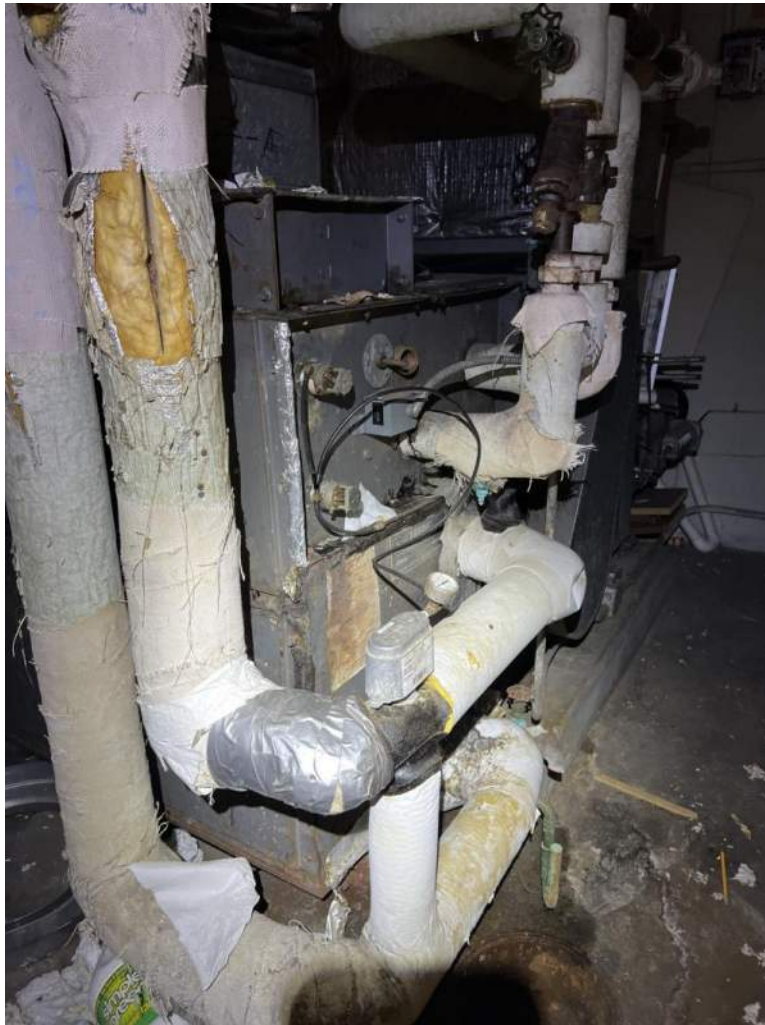
Air Handling Unit (Cooling and Heating)

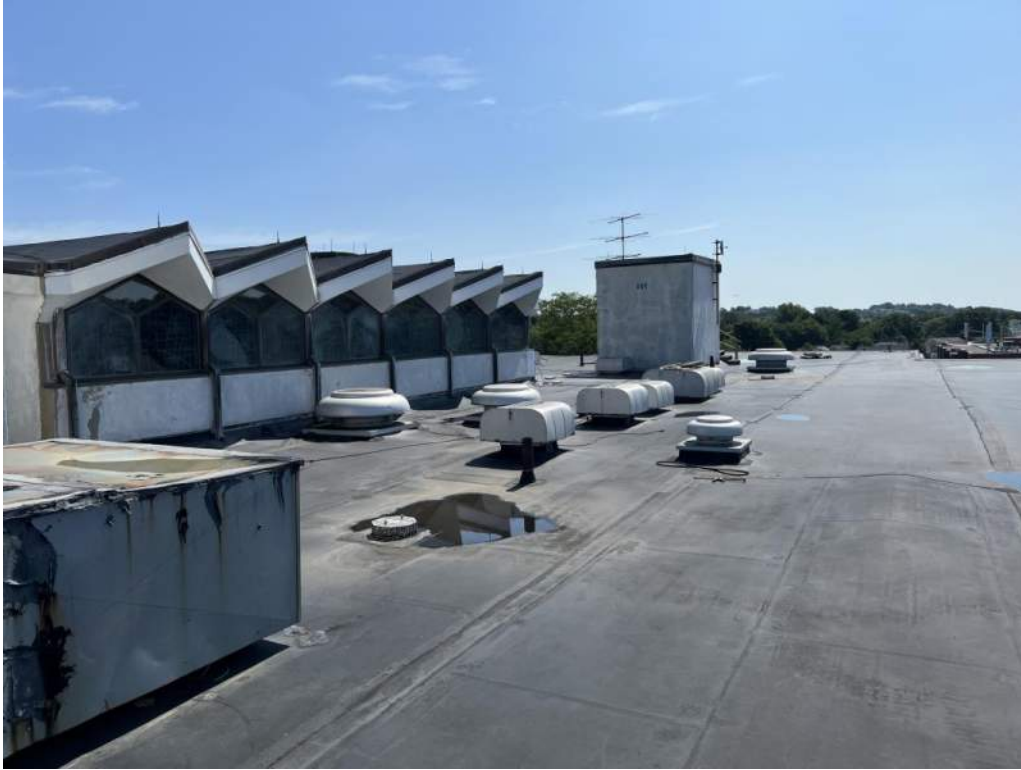
Roof Fans and Intakes

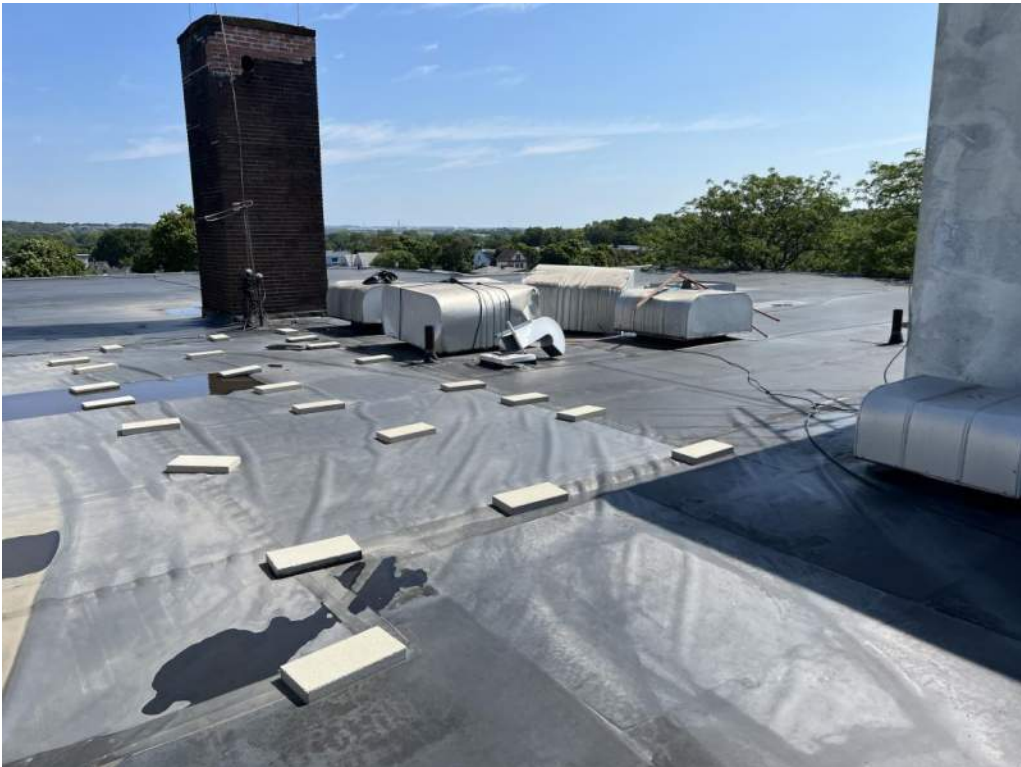
Damaged Roof Fan, Fan off Curb and Gooseneck Duct Broken

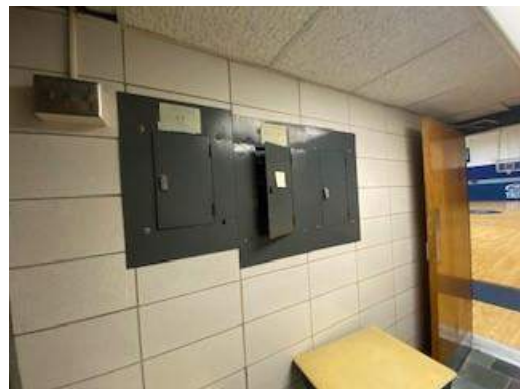
Typical Corridor Flush Sub-Panels

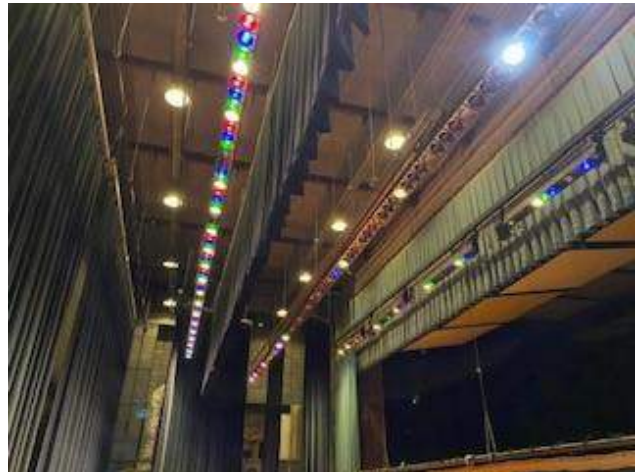
Typical Classroom Lighting

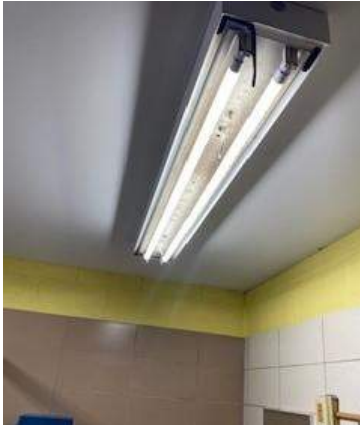
Typical Retrofitted LED Light Fixture

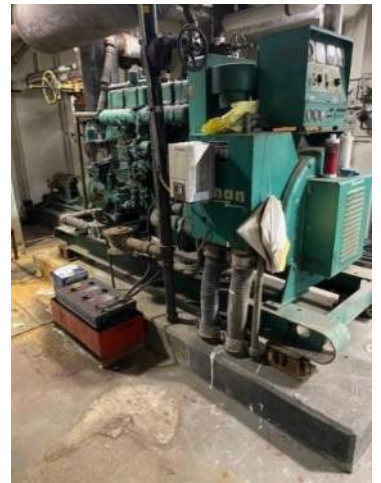
Manual 125-KW Natural Gas Generator

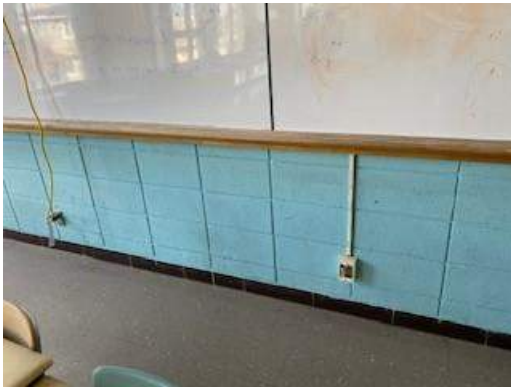
Typical Classroom Telecomm. Devices
