City of Everett ADA Transition Plan

June 2018

Institute for Human Centered Design

Police Station

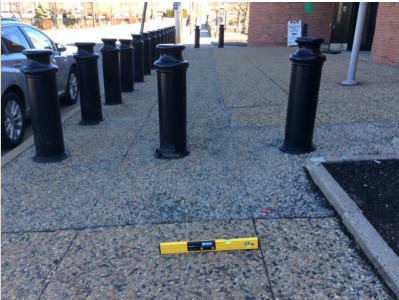
Cross slope > 1:50 (2.00%)	8.5%	Reduce cross slope to be no steeper than 1:50 (2.00%). (10' length, 4' width estimated)	1	200	\$200
2	Main Entrance	Ext		Exterior Access Route	Walkway

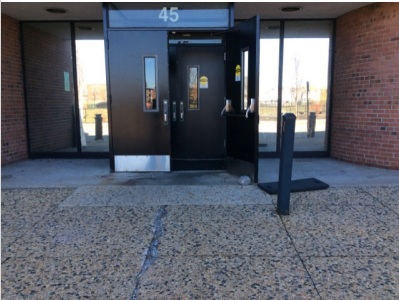
Running slope > 1:20 (5%)	6.6%	Reduce running slope to be no steeper than 1:20 (5%). (6' length, 3' width estimated)	1	90	\$90
3	Accessible Street Parking Space Curb Ramp	Ext.		Exterior Access Route	Curb Ramp

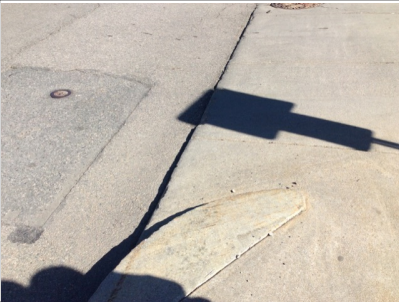
Level changes > 1/4"	.75"	Alter change in level to be 1/4" high max.	1	103	\$103
4	Route From Accessible On-Street Parking	Ext.		Exterior Access Route	Sidewalk

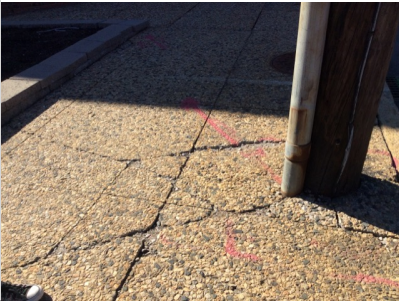
Surface is not stable, firm, and slip-resistant		Repair surface.	1	103	\$103
5	Sidewalk South of Entrance	Ext.		Exterior Access Route	Sidewalk

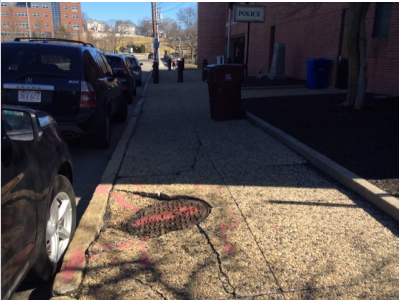
Route not maintained in operable working condition		Ensure the accessible route is maintained in operable working conditions.	1	Labor / 103	\$103

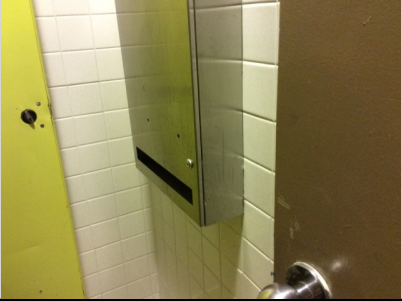
Obstructed by protruding objects	5"	Relocate dispenser out of the circulation path or provide a cane detectable barrier.	1	Labor / 153	\$153
Doors, Doorways, & Gates												
7	Holding Room	1	124	Doors, Doorways, & Gates	N/A

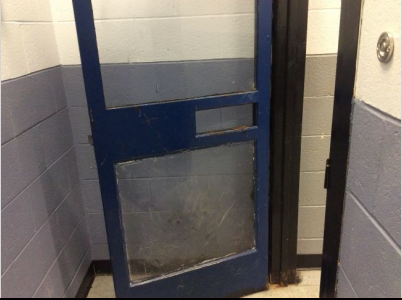
Clear width at door < 32"	30"	Use offset hinges to widen the door so that there is 32" min. clear width.	1	1116	\$1116
8	Juvenile Cell	1	128	Doors, Doorways, & Gates	N/A

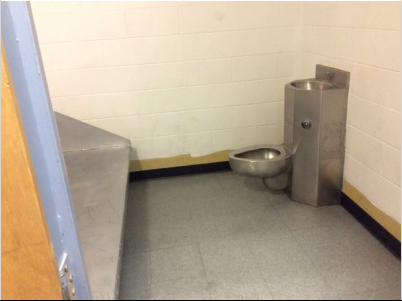
Clear width at door < 32"	25.3"	At the Juvenile Cell designated to be mobility accessible, widen the door so that there is 32" min. clear width.	1	1683	\$1683
9	Women's Cell	1	130	Doors, Doorways, & Gates	N/A

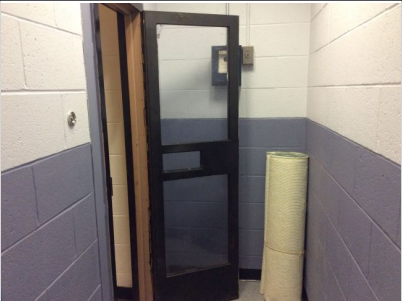
Clear width at door < 32"	20"	At the Women's Cell designated to be mobility accessible, widen the door so that there is 32" min. clear width.	1	1683	\$1683

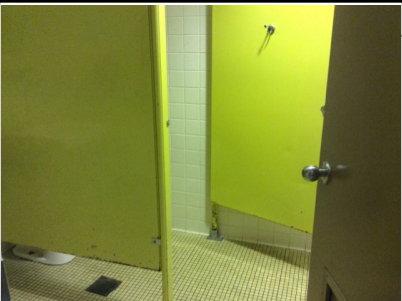
10	Women's Toilet Room by Lobby	1	104	Doors, Doorways, & Gates	Toilet Room

Maneuvering clearance(s) not provided	36" pull side	Remove toilet compartment partition.	1	Labor	\$0

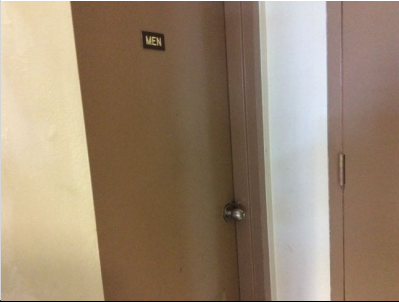
Hardware not operable with a closed fist	-	Provide hardware that can be operable with one hand and not require tight grasping, pinching, or twisting of the wrist.	1	242	\$242
12	Women's Toilet Room by Lobby	1	104	Doors, Doorways, & Gates	Toilet Room

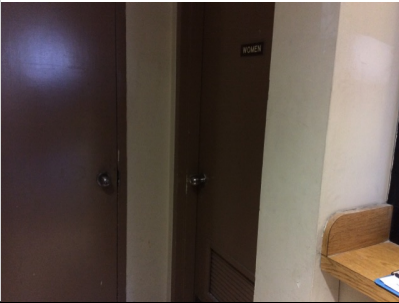
Hardware not operable with a closed fist		Provide hardware that can be operable with one hand and not require tight grasping, pinching, or twisting of the wrist.	1	242	\$242
13	Men's Toilet Room and Women's Toilet Room	2	207 208	Doors, Doorways, & Gates	Toilet Room

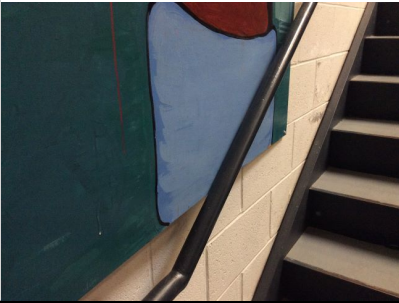
14	Stair by Mural	1	200	Stairways	Interior

Handrail < 1 1/2" from adjacent surface	0"	Mural makes handrail unusable. Ensure that handrails are mounted 1 1/2" min. from adjacent surface.	1	Labor	\$0
15	Stair	2	200	Stairways	Interior

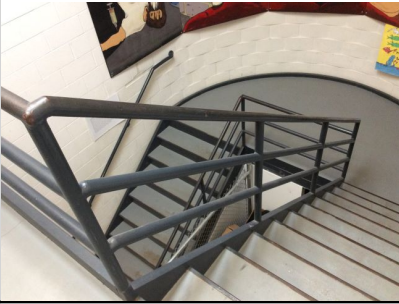
Handrails not continuous where required		Provide continuous handrails. Interior handrail is not continuous.	1	1110	\$1110

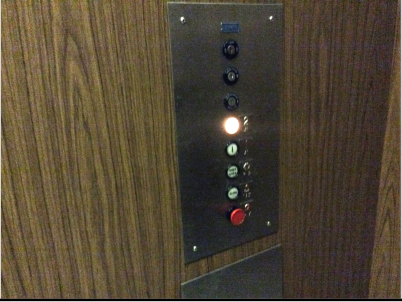
Tactile stars not provided at main entry level		Provide a tactile star on both sides of jambs at main floor. Provide a tactile star at the main floor on the control panel within the car.	3	48	\$144
Signage												
17	Instructional Room	2	243	Signage	Designation

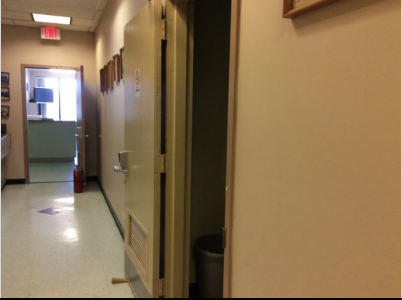
Not provided		Locate signage alongside the door on the latch side.	1	116	\$116
18	Main Entrance	1	101	Signage	Egress

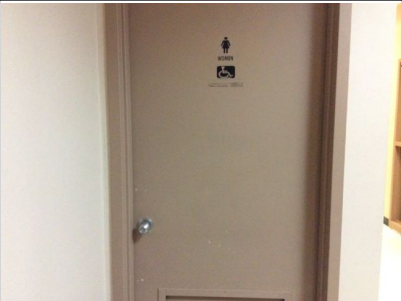
Raised characters not provided Braille not provided		Provide text with raised characters duplicated in braille.	1	116	\$116
20	Men's and Women's Toilet Rooms by Lobby	1	102 104	Signage	Designation

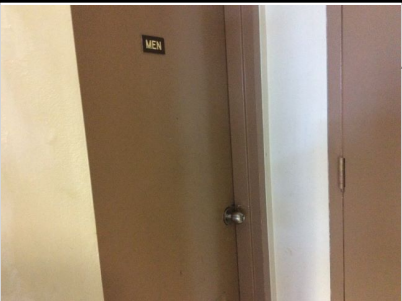
Raised characters not provided Braille not provided International Symbol of Acc. not compliant	-	Provide text with raised characters duplicated in braille. Replace sign with a sign containing the International Symbol of Accessibility after toilet rooms are made compliant.	2	116	\$232

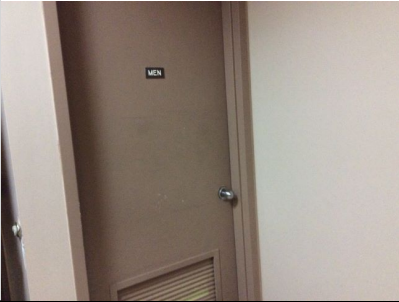
Raised characters not provided Braille not provided International Symbol of Acc. not compliant		Provide text with raised characters duplicated in braille. After toilet room is made compliant, replace sign with a sign containing the International Symbol of Accessibility.	1	116	\$116
Service Counter												
22	Lobby	1	101	Service Counter	N/A

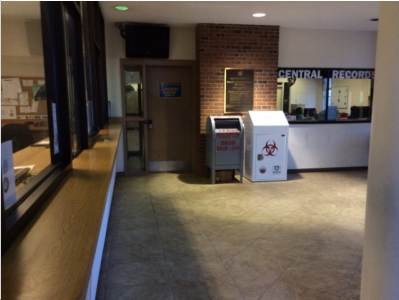
Counter > 36" high	41.5"	Provide a counter that is 36" max. above the ground or finish floor for each of the two counters in the front lobby.	2	440	\$880
23	Booking	1	122	Service Counter	N/A

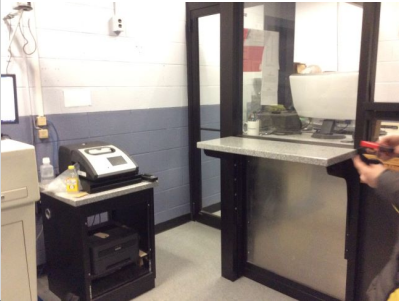
Counter > 36" high	42"	Provide a counter that is 36" max. above the ground or finish floor.	1	440	\$440
Detention Facilities												
24	Juvenile Cell	1	128	Detention Facilities	Juveniles

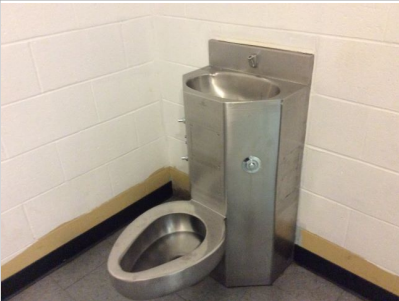
Mobility cell lacks access to accessible toilet/lavatory		Ensure an accessible toilet/lavatory is provided in one Juvenile Cell, including compliant ligature resistant grab bars.	1	5005	\$5005

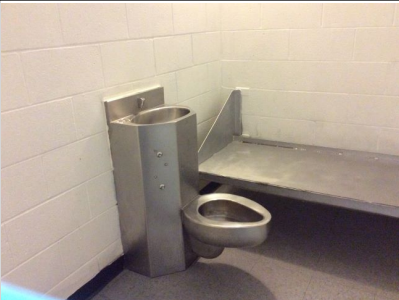
25	Women's Cell (Same in Men's)	1	130	Detention Facilities	Women's

Mobility cell lacks access to accessible toilet/lavatory		Ensure an accessible toilet/lavatory is provided in one Women's Cell, including compliant ligature resistant grab bars.	2	5005	\$10010
Toilet & Bathing Rooms

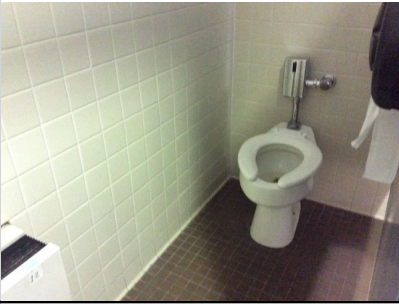
Accessible plumbing fixtures or stalls not provided Audible and visible alarms not provided	36"	Provide one accessible wheelchair stall or add an accessible single-user toilet room. When fire system is updated, ensure that a visible and audible fire alarm is installed.	1	3437	\$3437
27	Men's Toilet Room	2	207	Overall Access	Toilet Room

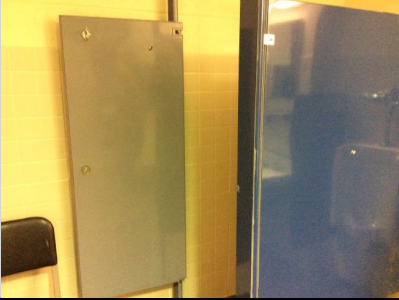
Accessible plumbing fixtures or stalls not provided Audible and visible alarms not provided		Provide one accessible wheelchair stall or add an accessible single-user toilet room. When fire system is updated, ensure that a visible and audible fire alarm is installed.	1	3437	\$3437
28	Women's Toilet Room by Lobby	1	104	Overall Access	Toilet Room

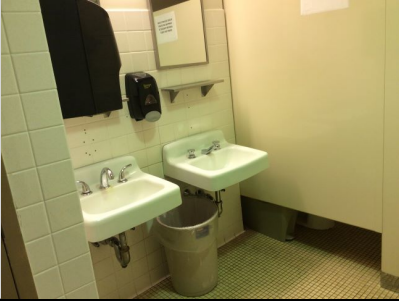
29	Women's Toilet Room	2	208	Overall Access	Toilet Room

Audible and visible alarms not provided		When fire system is updated, ensure that a visible and audible fire alarm is installed.	1	346	\$346
Lavatory												
30	Men's Toilet Room	2	207	Lavatory	N/A

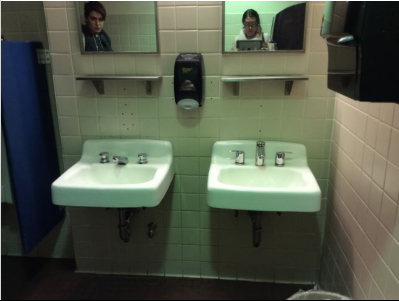
Toe or knee clearances not provided Plumbing underneath is exposed Mirror above lavatory w/reflective surface > 40"	26.5" - 51"	Provide at least one lavatory with knee and toe clearance positioned for a forward approach. Insulate or otherwise configure pipes to prevent contact, for at least one lavatory. Lower mirror so that the bottom surface is at 40" max. above finish floor.	1	1017	\$1017

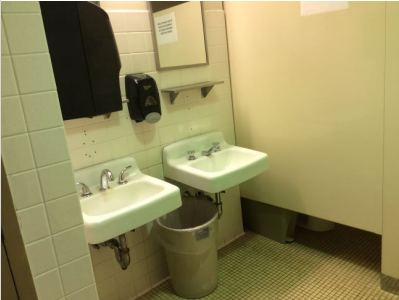
Toe or knee clearances not provided Plumbing underneath is exposed Mirror above lavatory w/reflective surface > 40"	26.5" - 51.1"	Provide at least one lavatory with knee and toe clearance positioned for a forward approach. Insulate or otherwise configure pipes to prevent contact, for at least one lavatory. Lower mirror so that the bottom surface is at 40" max. above finish floor.	1	1017	\$1017
32	Men's Toilet Room by Lobby	1	102	Lavatory	N/A

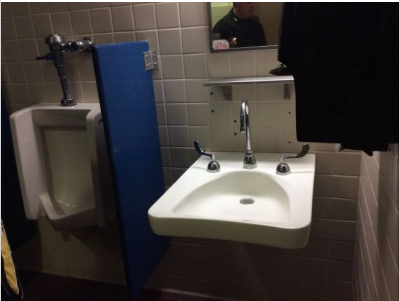
Plumbing underneath is exposed Mirror above lavatory w/reflective surface > 40"	- 55.7"	Insulate or otherwise configure pipes to prevent contact, for at least one lavatory. Lower mirror so that the bottom surface is at 40" max. above finish floor.	1	174	\$174
33	Women's Toilet Room by Lobby	1	104	Lavatory	N/A

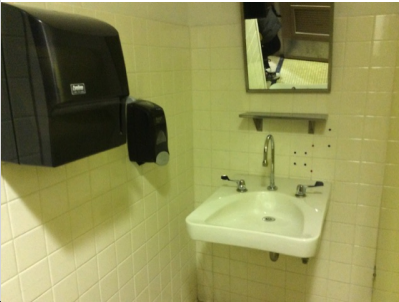
Plumbing underneath is exposed Mirror above lavatory w/reflective surface > 40"	- 51.5"	Insulate or otherwise configure pipes to prevent contact, for at least one lavatory. Lower mirror so that the bottom surface is at 40" max. above finish floor.	1	174	\$174

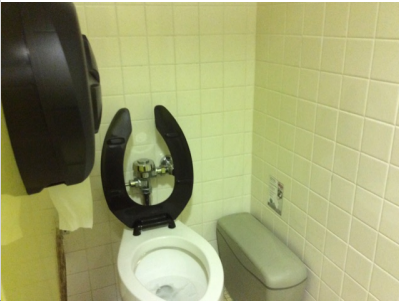
Toilet Compartment												
34	Women's Toilet Room by Lobby	1	104	Toilet Compartment	Accessible Compartment

Side grab bar < 42" long Rear grab bar < 42" long Non-compliant toilet paper dispenser Clearance at toilet < 60" clear width Clearance at toilet < 72" clear depth (MAAB)	- - - 35.8" 51.6"	Remove toilet partitions & convert to single user toilet. Provide a side wall grab bar that is 42" long 12" max. from the rear wall. Provide a rear grab bar that is 42" long min. & extends from the toilet 12" min. on 1 side and 24" min. on the other side (open side). Relocate toilet paper so it is under the grab bar, & between 7"- 9" in front of the toilet. Ensure there is 60" wide min. and 72" deep at toilet.	1	3091	\$3091
35	Women's Toilet Room	2	208	Toilet Compartment	Accessible Compartment

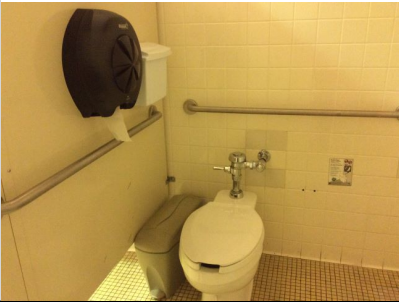
Flush control not on open side Non-compliant toilet paper dispenser Centerline < or > 18" (MAAB)	- - 17.5"	Provide the flush control on the open side of the toilet (transfer side). Relocate toilet paper so that it is 15" min high, located under the grab bar, and between 7" and 9" from the front of the toilet. Ensure nothing is mounted over the grab bars. Centerline is not compliant with MAAB, but compliant with ADA and usable.	1	540	\$540

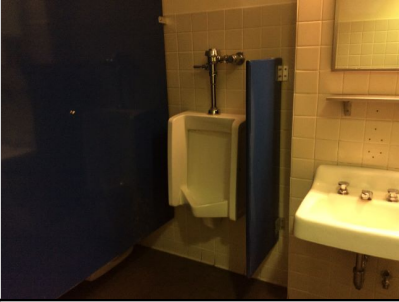
Rim > 17" high Clear floor space not provided at urinal Flush control too high or not properly located	23" 28.5" 53"	Provide at least one urinal with the rim no higher than 17" above the finish floor. Remove partition to provide a 30" min. by 48" min. clear floor space positioned for a forward approach. Mount flush control at 44" max. above the finish floor.	1	1752	\$1752
37	Men's Toilet Room by Lobby	1	102	Urinal	N/A

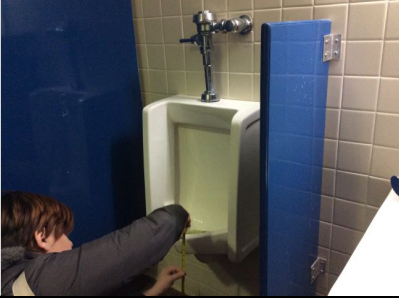
Rim > 17" high Flush control too high or not properly located	24" 52"	Provide at least one urinal with the rim no higher than 17" above the finish floor. Mount flush control at 44" max. above the finish floor.	1	1624	\$1624
Dispensers												
38	Men's Toilet Room by Lobby	1	102	Dispensers	Paper Towel Dispenser

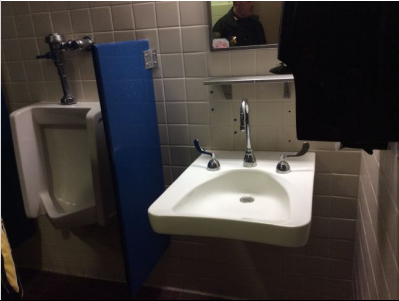
Controls > 42" high Dispenser acts as a protruding object	52.6 -	Relocate so the operable part is 42" max. above the finish floor. Relocate dispenser out of the circulation path.	1	353	\$353

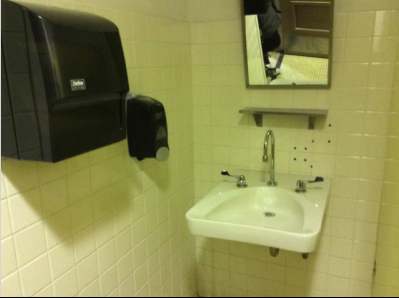
39	Women's Toilet Room by Lobby	1	104	Dispensers	Paper Towel Dispenser

Controls > 42" high Dispenser acts as a protruding object	54" -	Relocate so the operable part is 42" max. above the finish floor. Relocate dispenser out of the circulation path.	1	353	\$353
40	Men's Toilet Room	2	207	Dispensers	Paper Towel Dispenser

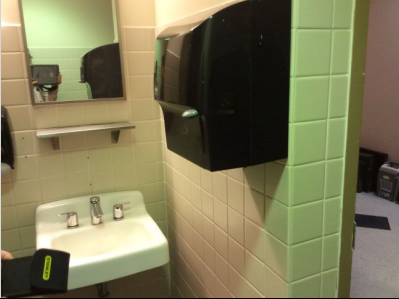
Controls > 42" high Dispenser acts as a protruding object	53.4"	Relocate so the operable part is 42" max. above the finish floor. Relocate dispenser out of the circulation path.	1	353	\$353

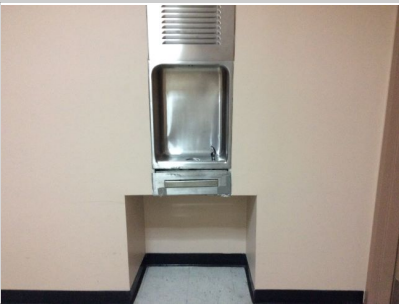
Spout > 36" high (wheelchair users)	38"	Install a Hi-Lo fountain.	1	2108	\$2108
