## City of Everett ADA Transition Plan

March 2018

Institute for Human Centered Design

## City Hall

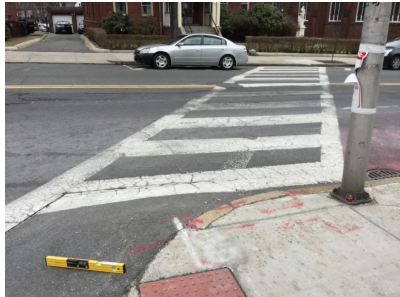
Curb ramp not provided	-	Provide curb ramp at intersection on opposite side of street.	1	1225	\$1225
<b>Diagonal Curb Ramp</b>										
E3	Broadway and Church St.	Diagonal Curb Ramp	N/A

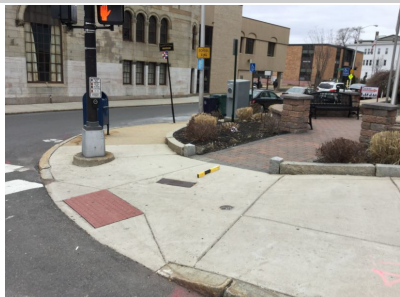
Landing > 1:50 (2.00%)	6.5%	Reduce slope to be no steeper than 1:50 (2.00%).	1	123	\$123
<b>Detectable Warnings</b>										
E4	Broadway and Church St.	Detectable Warnings	N/A

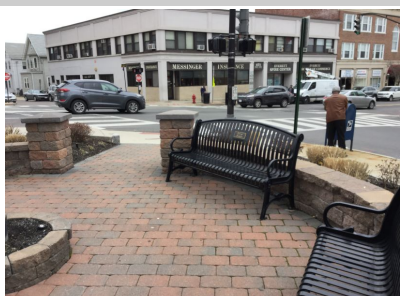
Detectable warnings not provided	-	Provide a detectable warning on curb ramp/platform edge at far side of street.	2	180	\$360

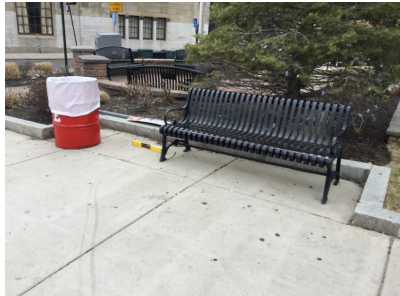
Clear floor space adjacent to the bench not provided	-	Provide a 30" x 48" clear space adjacent to the bench. Relocate trash can.	1	Labor	\$0
<b>Universal Design</b>										
E7	Church St. Accessible Entrance

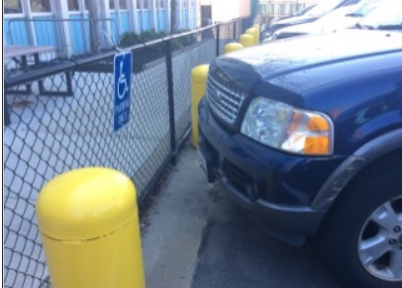
Sign < 60" above finished grade	28.8"	Locate sign with the bottom of the sign 60" above the ground.	1	Labor	\$0

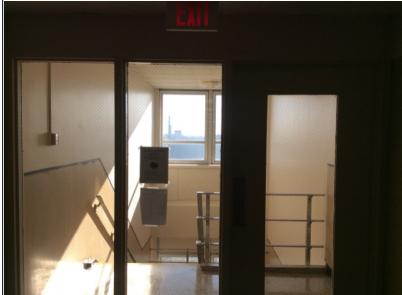
<b>Access to Goods and Services</b>												
<b>Means of Egress</b>												
10	Stair 2 (Same at Other Stair and on Level 2)	3		Means of Egress	N/A

Tactile exit sign not provided		Ensure tactile exit signs with raised characters and braille are provided at exit doors leading to enclosed stairways. Mount signs between 48"-60" above finish floor located on the latch side of the door.	4	116	\$464

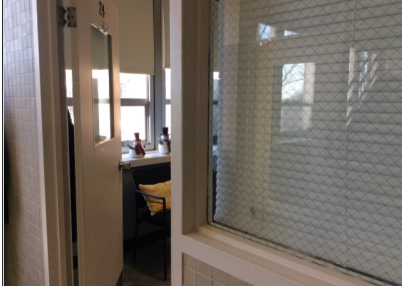
Hardware not operable with a closed fist		Provide hardware that can be operable with one hand and not require tight grasping, pinching, or twisting of the wrist.	4	242	\$968

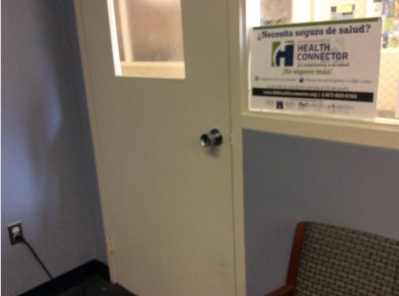
Hardware not operable with a closed fist		Provide hardware that can be operable with one hand and not require tight grasping, pinching, or twisting of the wrist.	4	242	\$968
38	Stair 2 by Accessible Entrance	LL		Doors, Doorways, & Gates	Circulation

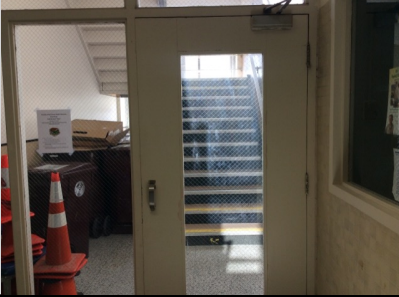
Door requires > 5 lbs. of force to open	10 lbs	Adjust closers so doors do not require more than 5 pounds of force to open. Note: Fire doors shall have the opening force allowable by the appropriate administrative authority.	1	Labor	\$0

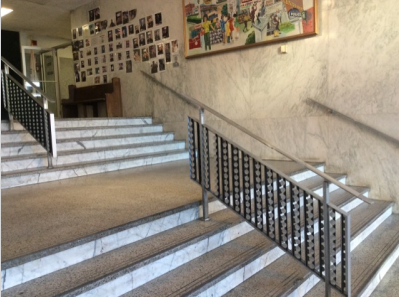
<b>Stairways</b>												
39	Front Entrance	1		Stairways	Interior

Handrails do not extend 12" from stairs Handrails have non-compliant cross section		Top: Ensure handrails extend horizontally above the landing for 12" min. beginning above the first riser nosing. Provide handrails with 1 1/4" - 2" circular cross sections. (30 linear ft. of handrail estimated)	1	1110	\$1110
40	Stair 2 by Accessible Entrance (New Handrails for all Stories)	LL		Stairways	Interior

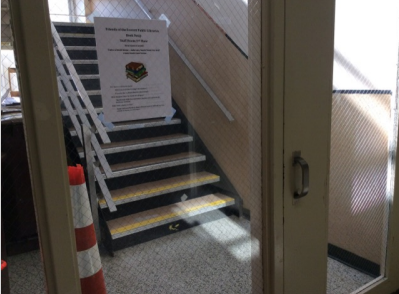
Handrails have non-compliant cross section		Provide handrails with 1 1/4" - 2" circular cross section.	3	2220	\$6660

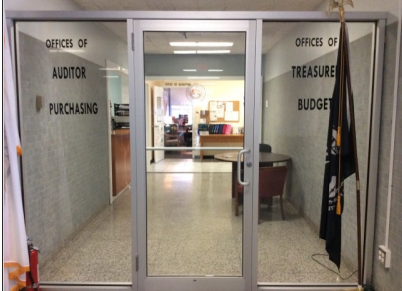
Raised characters not provided Braille not provided		Provide text with raised characters duplicated in braille.	9	116	\$1044

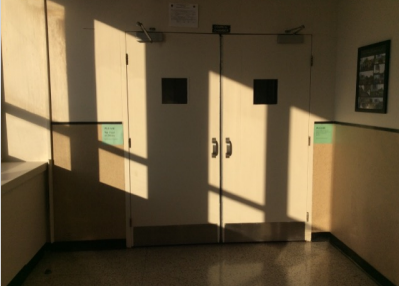
50	Council Chambers (2 Entry Doors)	3	38	Signage	Egress

Raised characters not provided Braille not provided		Provide text with raised characters duplicated in braille.	2	116	\$232

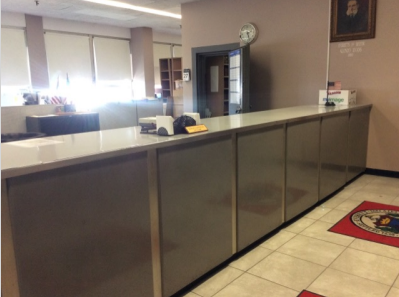
Counter > 36" high	40"- 42.5"	Provide a counter that is 36" max. above the ground or finish floor.	2	440	\$880
58	Department of Planning and Development and Health Department, Inspectional Services	2	25 20 26	Service Counter	N/A

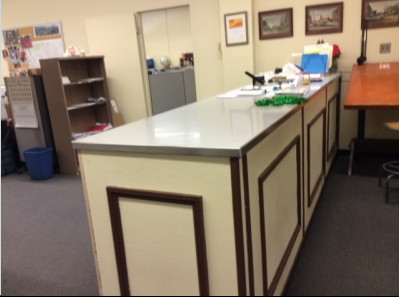
Counter > 36" high	42.5"-43.3"	Provide a counter that is 36" max. above the ground or finish floor.	3	440	\$1320
59	Mayor's Office, Retirement Office, Human Resources, Registrars of Voters, City Council	3	31 30 32 34 38	Service Counter	N/A

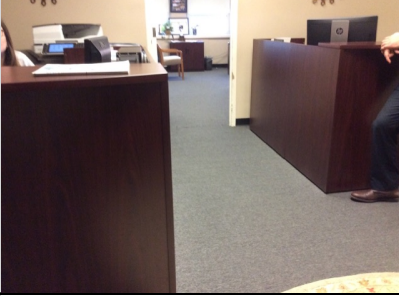
Counter > 36" high	42"-45"	Provide a counter that is 36" max. above the ground or finish floor.	5	440	\$2200

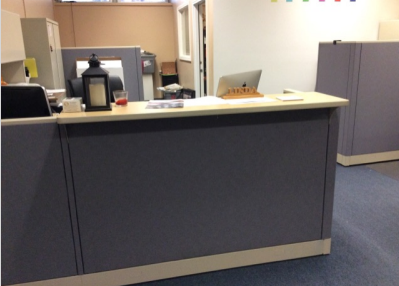
60	ECTV	LL	1	Service Counter	N/A

Counter > 36" high	42"	Provide a counter that is 36" max. above the ground or finish floor.	1	440	\$440

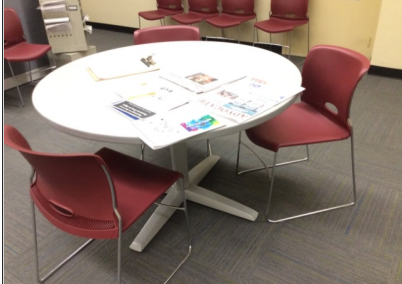
65	Parent Info Center	LL	6	Dining or Work Surfaces	Work Surface

Knee or toe clearance not provided		Provide at least 1 dining or work surface with 27" min. knee and toe clearance.	1	350	\$350

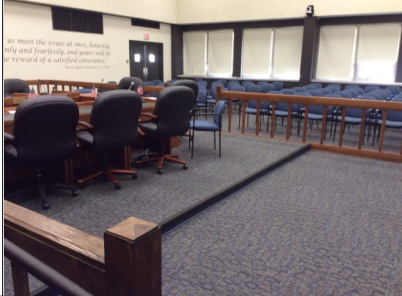
Assistive listening devices not provided		If audible communication is integral to the use of the space, provide an assistive listening system.	1	1688	\$1688
<b>Toilet &amp; Bathing Rooms</b>												
<b>Overall Access</b>												
68	Men's Toilet Room (Same at Women's Toilet Room)	2		Overall Access	Toilet Room

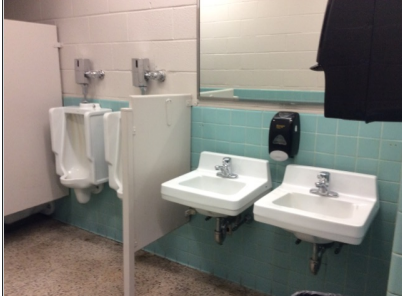
Accessible plumbing fixtures or stalls not provided Audible and visible alarms not provided		Provide one accessible wheelchair stall or add an accessible single-user toilet room. When fire system is updated, ensure that a visible and audible fire alarm is installed.	2	3437	\$6874

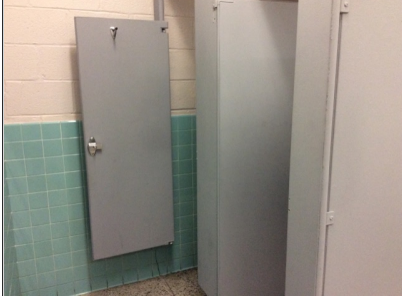
69	Men's Toilet Room	LL		Overall Access	Toilet Room

Accessible plumbing fixtures or stalls not provided Audible and visible alarms not provided		Provide one accessible wheelchair stall or add an accessible single-user toilet room. When fire system is updated, ensure that a visible and audible fire alarm is installed.	1	3437	\$3437
70	Men's Toilet Room (Same in Women's Toilet Rooms on 3 and LL)	3		Overall Access	Toilet Room

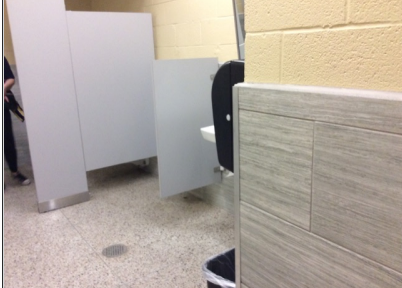
Audible and visible alarms not provided		When fire system is updated, ensure that a visible and audible fire alarm is installed.	3	346	\$1038

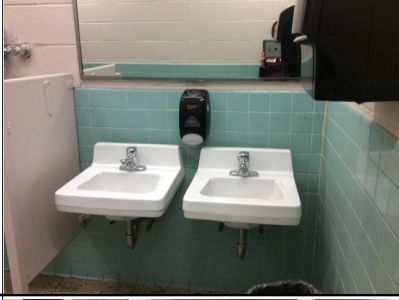
72	Women's Toilet Room and Men's Toilet Room	2		Lavatory	N/A

Plumbing underneath is exposed Mirror above lavatory w/reflective surface > 40"	- 48.7"	Insulate or otherwise configure pipes to prevent contact, for at least one lavatory. Lower mirror so that the bottom surface is at 40" max. above finish floor.	2	174	\$348
73	Women's Toilet Room	LL		Lavatory	N/A

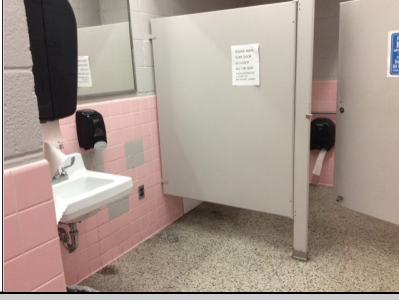
Plumbing underneath is exposed Mirror above lavatory w/reflective surface > 40"	- 48.6"	Insulate or otherwise configure pipes to prevent contact, for at least one lavatory. Lower mirror so that the bottom surface is at 40" max. above finish floor.	1	174	\$174
<b>Toilet Compartment</b>												
74	Women's Toilet Room	3		Toilet Compartment	Accessible Compartment

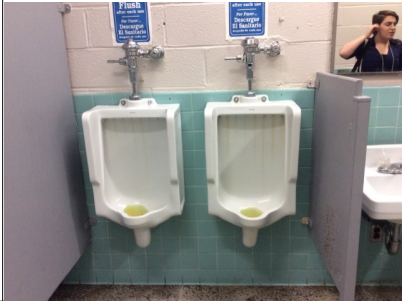
Rim > 17" high Flush control too high or not properly located	24" 53"	Provide at least one urinal with the rim no higher than 17" above the finish floor. Mount flush control at 44" max. above the finish floor.	2	1811	\$3622
<b>Dispensers</b>												
78	Men's Toilet Room	2		Dispensers	Paper Towel Dispenser

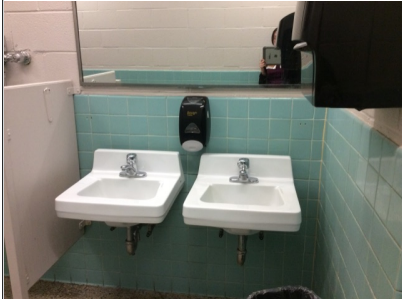
Controls > 42" high Dispenser acts as a protruding object	50" -	Relocate so the operable part is 42" max. above the finish floor. Relocate dispenser out of the circulation path.	1	353	\$353

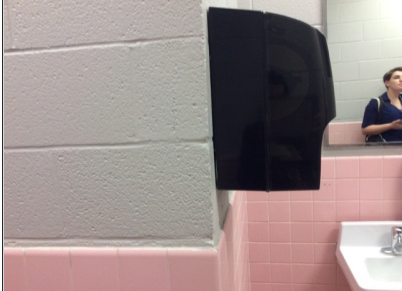
79	Women's Toilet Room	2		Dispensers	Paper Towel Dispenser

Controls > 42" high Dispenser acts as a protruding object	50"	Relocate so the operable part is 42" max. above the finish floor. Relocate dispenser out of the circulation path.	1	353	\$353

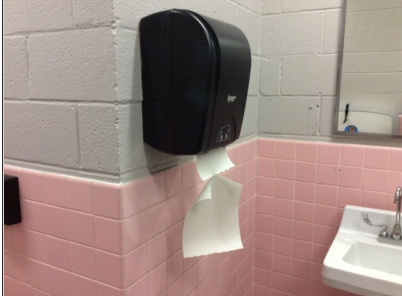
Controls > 42" high Dispenser acts as a protruding object	50"	Relocate so the operable part is 42" max. above the finish floor. Relocate dispenser out of the circulation path.	1	353	\$353
81	Women's Toilet Room and Men's Toilet Room	3		Dispensers	Paper Towel Dispenser

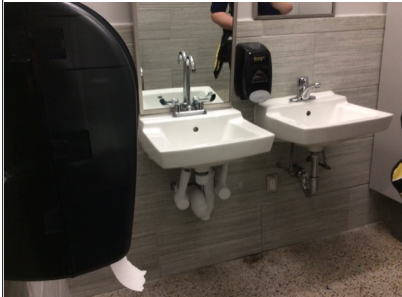
Dispenser acts as a protruding object		Relocate dispenser out of the circulation path.	2	353	\$706
82	Women's Toilet Room	LL		Dispensers	Tampon Dispenser

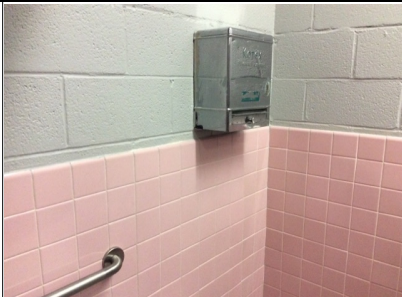
Dispenser acts as a protruding object	6"	Relocate dispenser out of the circulation path.	1	353	\$353
<b>Additional Access</b>												
<b>Drinking Fountains</b>												
83	Corridor	2 3		Drinking Fountains	High

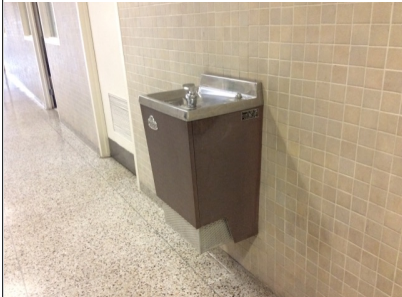
No drinking fountain provided for seated users		Provide an additional drinking fountain for seated users or install a Hi-Lo drinking fountain.	2	2014	\$4028
