# Sacramone Park

## City of Everett ADA Transition Plan

August 2018

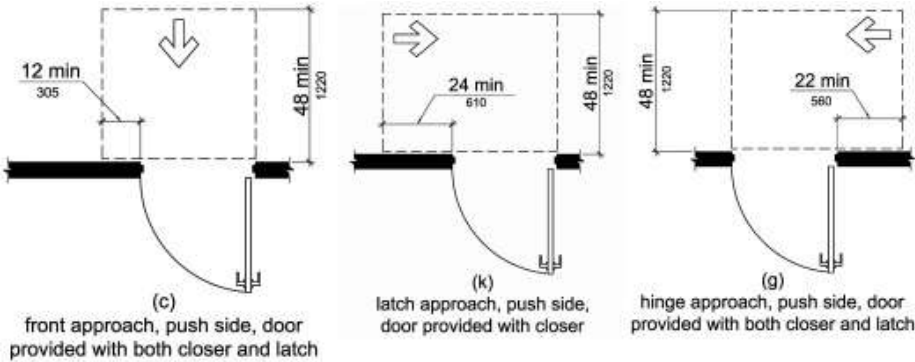
Gates lack a vertical solid pushing surface within 10 inches of the ground. One gate by the picnic area lacks maneuvering clearance on the pull side. Toilet room facilities were under construction. At the time of survey there was lack of maneuvering clearance on the latch push side of the toilet room doors due to a drainage ditch. Per the drawings, the doors will have both a latch and closer. The following maneuvering clearance on the push side is required:

Push side door maneuvering clearance diagrams.

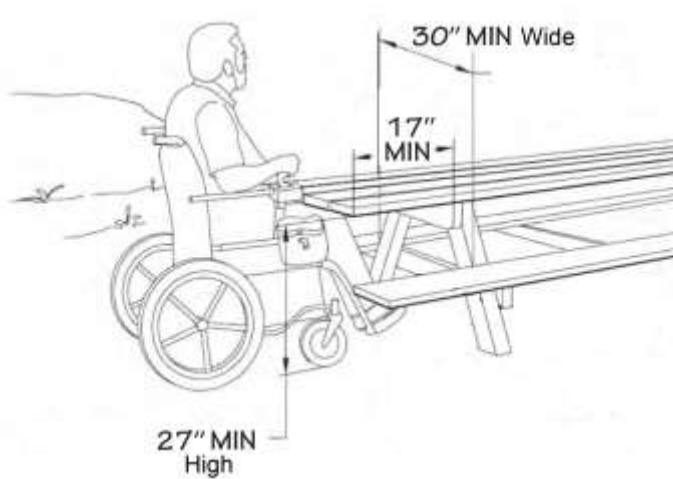
Accessible picnic tables in the park comply with the MAAB 521 CMR, but do not comply with the ADA 2010 standards. When purchasing tables in the future, ensure they have proper knee and toe clearance per the ADA in addition to the MAAB. The diagram details knee and toe clearance required by the ADA:

Toe and knee clearance at picnic table per ADA standards.

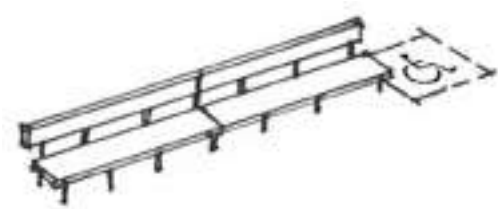
No space is provided for a wheelchair user to sit alongside their peers in any of the four (4) baseball dugouts.

Team seating area illustration.

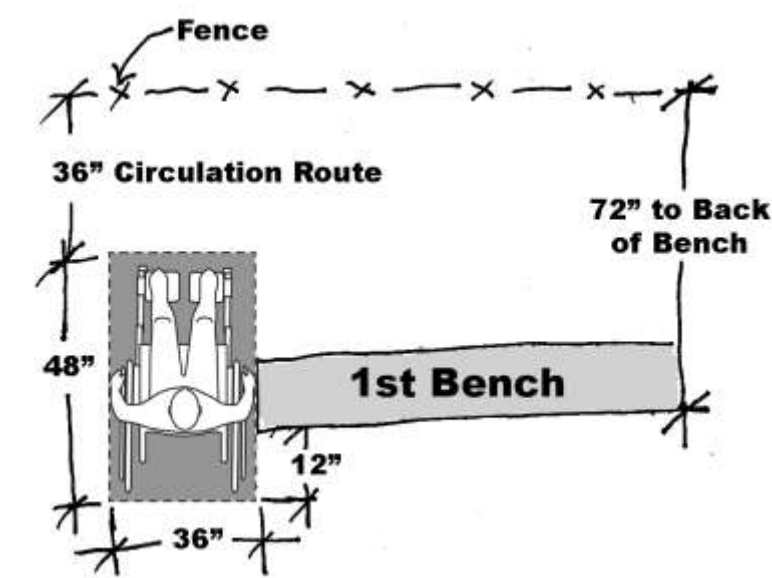
Three (3) bleachers did not have adequate clear space for wheelchair users to sit alongside their companions. A larger paved area should be added on one side of the Tileston Street and Santilli Highway Bleachers. We recommend relocating the bleacher on the south side to ensure that there is adequate space for a wheelchair user to sit shoulder to shoulder with a companion without blocking the circulation route. See diagram below:

South bleacher placement for a wheelchair accessible space.

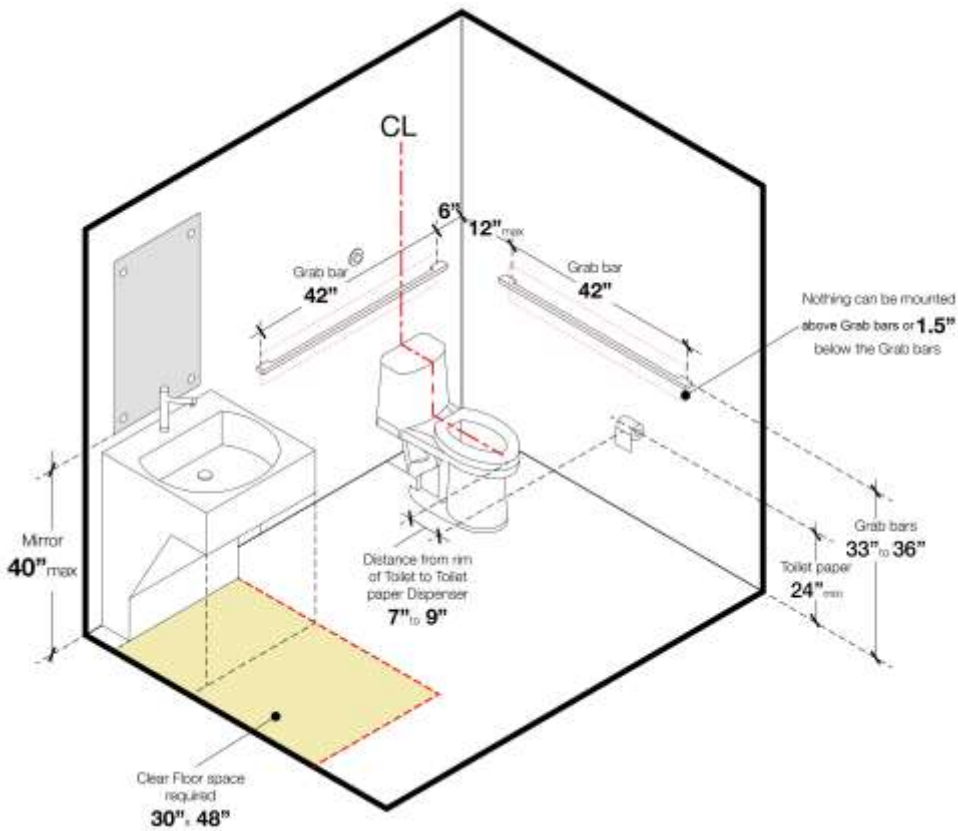
Size of accessible compartments and clear space at urinals and lavatories at Sacramone Park Field House Permit Set from 03-15-2018 is drawn in compliance with ADA standards and MAAB code. Some details are not called out, such as the location and heights of fixtures, accessories and grab bars within the toilet rooms. Location of toilet paper dispenser is represented incorrectly in toilet room drawings based on 2010 ADA Standards: it should be located 7"-9" in front of the rim of the toilet. The rim of the urinal should be mounted no higher than 17" above finished floor and the flush control should be no higher than 44" above finished floor. Included is a diagram outlining heights of other items in a toilet room per MAAB and ADA 2010 Standards:

ADA 2010 and MAAB toilet room height details.
