Everett Public Schools

Middle School Conversion (Former Everett High School)

Facility Assessment Study - Feasibility Report

July 22, 2024

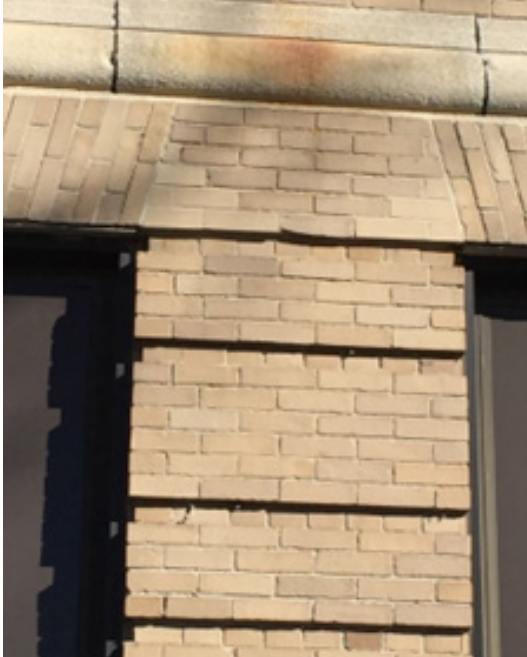
Continuous cast stone bands require repointing

The existing exterior masonry walls appear to be in overall fair condition, though on the interior in numerous areas it is evident that water has migrated through the exterior brick masonry façade causing spalling and crumbling of the interior finishes at the exterior wall surfaces. At a minimum masonry cracks and failure should be repaired, replaced and approximately 50% repointed. Ornamental Cast stone balconies retain water, which is deteriorating the material on the underside.

As part of any proposed future addition/renovation to the existing building, it is recommended that exterior walls be insulated at the interior face to maximize energy efficiency and 50% of existing exterior masonry be repointed or replaced to minimize ongoing and future masonry deterioration. The steel lintels above all openings are in fair condition and should be replaced as required. See the structural narrative for any additional information.

The copper cap at the top of the 1920's original building, along with all related wood blocking, should be replaced in its entirety. The brick veneer of the building should be cleaned in its entirety. The cast stone should be repointed and ornamental balconies should be lined with a membrane or water proof material as the standing water is damaging the integrity of the cast stone.

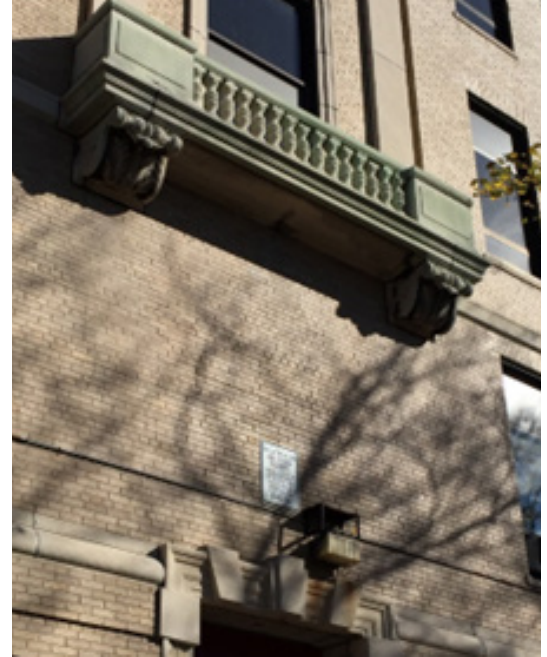
Ornamental cast stone balconies

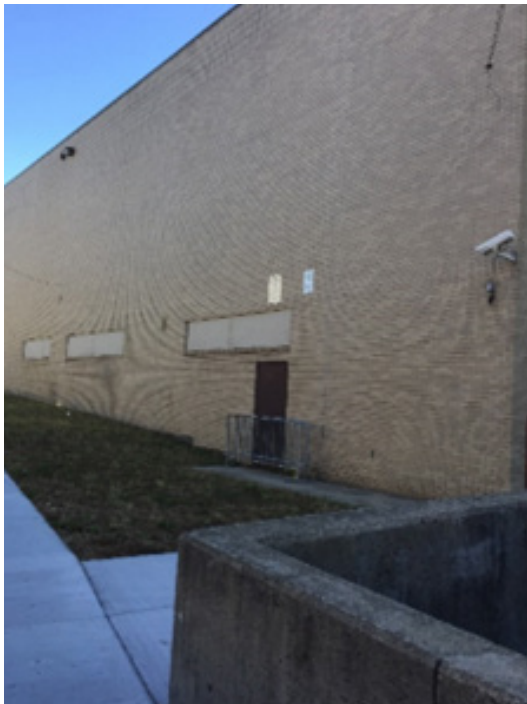
*1970's addition facing Linden Street
Boarded window openings*

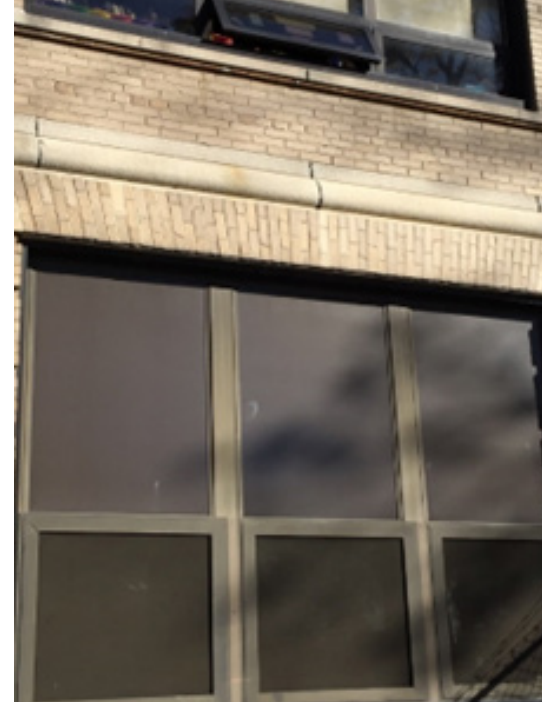
Aluminum windows w/double pane glazing & metal panels

All doors in the 1920's building and 1970's are past their longevity showing signs of paint and weather stripping deterioration, hardware deficiencies and backer rod and sealant failure and should be removed in their entirety and substituted with thermally superior and appropriate period style doors. See above picture for example. The building is currently not handicap accessible from any of the exterior entrances. The existing concrete stair systems are in fair condition at the main entrance and side entries, though none of these entries are handicap accessible. Most windows are in fair condition. All caulking should be replaced in its entirety where the window frame meets its adjacent exterior wall surface. Steel lintels are in fair condition but further investigation would be required, see structural narrative for any additional information.

As part of any addition or renovation project it is recommended all existing doors be replaced in their entirety and all windows replaced and re-caulked on the exterior in their entirety. All deficiencies listed above should be addressed.

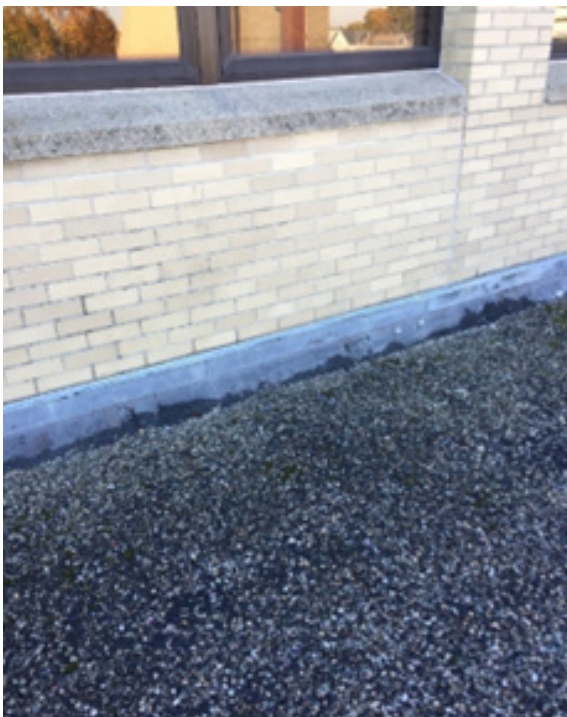
Tar and gravel roof, continuous thru-wall flashing

The entire roof system on both the original 1920's building and the 1970's addition, are in poor to failed conditions. There are numerous soft spots on the roof, metal and membrane flashings have failed.

As part of any addition/renovation project, it is recommended that all existing roof systems and associated components be replaced in their entirety.

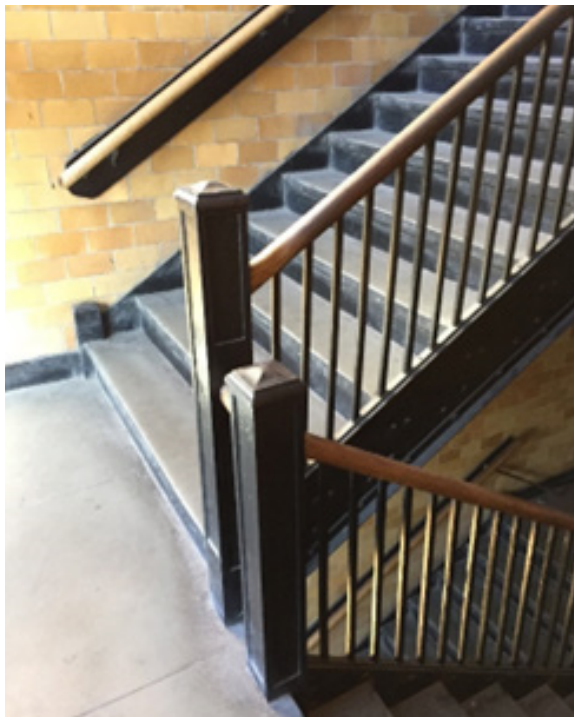
Interior stair rails and nosings non-compliant

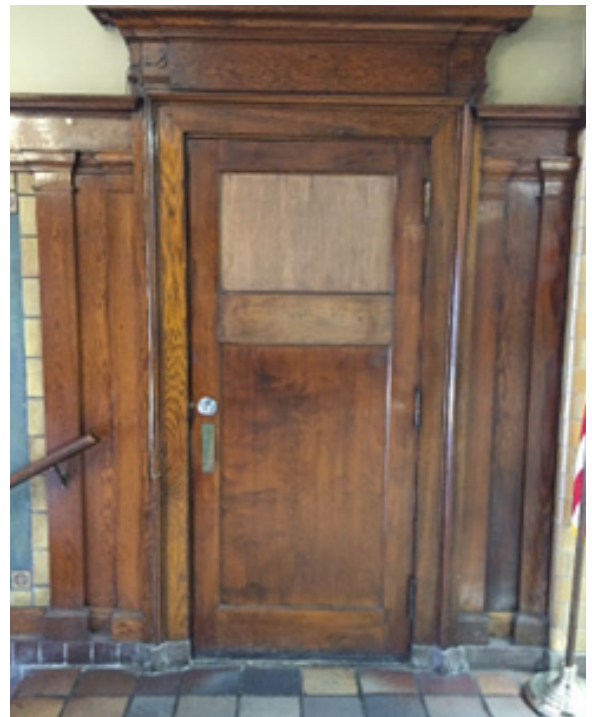
*Existing interior door and trims.
Hardware non-compliant.*

As part of any proposed addition/renovation, all existing interior doors and hardware must be replaced, as required to comply with current ADA, MAAB, and Building code requirements.

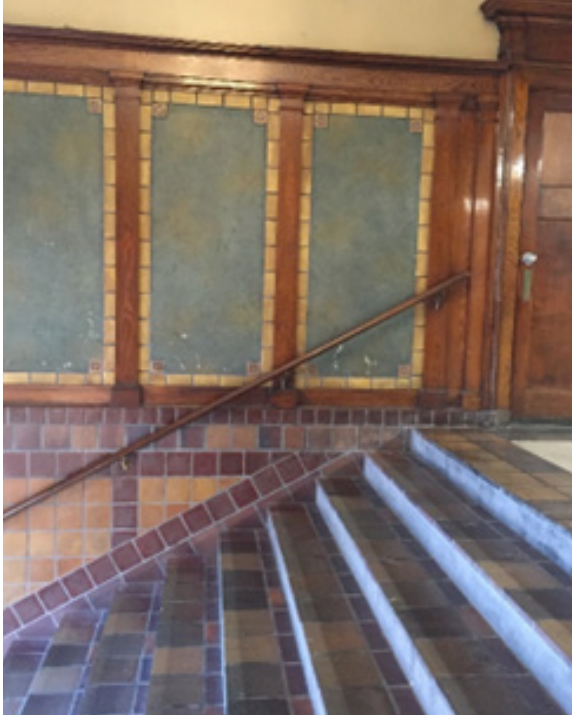
Existing interior main entry stairs non accessible

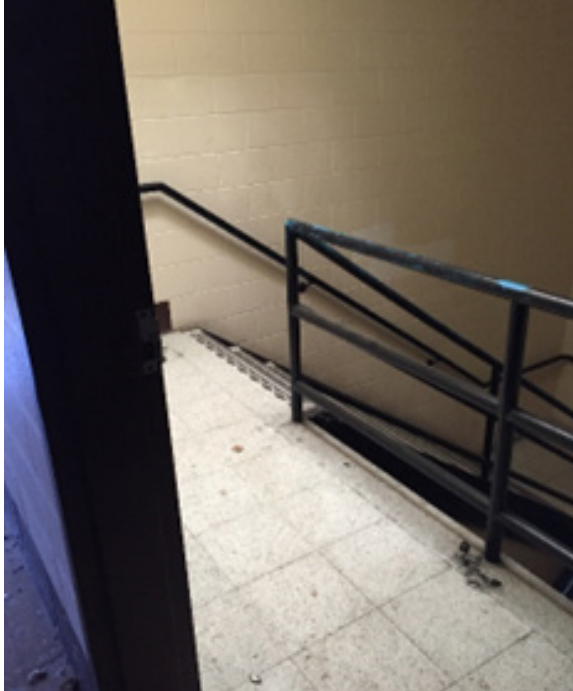
Non-compliant stairwell

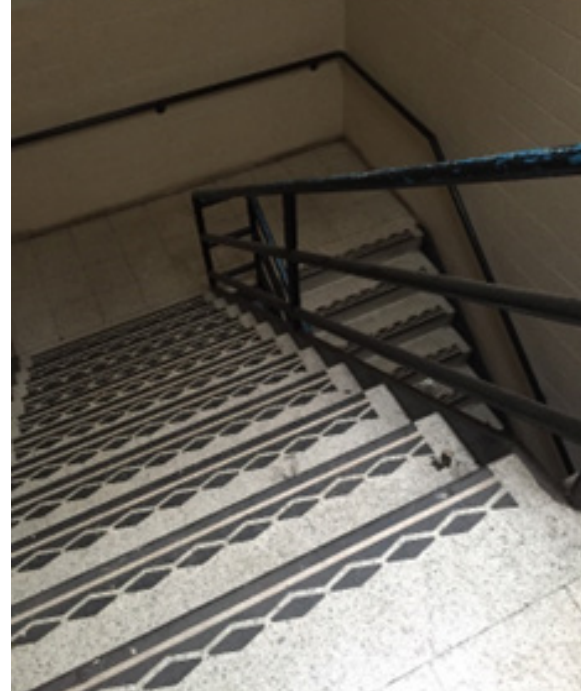
Non-compliant rails and guardrails

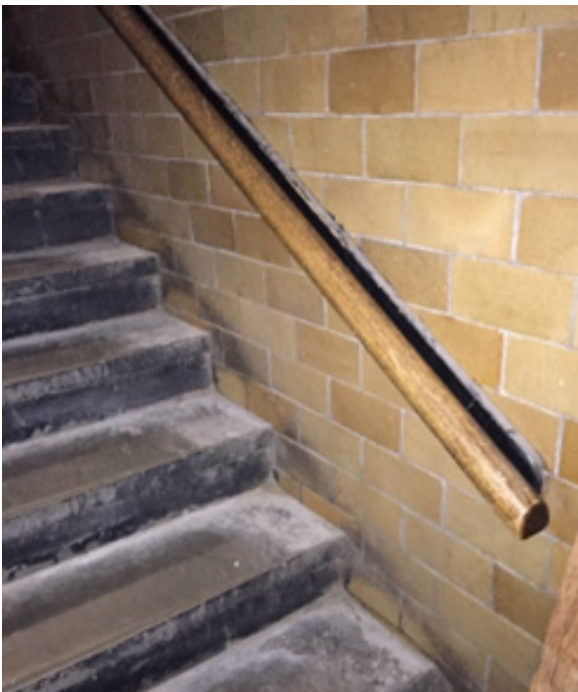
Non-Compliant rails and stair tread nosings

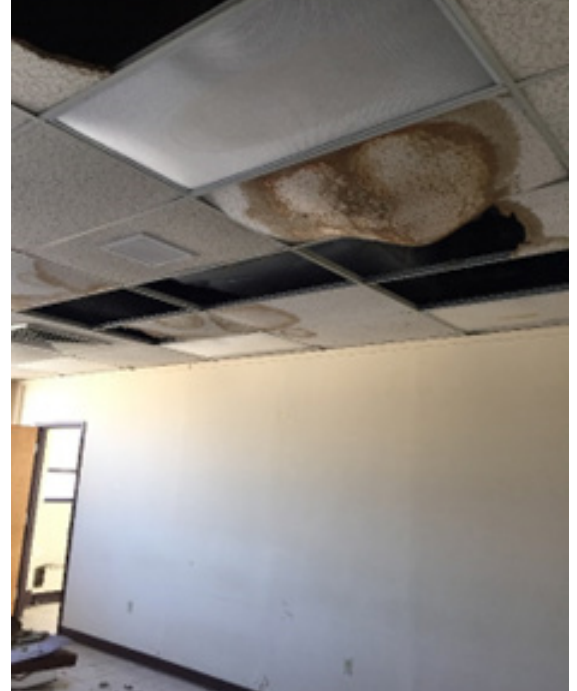
Suspended ceilings located throughout the building are in poor condition with selected individual areas (50%) exhibiting damaged or missing components. Plaster ceilings are in fair to poor condition and areas such as the boiler room exhibit sections where plaster no longer exists.

Classroom acoustical ceiling tiles

As part of any proposed addition/renovation existing ceiling systems will require complete removal and replacement. Including all grids and attachments.

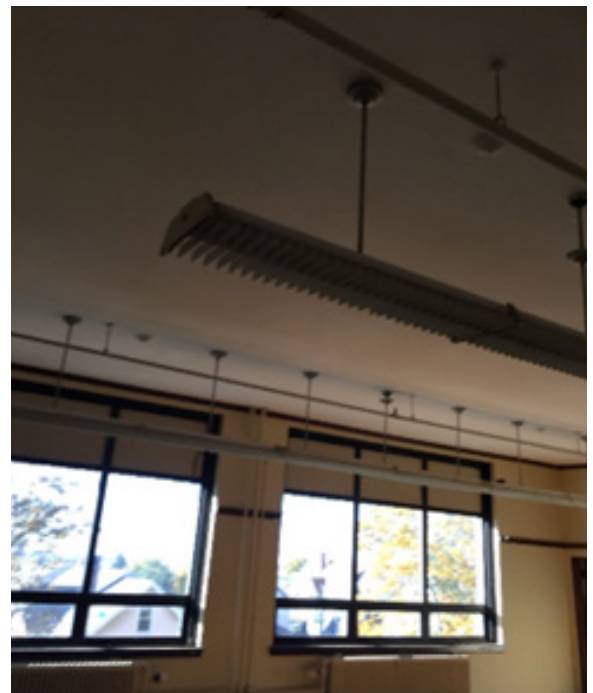
Classroom plaster ceilings

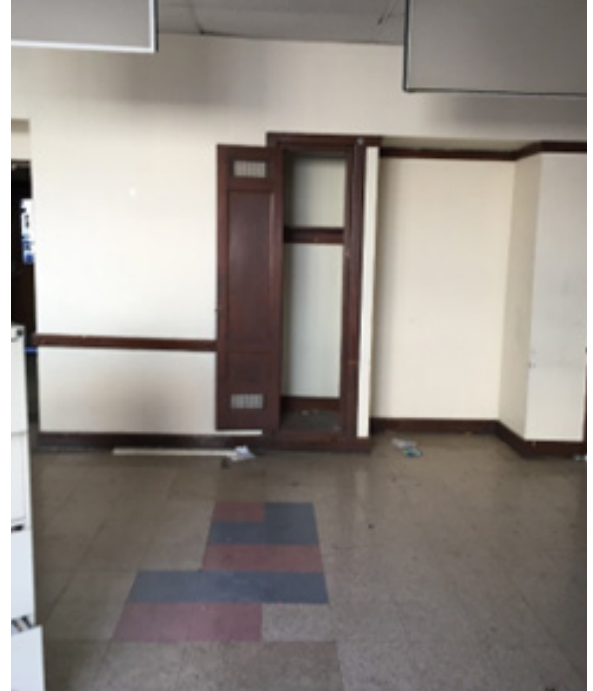
Existing floor finishes throughout the existing building are in poor condition, exhibiting varying degrees of deterioration beyond what could be considered normal wear and tear and are at the end of their useful life. See Hazardous Materials study for areas containing asbestos.

VCT & VAT floor in classroom

As part of any proposed addition/renovation, all existing floor finishes must be removed and replaced in their entirety.

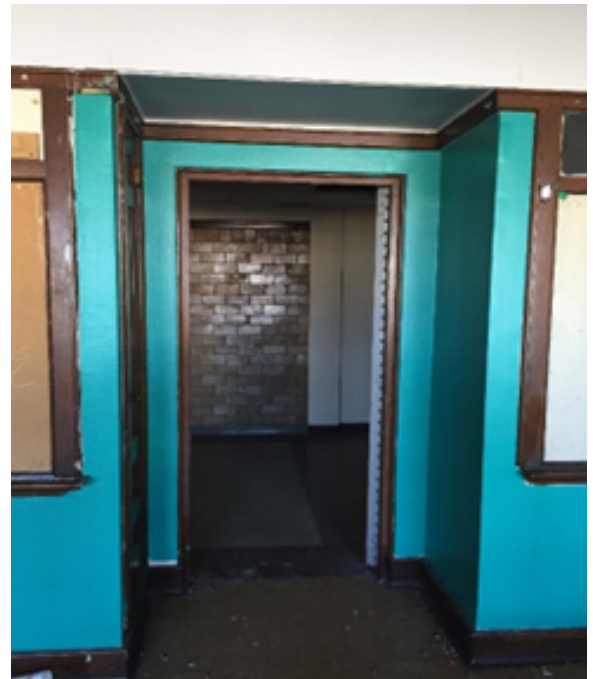
Original wood door systems in corridors and into classrooms with some hardware upgrades required

Same as above.

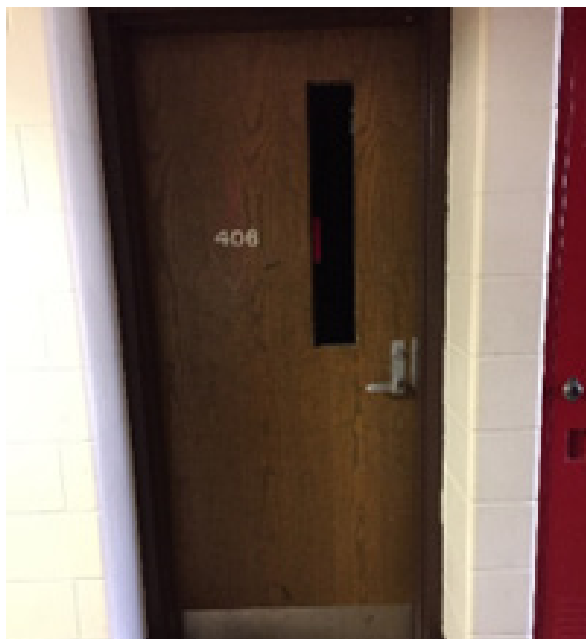
Original wood door system with hardware upgrade

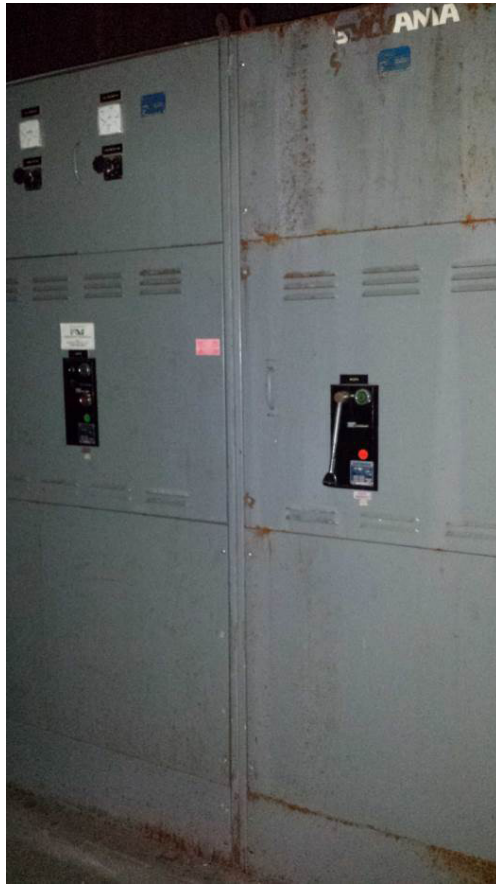
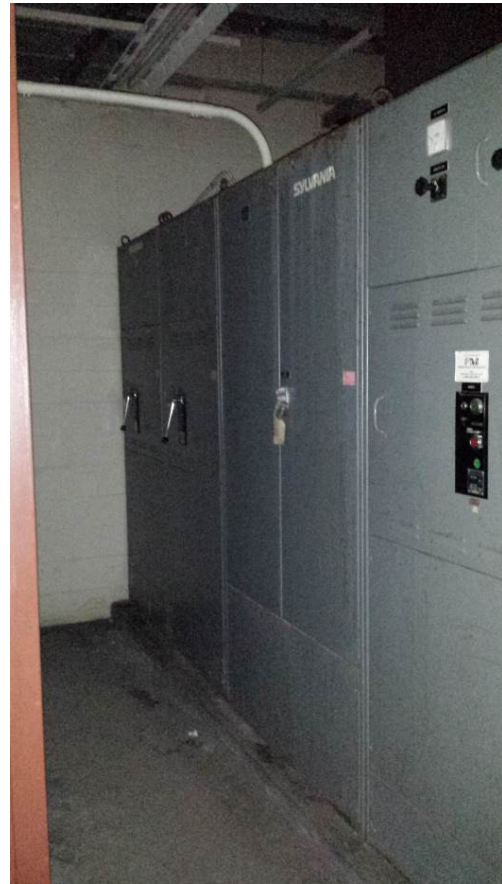
Main Switchboard

The main switchboard has utility metering and has four feeder circuit breakers with main switches that provide power to four distribution panels respectively. The utility meter is mounted across from the switchboard. The circuit breaker providing power to a distribution panel located on the third floor no longer closes and currently the third floor does not have power as a result of this.

All of the electrical distribution equipment is in poor to fair condition at best and is beyond its useful life period of 25 to 30 years.

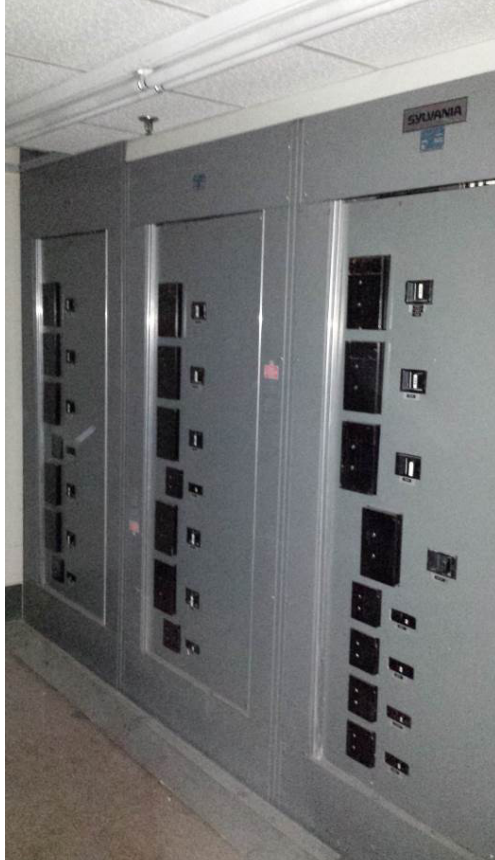
Distribution Panelboard

One of the distribution panelboards is located in the basement mechanical room, two are within electrical rooms on the first floor and the fourth is located in an electrical room on the third floor. The distribution panelboards have feeder circuit breakers that provide power to motor control centers, 277/480V panelboards and dry type transformers, the transformers provide power to 120/208V panelboards.

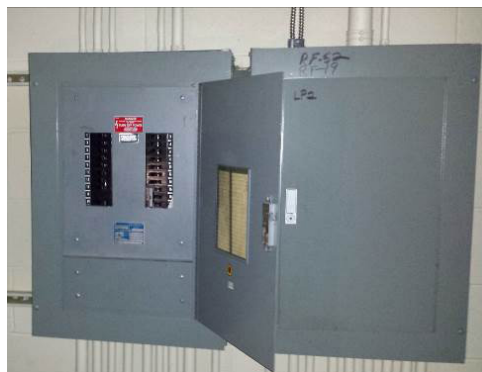
Panelboards in Electrical Room

Both the 277/480V and 120/208V panelboards are located throughout the building in electrical rooms, electrical closets and flush mounted in corridors and the kitchen. The 277/480V panelboards provide branch circuit power to lighting and small mechanical loads, the 120/208V panelboards provide branch circuit power to receptacles, small mechanical motors, and miscellaneous loads.

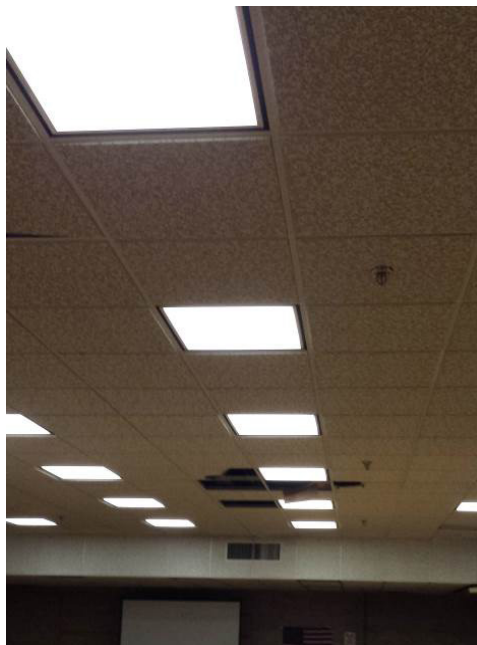
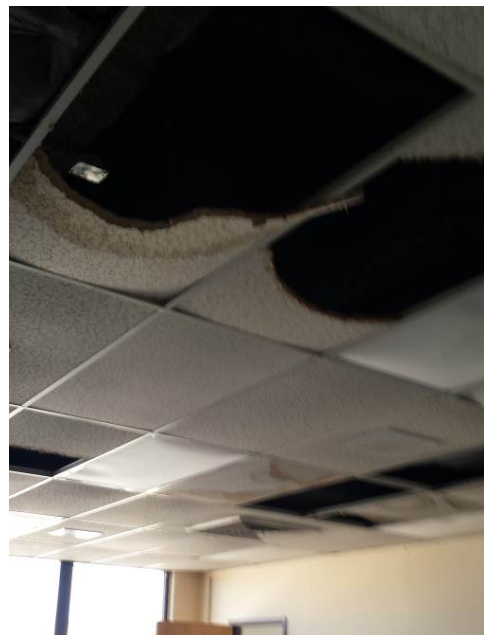
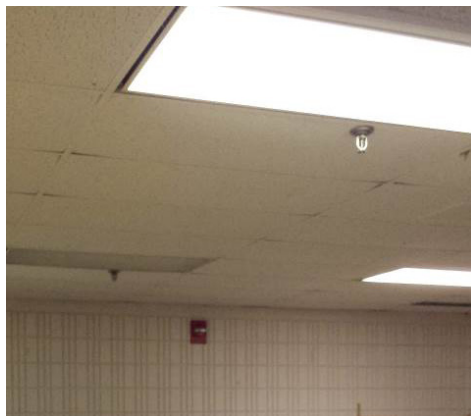
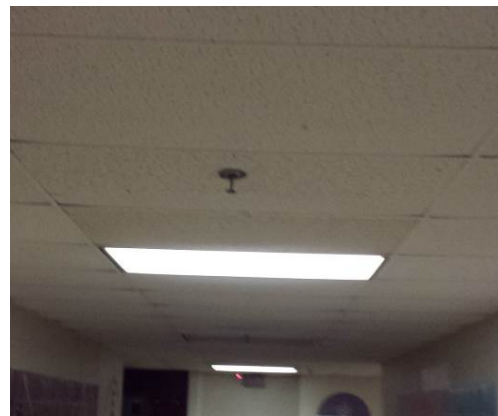
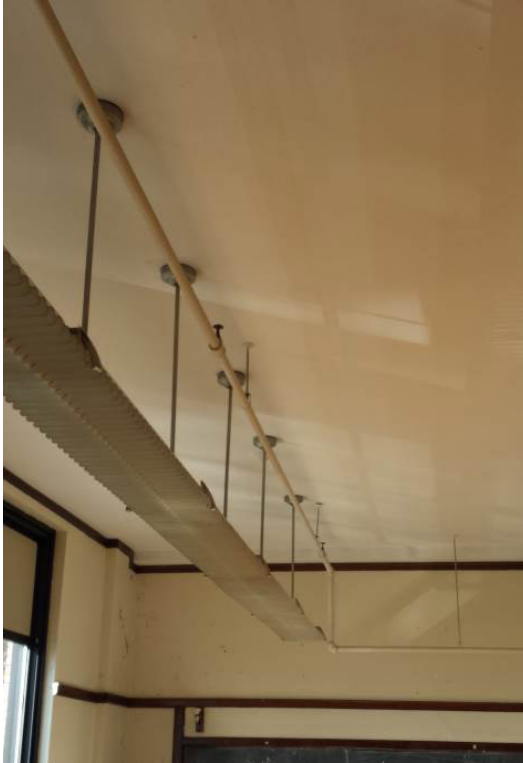
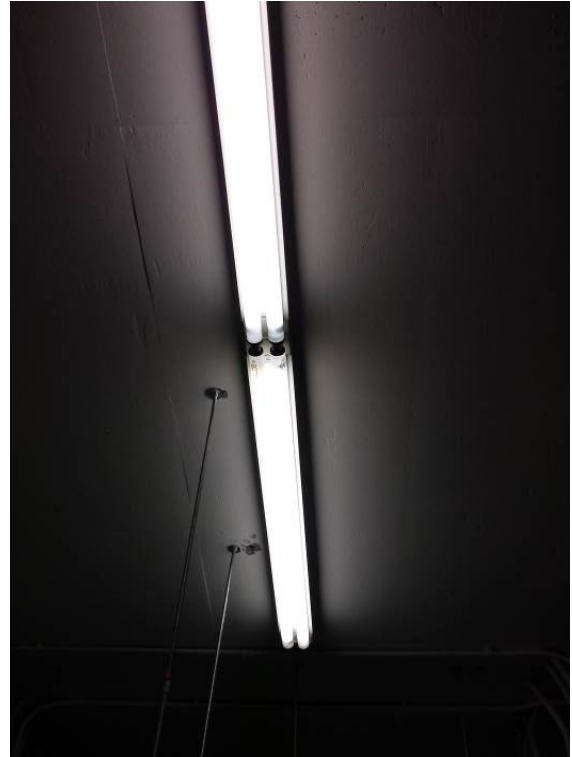
2x4 Lensed Troffer in Library

The building lighting consists primarily of recessed mounted 2x4 lensed troffer fluorescent light fixtures located in corridors, building addition classrooms, library, bathrooms, cafeteria, and kitchen areas. Pendant-mounted louvered fluorescent light fixtures are located in the original building classrooms. Industrial strip fluorescent light fixtures are located in mechanical, electrical and storage rooms.

In general, the interior lighting system is in poor condition in which many of the fixtures either have broken lenses or no lenses at all, the fixtures have passed their useful life period of 20 to 25 years. The older fluorescent technology that is installed is no longer considered energy efficient compared to today's LED fixtures.

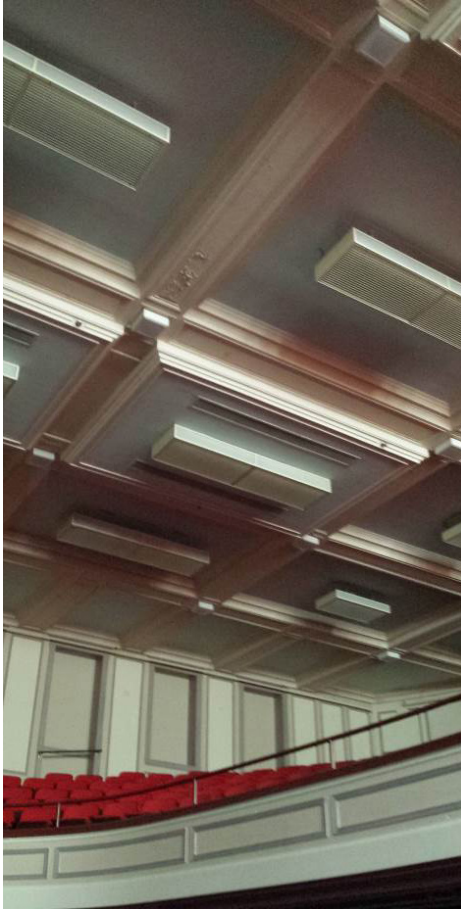
Tandem mounted surface mounted 2x4 small cell parabolic fluorescent fixtures are located in the auditorium and what appear to be high bay HPS light fixtures are located in the gymnasium.

Tandem 2x4 Parabolic in Auditorium

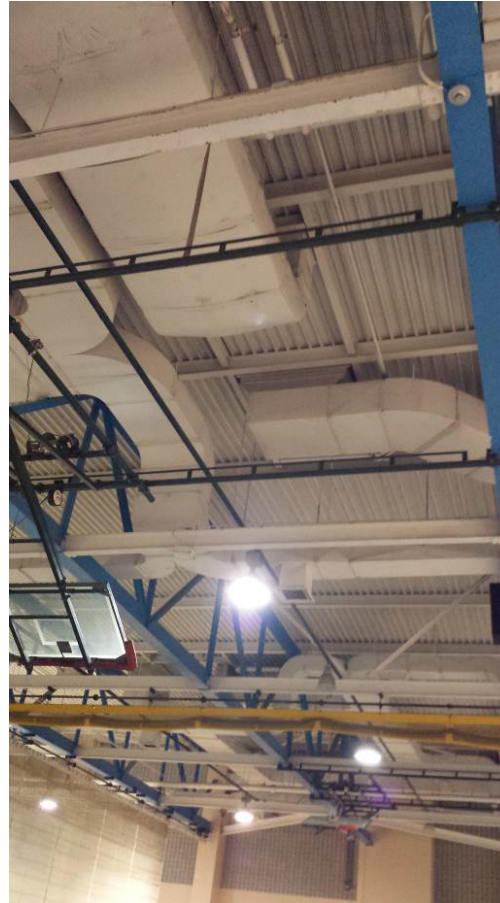
High Bay HPS in Gymnasium

- Assess the existing Gym conditions to ensure that the lighting and power are adequate for the space. Furnish and install new fire alarm devices (pull stations and speaker-visual devices) throughout the space.

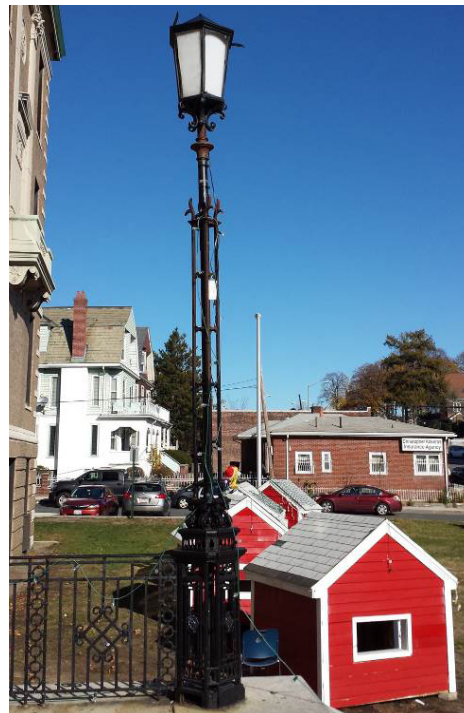
There are a few building-mounted wall pack lights that provide perimeter lighting around the building, these fixtures appear to be in poor condition. The front street entrance to the original building has architectural streetlights on either side of the entrance stairs, these appear to be in fair to good condition.

Architectural Street Light at Front Street Entrance

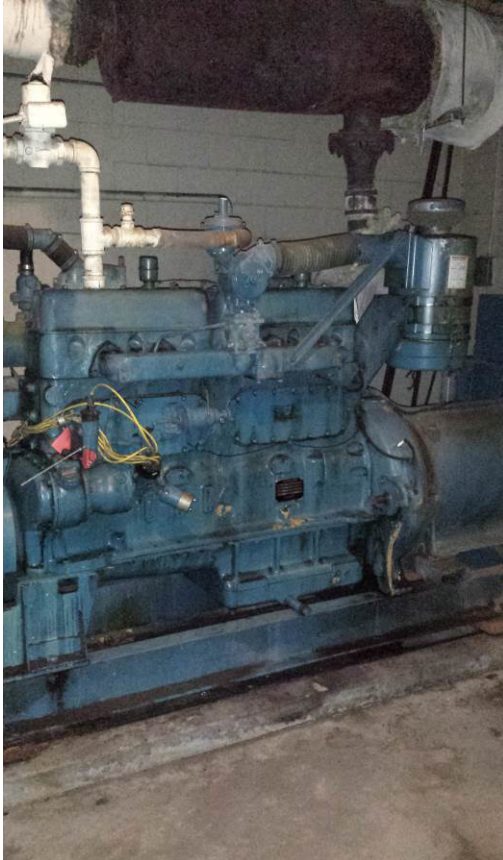
Generator

The building has a 170KW, 277/480V, 3-phase gas engine generator located in the basement mechanical room just adjacent to the main electrical room. The generator provides power through a 400 Amp automatic transfer switch located within this same location. The transfer switch provides power to an emergency power distribution panel which has feeder circuit breakers that provide power to 277/480V panelboards located on each of the floor levels. The panelboards provide power to dry-type transformers and light fixtures. These light fixtures are designated as emergency lighting fixtures which provide code-required emergency egress lighting. The 120/208V panelboards provide power to various heating equipment, refrigeration equipment and miscellaneous loads. The system is not separated into an emergency power and standby power system and the equipment does not appear to be located in two-hour fire rated rooms as required by today's electrical code.

The emergency power system is in poor condition and is beyond its useful life period of 25 to 30 years. The gas generator is not properly vented. The system does not comply with current electrical and life safety code requirements. Separation between Life Safety and Standby power is required.

- Replace the emergency power system with an exterior diesel fueled generator with proper separation between emergency and standby power.
- Replace the entire fire alarm system with a new addressable voice evacuation notification system and annunciator panels with microphones. Smoke detector detection would be added within all corridors and large gathering areas. New automatic detection and signal detection would be new.

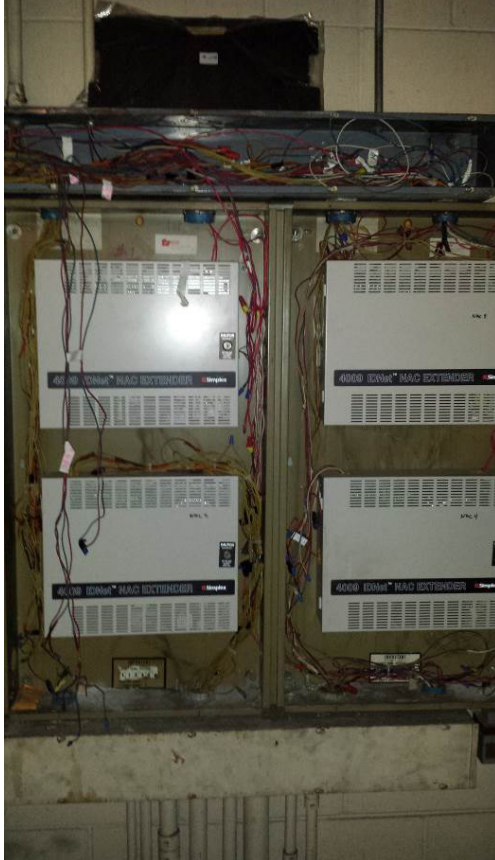
The fire alarm system consists of an addressable non-voice notification system manufactured by Simplex. The system infrastructure appears to be original to the building addition/renovation but looks to have had front-end equipment and horn/strobe devices replaced within the last 10 years or so. The main fire alarm control panel could not be located via the site investigation but is assumed to be in the original building occupied by the charter school. Within the basement mechanical room where the original control panel was located, the equipment has been replaced with newer notification extenders that tie into the original existing circuitry. The fire alarm remote annunciator panel is located in the main front entrance of the original building. Existing drawings indicate that the system communicates with a master box to provide city fire department notification.

Original Control Panel with new Equipment

The fire alarm notification is inadequate for a school building with no notification devices within classrooms and is not compliant with current codes for voice notification. The maintenance staff indicated that the system is having many issues with ground faults and equipment is constantly tripping and parts must be replaced.

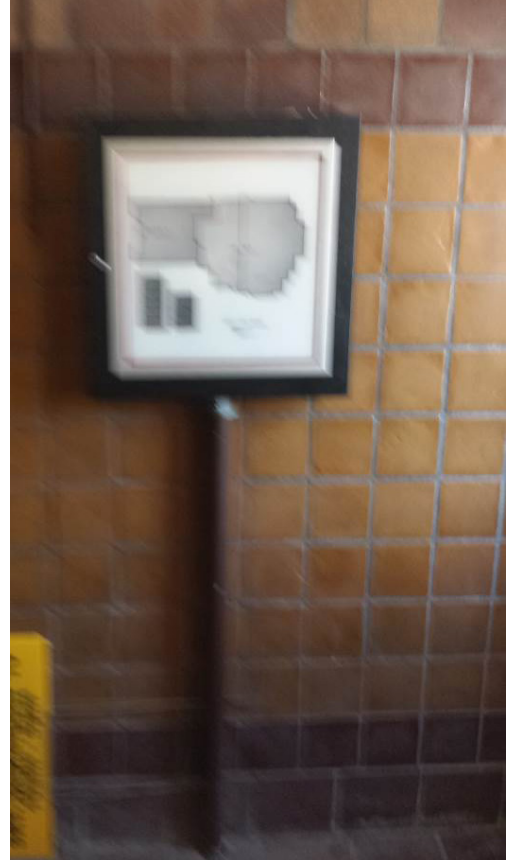
Annunciator in Man Entrance Lobby

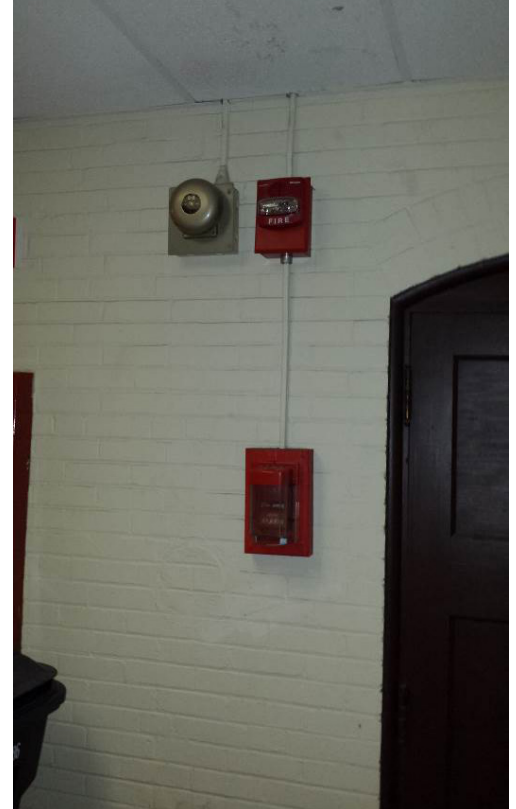
Pull stations and horn/strobes appear to be adequately located throughout the corridors and large gathering areas, but not located within classrooms. There were no smoke detectors observed to be installed in the building.

Horn Strobe and Pull Station
